## Germolles' palace wall paintings: an interdisciplinary project for the rediscovery of a unique 14th century decoration

Book Title: Digital Techniques for Documenting and Preserving Cultural Heritage

# WALL PAINTINGS IN THE CHÂTEAU DE GERMOLLES: AN INTERDISCIPLINARY PROJECT FOR THE REDISCOVERY OF A UNIQUE FOURTEENTH-CENTURY DECORATION

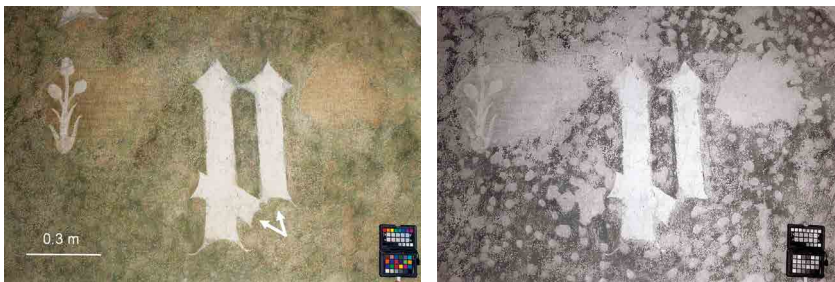
**Figure 4.4. VIS and IR (approx. 830–1000 nm) photographic images of the letter P highlighted in figure 4.3. Arabesques in the lower part of the letter P are indicated in the VIS image. They seem to disappear in the IR image. Photos: Francesca Piqué, 2016.**

The extent of conservation work carried out in the twentieth century was revealed by infrared (IR) pictures (approx. 830–1000 nm) of the details of the walls, produced with a modified Canon EOS 5D Mark II digital camera which was equipped with filters and illuminated with a halogen Lowel V (500 W) light (Piqué 2013). Owing to the difference in IR absorption between the original and the repainted green background, the infrared pictures show clearly both the original and non-original areas. The losses caused by the nineteenth-century keying process were filled after the concealing stucco plaster had been removed. The missing decoration was recreated over these fills by repainting with material of

high IR reflection, while the authentic copper-based green which remained in the original portions of the plaster, had low IR reflection (high absorption) (fig. 4.4).

Furthermore, the embellishments (such as the arabesques) at the lower extremities of the P, in figure 4.4, are less visible in the IR image. Hyperspectral imaging was used to investigate these embellishments further. The CCD camera (HS-XX-V10E), developed by SPECIM, has a  $1600 \times 840$  pixel resolution, a spectral resolution of 2.8 nm and a wavelength range between 400 to 1000 nm. The wall paintings were illuminated by two halogen lamps oriented at  $45^\circ$ . The data processed with ENVI 5.2 + IDL software produced an RGB image (R = 650 nm; G = 540 nm; B = 450 nm) and grayscale images at wavelengths ranging from 500 to 1000 nm. These pictures were used to indicate specific features such as the original profile of the P letters (a dotted white line in the image at 1000 nm, in fig. 4.5) and their embellishment by the medieval artists (dotted red line on RGB image, in fig. 4.5). The arabesques were added over the original green background and each letter P was embellished differently.

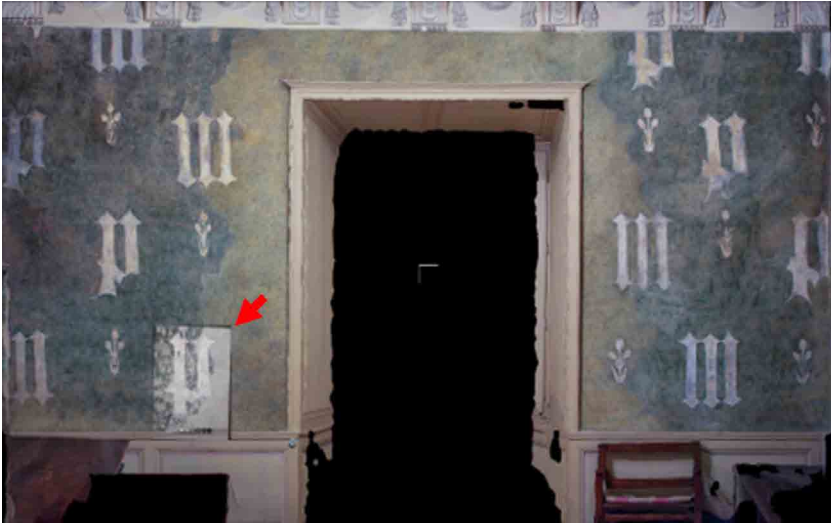
**Figure 4.15.** Snapshot from the SIVT application tested on Germolles case study data. The rectified and registered IR image of the P (red arrow) is displayed on top of the orthophotography of room dn south wall. Photos: Stefanie Wefers and Tobias Reich, 2016 and Francesca Piqué, 2013.

Another promising application, Spatial Image analysis and Viewing Tool (SIVT) (Wefers 2016) was tested to provide a combined visualization and analysis of images of the details of the Germolles wall paintings. Different 3D data sets, including orthophotograph of room dn south wall, were registered and integrated into SIVT as basemaps. Images of the details of the wall painting (such as an IR image of the same P as in fig. 4.14) were semi-automatically registered, allowing a combined visualization of the orthophotograph and detailed images (fig. 4.15). This alignment process may potentially enable locating pictures of the wall details, taken during a conservation campaign for documentation, condition monitoring, or conservation intervention.
