WALL PAINTINGS IN THE CHÂTEAU DE GERMOLLES: AN INTERDISCIPLINARY PROJECT FOR THE REDISCOVERY OF A UNIQUE FOURTEENTH-CENTURY DECORATION

CHRISTIAN DEGRIGNY and FRANCESCA PIQUÉ

Keywords: Château de Germolles, dukes of Burgundy, Middle Ages, wall paintings, tin leaf decoration, spatial and spectral imaging techniques, COSCH

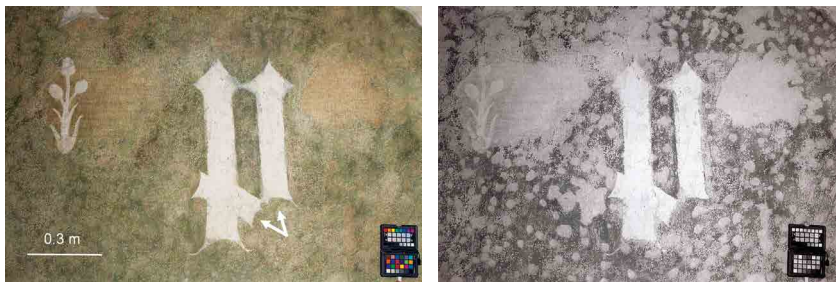
Figure 4.4. VIS and IR (approx. 830–1000 nm) photographic images of the letter P highlighted in figure 4.3. Arabesques in the lower part of the letter P are indicated in the VIS image. They seem to disappear in the IR image. Photos: Francesca Piqué, 2016.

The extent of conservation work carried out in the twentieth century was revealed by infrared (IR) pictures (approx. 830–1000 nm) of the details of the walls, produced with a modified Canon EOS 5D Mark II digital camera which was equipped with filters and illuminated with a halogen Lowel V (500 W) light (Piqué 2013). Owing to the difference in IR absorption between the original and the repainted green background, the infrared pictures show clearly both the original and non-original areas. The losses caused by the nineteenth-century keying process were filled after the concealing stucco plaster had been removed. The missing decoration was recreated over these fills by repainting with material of

high IR reflection, while the authentic copper-based green which remained in the original portions of the plaster, had low IR reflection (high absorption) (fig. 4.4).

Furthermore, the embellishments (such as the arabesques) at the lower extremities of the P, in figure 4.4, are less visible in the IR image. Hyperspectral imaging was used to investigate these embellishments further. The CCD camera (HS-XX-V10E), developed by SPECIM, has a 1600×840 pixel resolution, a spectral resolution of 2.8 nm and a wavelength range between 400 to 1000 nm. The wall paintings were illuminated by two halogen lamps oriented at 45° . The data processed with ENVI 5.2 + IDL software produced an RGB image (R = 650 nm; G = 540 nm; B = 450 nm) and grayscale images at wavelengths ranging from 500 to 1000 nm. These pictures were used to indicate specific features such as the original profile of the P letters (a dotted white line in the image at 1000 nm, in fig. 4.5) and their embellishment by the medieval artists (dotted red line on RGB image, in fig. 4.5). The arabesques were added over the original green background and each letter P was embellished differently.
