Axane commitment for a sustainable, reliable, and field proven power source through partnership with laboratories and design efforts

**J. André¹, N. Caqué¹, E. Rossinot¹, E. Claude¹,
M. Chatenet², L. Dubau², F. Maillard²,
L. Flandin³, C. Bas³, G. De Moor³
O. Lottin⁴, G. Maranzana⁴, J. Dillet⁴**

First degradations phenomena experienced

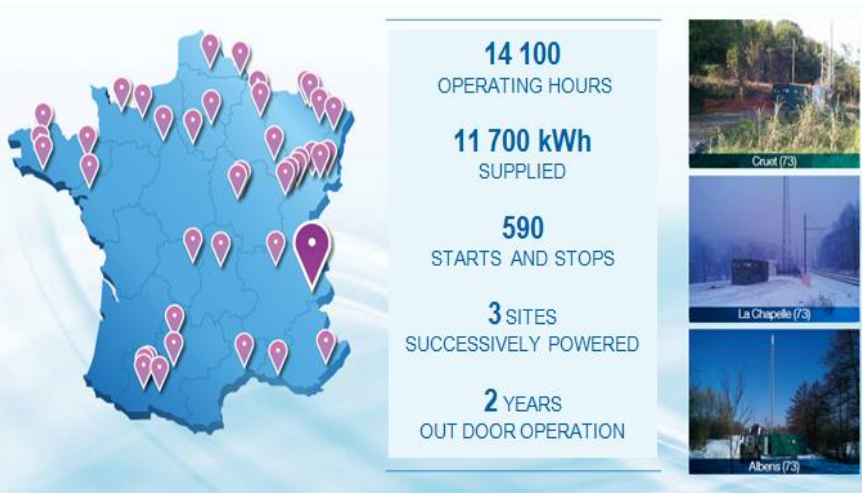
NRJ Container # 21 reached 14.100 operating hours without failure
System was stopped at the end of the contractual operation period

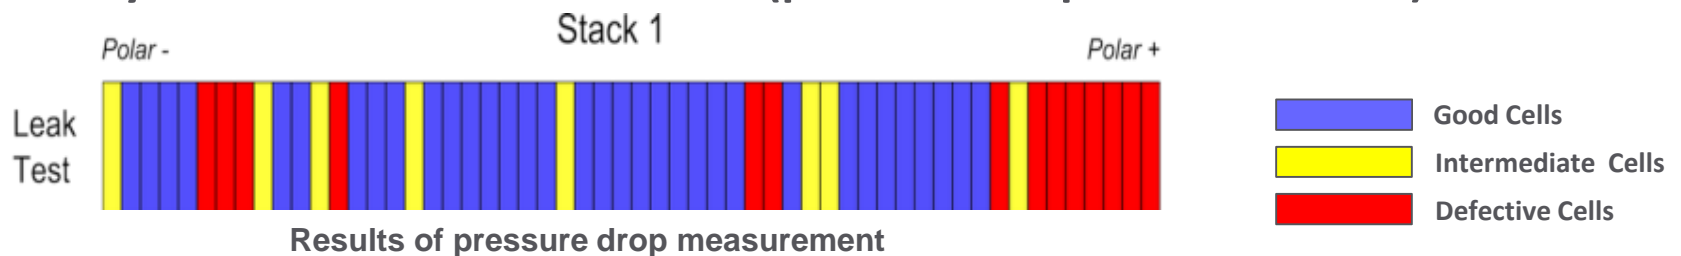
Two 55-cells stack shut down after failure of air humidifier after 1500h

=> System fault due to H₂ leak

=> Every cell tested to localised leak (pressure drop measurement)

➤ Several membranes failed after 1500 h

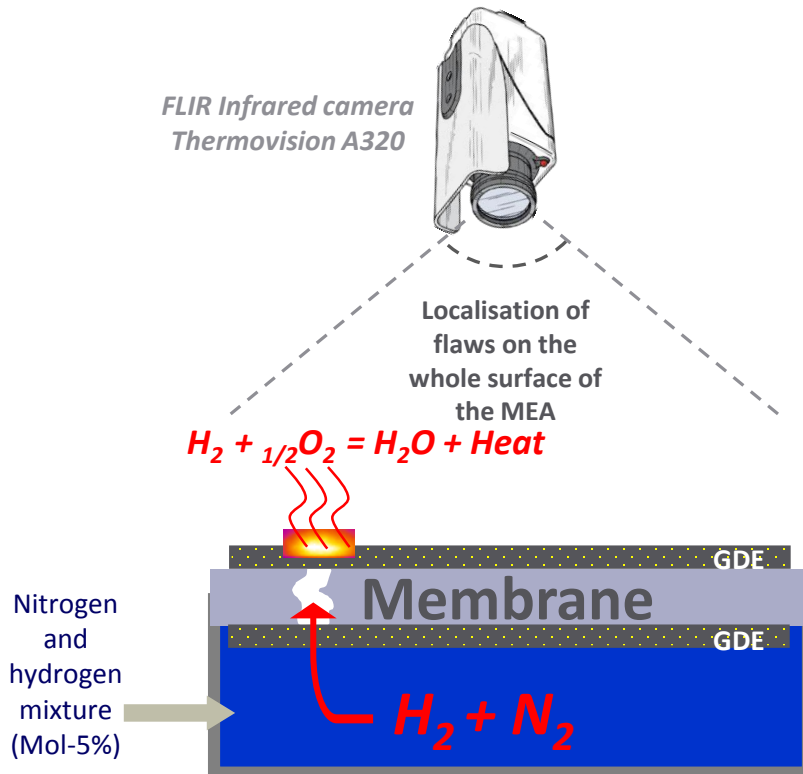
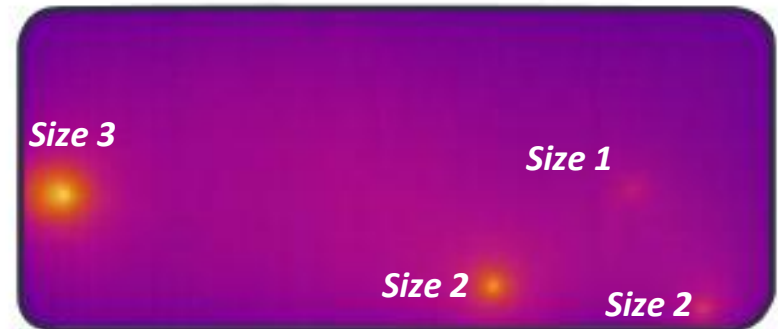
Infrared Thermography

Temperature \rightarrow defect size

The flaws are classified as a function of the generated heat recorded by the camera

➤ Localisation and quantification of membrane defects

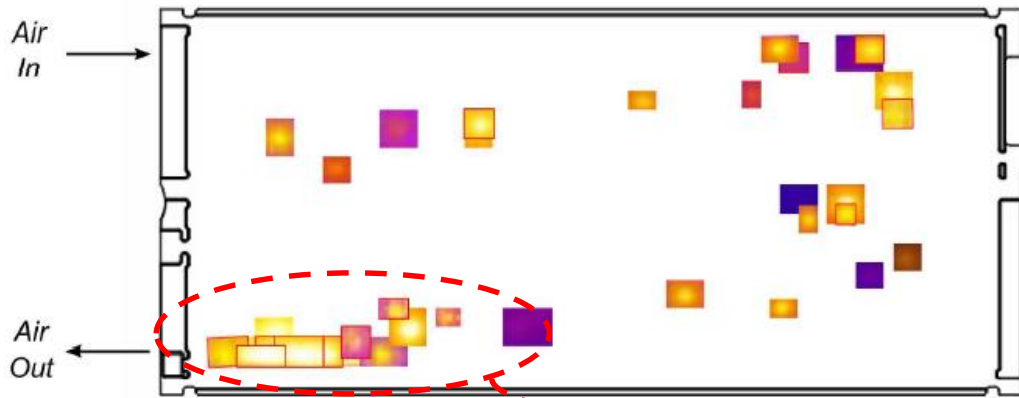
Stack 1 → total flaws detected on the 55 cells¹

Responsible for stack shut-down

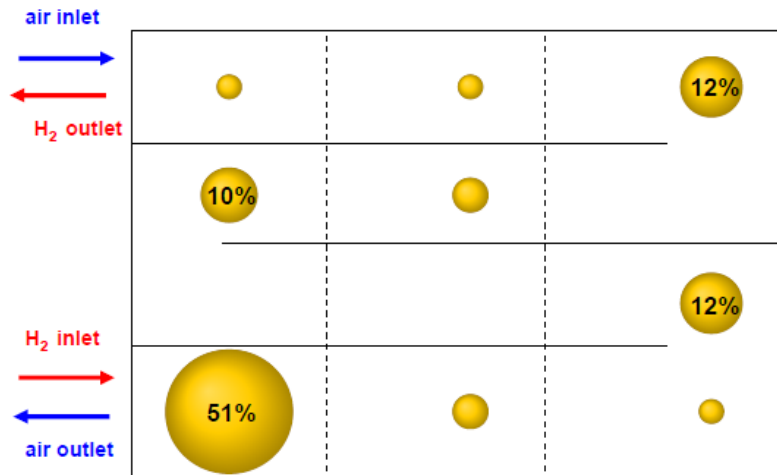
Cracks with length ranging from 0.5 to 1.2 mm promoting unsafe level of H₂ leak

- Critical defects appeared more frequently near air outlet (H₂ inlet)
- Cathode flooding? May be promoted by humidifier failure (=> insufficient air flow)
- Larger pinholes look like mechanical tears => mechanical constraints
- Degradation specific to cell design

Ways of improvement:

- => tougher membrane material (mechanical reinforcement, chemical stabilizers...)
- => better air and H₂ management :

- Threshold air flow to ensure water removal,
- when possible, hydrogen humidification thanks to recirculation,
- cell re-design bearing in mind the goal to homogeneously “feed” the cells at both local and global scale: ensuring proper channel to channel distribution, reduce channel and land width, help O₂ rich flow reach cathode outlet while avoiding inlet drying.

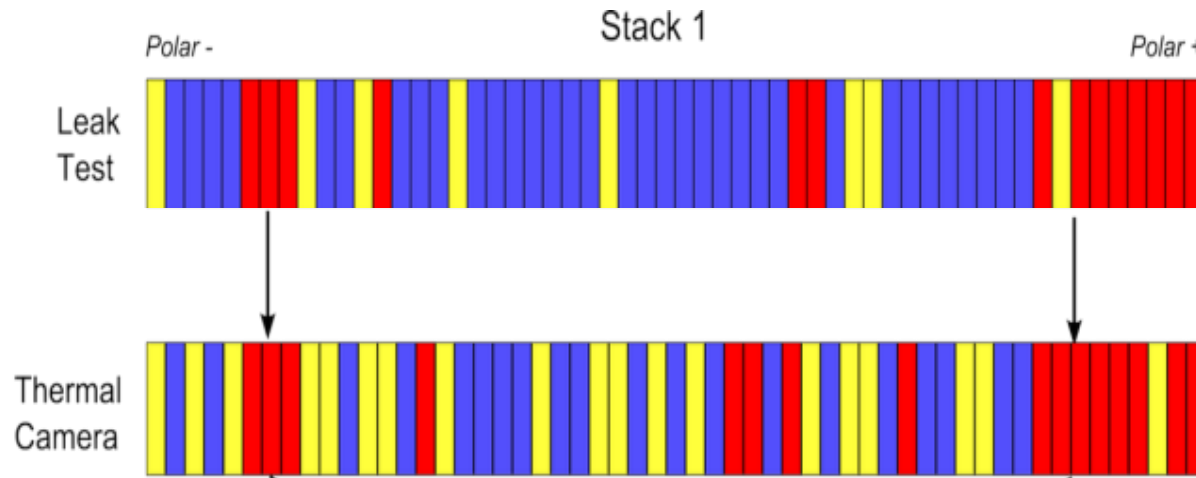
=> All MEAs of stack 1 were characterised with thermal camera setup

- Pressure drop and thermal camera results are consistent
- Infrared thermography is much more sensitive (IR able to disqualify « leak proof » MEAs with local membrane weaknesses)

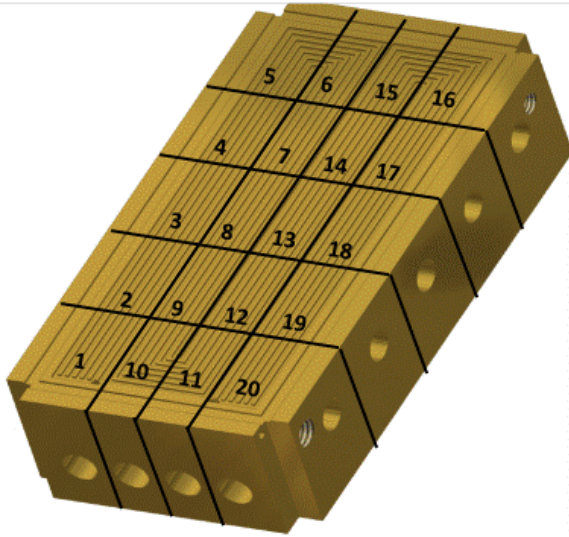
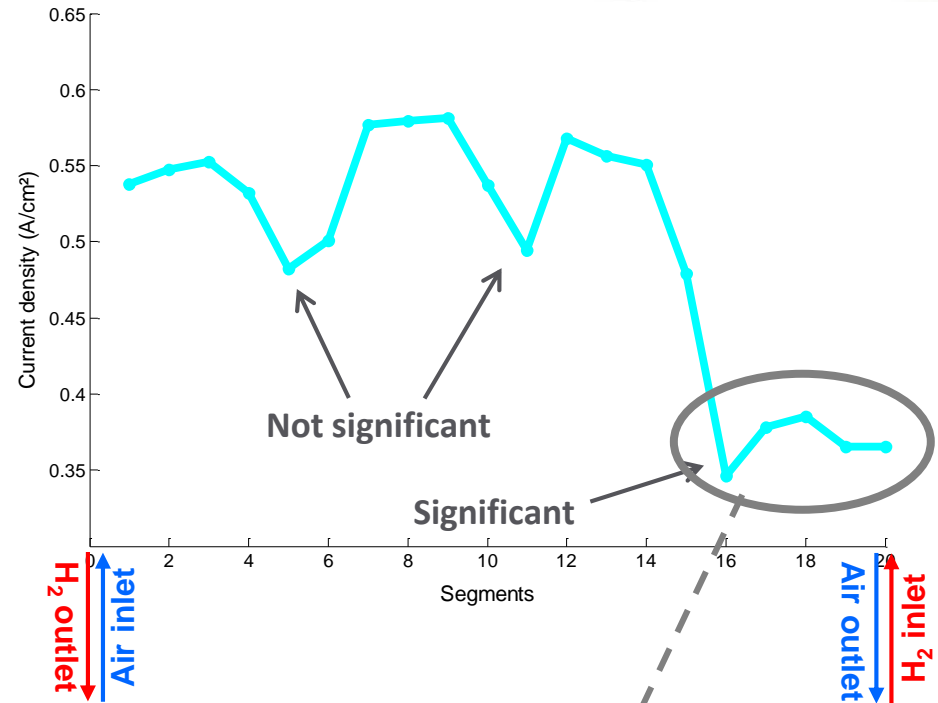
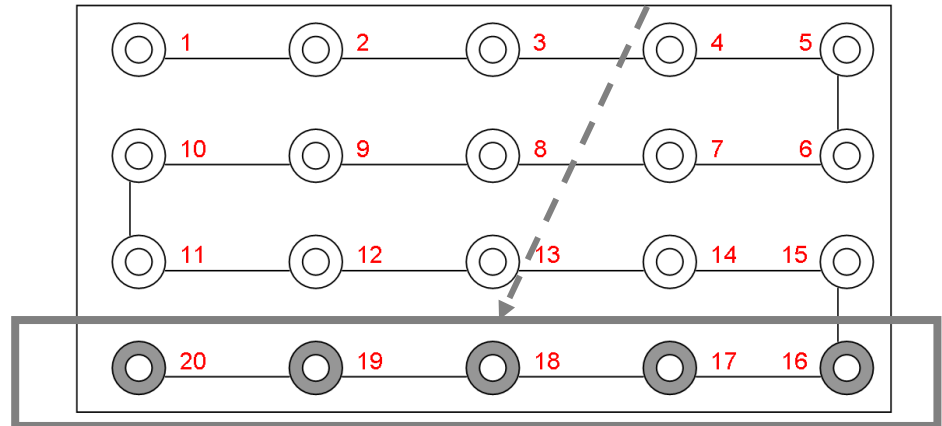
- Segments with a lower current density at nominal operating point.
- Oxygen starvation, flooding.

Heterogeneous channel length linked to gas port positioning (same cell side) !

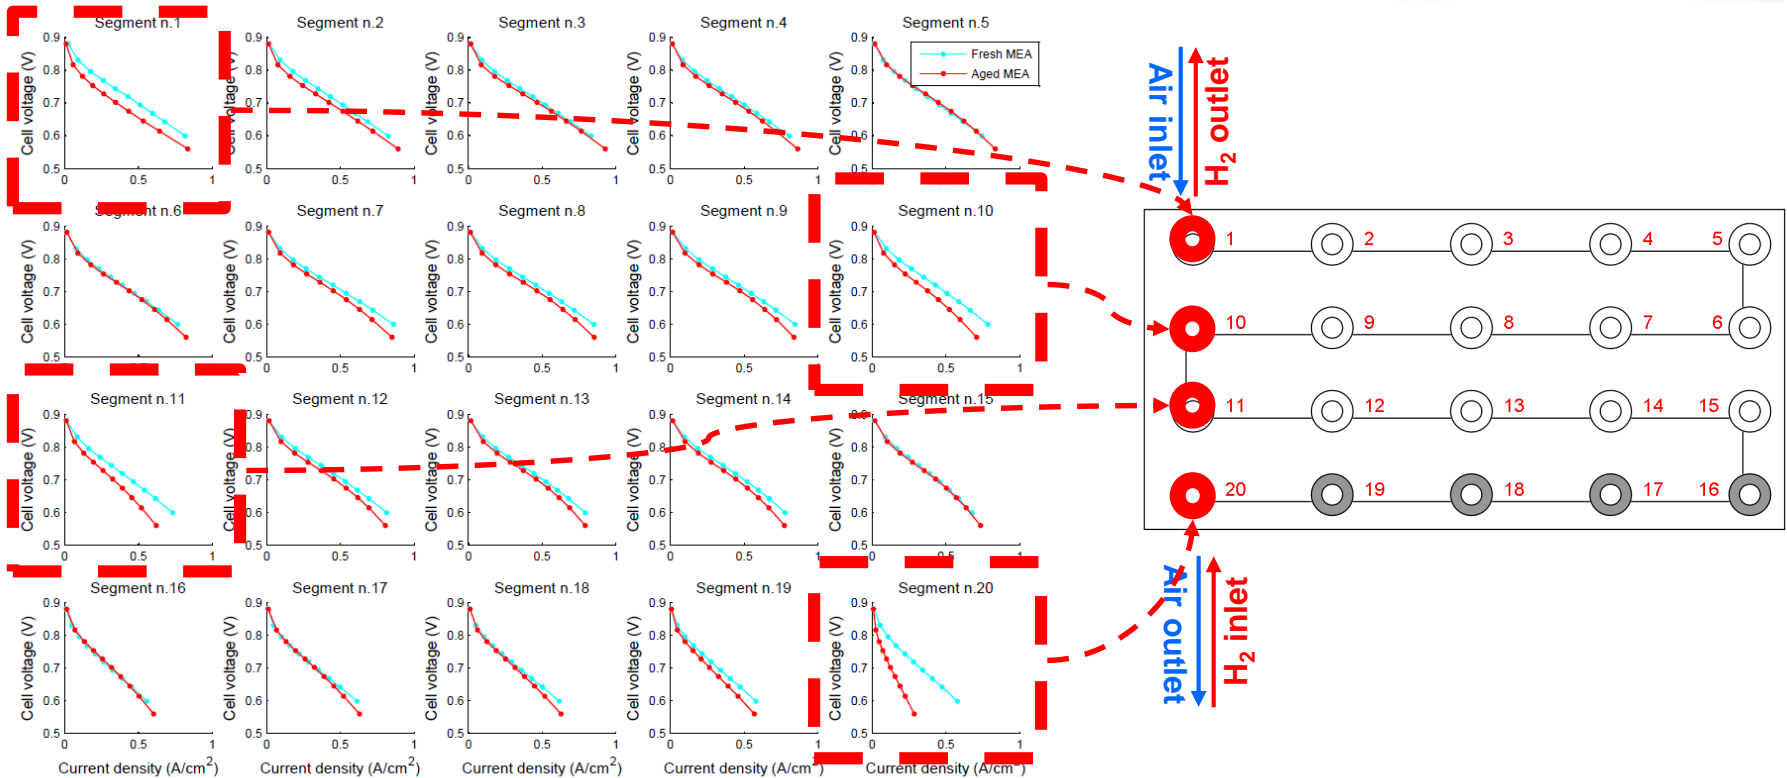
- Carbon corrosion at cathode inlet (start & stop)
- Segments between inlets and outlets are also more degraded
- Assumption: dry H₂ bypass => anode purges lead to strong drying => dry/wet cycling, may be related to PEM defects
- Degradation phenomena still related to the hardware design

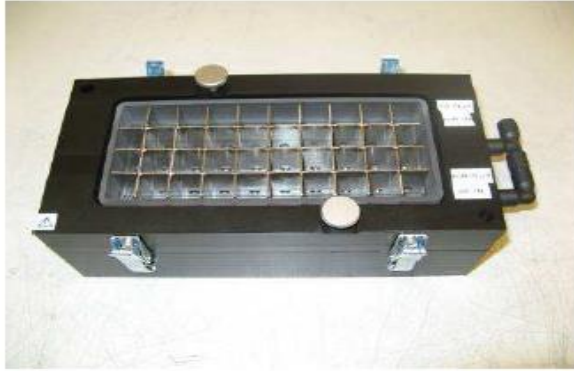
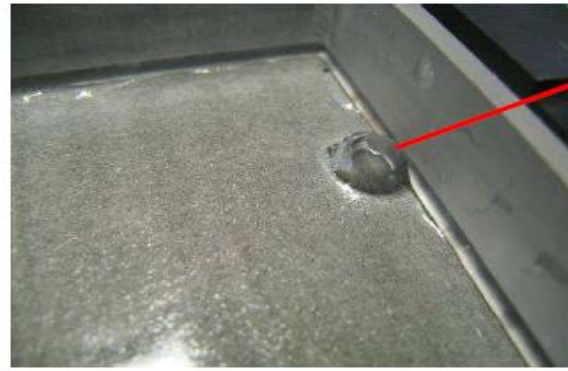
A closer look at air outlet / H2 inlet area

air bubble

Bubble mapping device applied to localize pinholes through MEAs

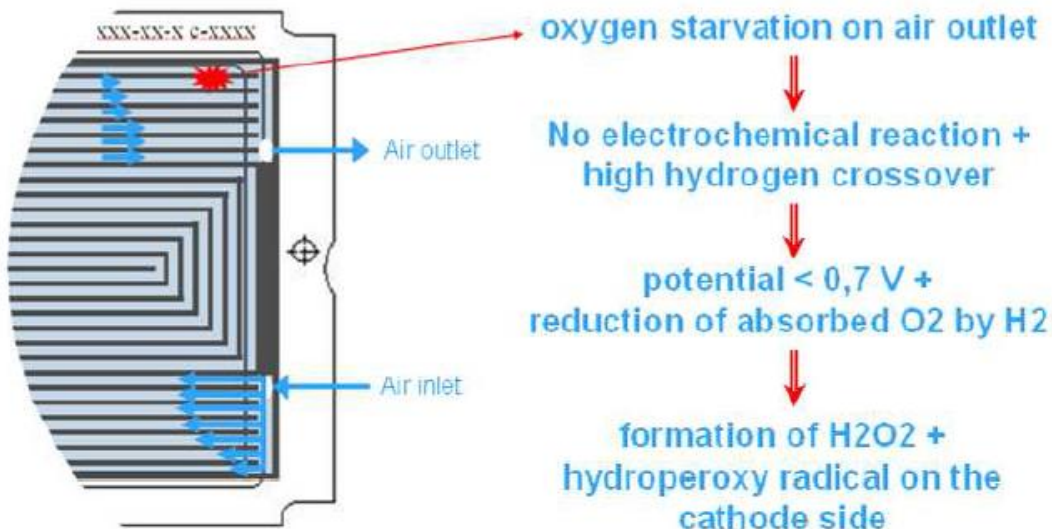
Specific degradation mechanism in this area ?

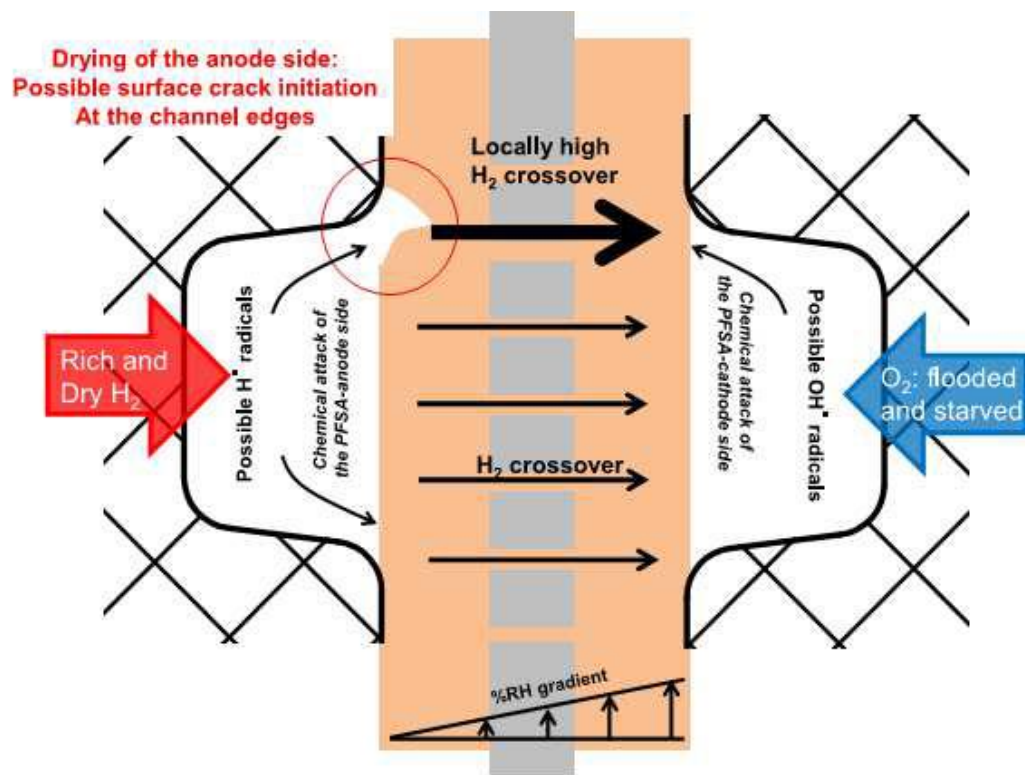
3-layered membrane after 12800 hours of operation

Chemical degradation initiated on anode side, cathode side degradation enhanced after ~70% thickness loss on the anode

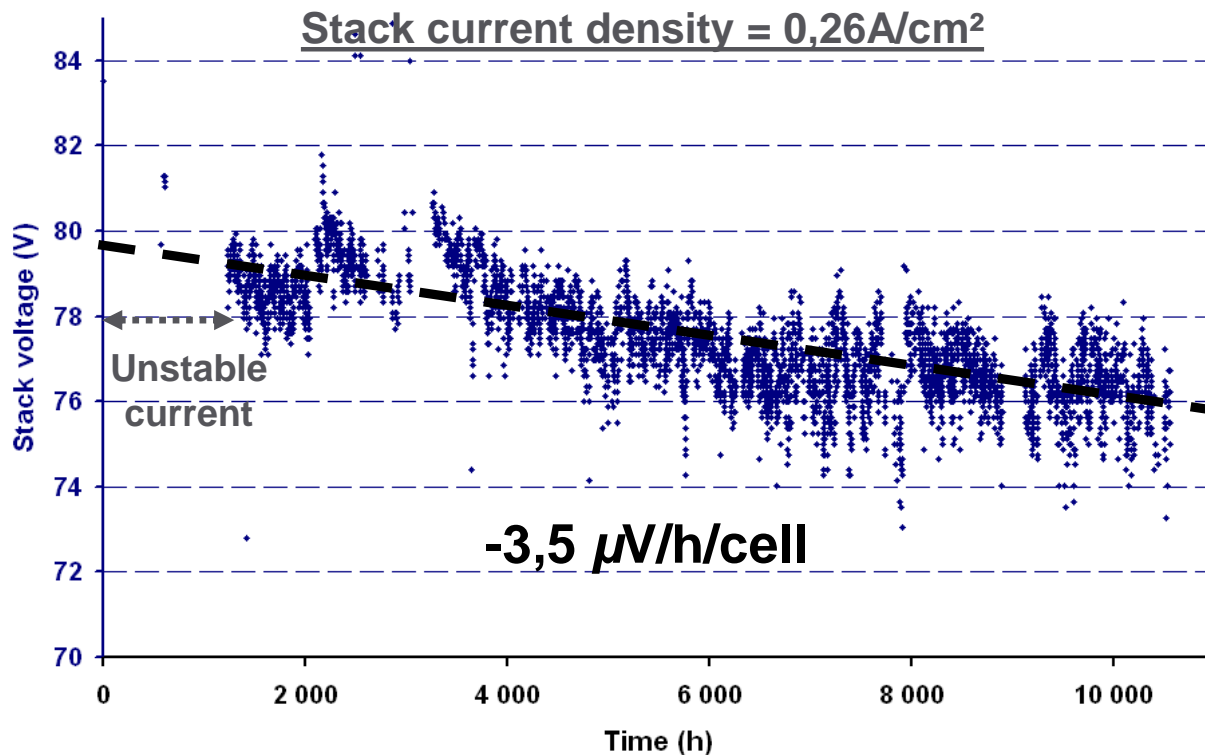
- Large increase of membrane lifetime
- Low performance degradation probably related to catalyst layer degradation
- Catalyst layers undergo heterogeneous ageing too¹
- New target: ↗ performances and ↘ CL aging in various operating condition
=> ↗ stack efficiency => ↘ H₂ consumption
