Mechanical behaviour of different type of shear band connections being used in reconstruction housing in Nepal

Santosh Yadav, Yannick Sieffert, Eugénie Crété, Florent Vieux-Champagne,
Philippe Garnier

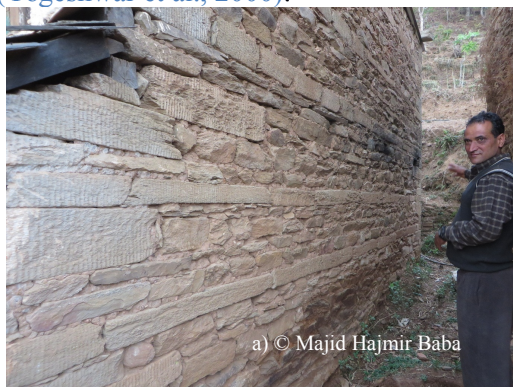
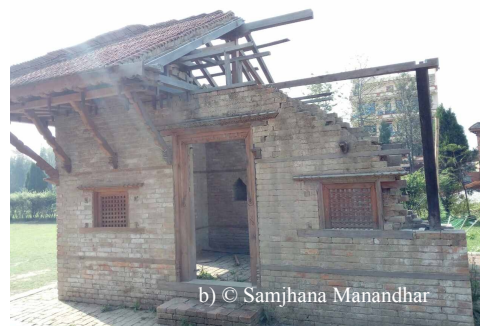
Figure 2. a) Use of stone as a shear band, b) Timber shear band in brick masonry, c) Use of concrete and timber shear band in clay mortar masonry and d) Concrete shear band in cement mortar masonry building

Figure 2 a) shows the use of stones as shear bands in the Gatlang village of Rasuwa District which was constructed before the earthquake in 2015 and resisted well during the seismic action. Similarly, timber shear band used in brick masonry structure can be seen in Banepa as shown in Figure 2 b) where the complete collapse of the roof occurred during 2015 earthquakes, which might be due to the heavy weight of the roof or lack of proper connections between the walls and the roof. After 2015 earthquakes, people started using shear bands as they understood their relevancy as an aseismic feature. Moreover, different NGOs and INGOs have started training masons on properly implementing shear bands. Figure 2 c) shows the use of concrete and timber shear bands in stone masonry structures with clay mortar in Megapauwa, Dolakha district, and in Figure 2 d), a concrete shear band can be seen in a stone masonry with cement mortar building in Kavrepalanchok district.
