# Mechanical behaviour of different type of shear band connections being used in reconstruction housing in Nepal

Santosh Yadav, Yannick Sieffert, Eugénie Crété, Florent Vieux-Champagne,  
Philippe Garnier

Keywords: shear band; masonry building; seismic load; local building cultures

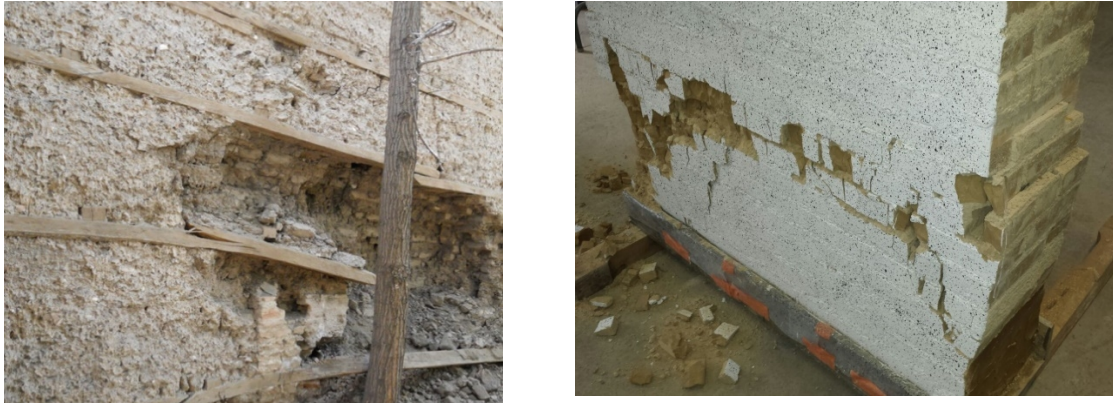
**Figure 1. Use of Horizontal timber shear band in Turkey (left) [Photograph copyright: A. Caimi] and prevention of in-plane shear crack propagation with the use of shear band (right) [Photograph copyright: Florent Vieux-Champagne]**

Similarly, the use of horizontal shear band helps to prevent the in-plane shear crack propagation as shown in Figure 1 (right). In this way, the crack is limited within the two-shear bands layer that prevents the complete failure of the wall. The sliding behaviour of those shear bands leading to dissipation of energy due to frictional behaviour at the interface layer can be observed. These bands also help to check the horizontal alignment of wall level at a different level during construction.

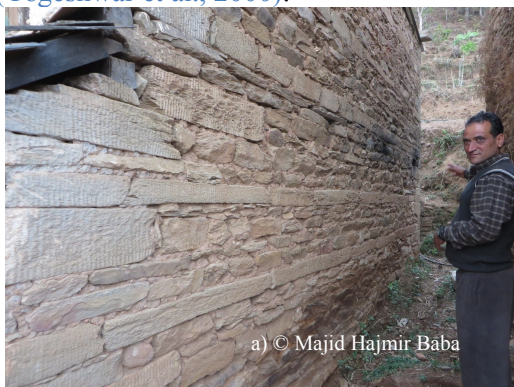
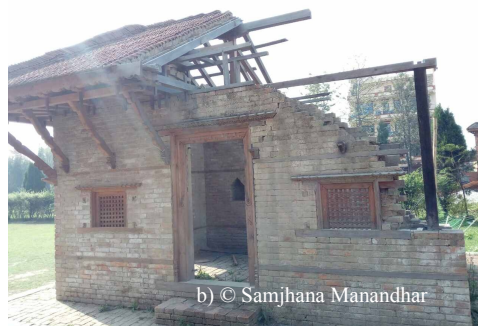
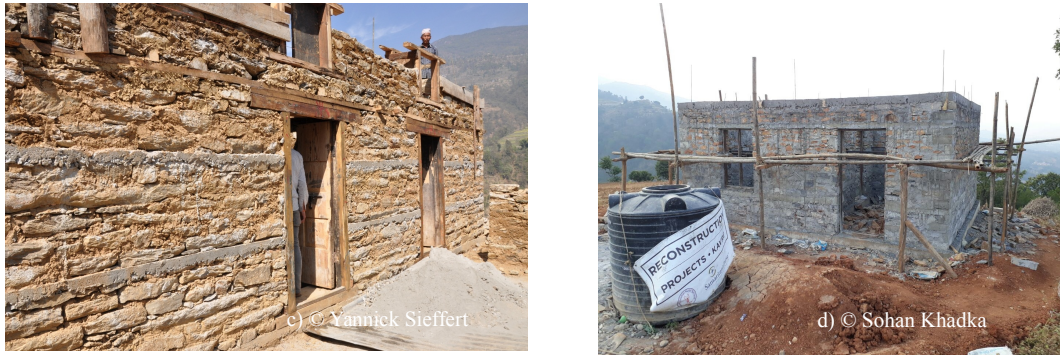
**Figure 2. a) Use of stone as a shear band, b) Timber shear band in brick masonry, c) Use of concrete and timber shear band in clay mortar masonry and d) Concrete shear band in cement mortar masonry building**

Figure 2 a) shows the use of stones as shear bands in the Gatlang village of Rasuwa District which was constructed before the earthquake in 2015 and resisted well during the seismic action. Similarly, timber shear band used in brick masonry structure can be seen in Banepa as shown in **Figure 2 b)** where the complete collapse of the roof occurred during 2015 earthquakes, which might be due to the heavy weight of the roof or lack of proper connections between the walls and the roof. After 2015 earthquakes, people started using shear bands as they understood their relevancy as an aseismic feature. Moreover, different NGOs and INGOs have started training masons on properly implementing shear bands. Figure 2 c) shows the use of concrete and timber shear bands in stone masonry structures with clay mortar in Megapauwa, Dolakha district, and in Figure 2 d), a concrete shear band can be seen in a stone masonry with cement mortar building in Kavrepalanchok district.

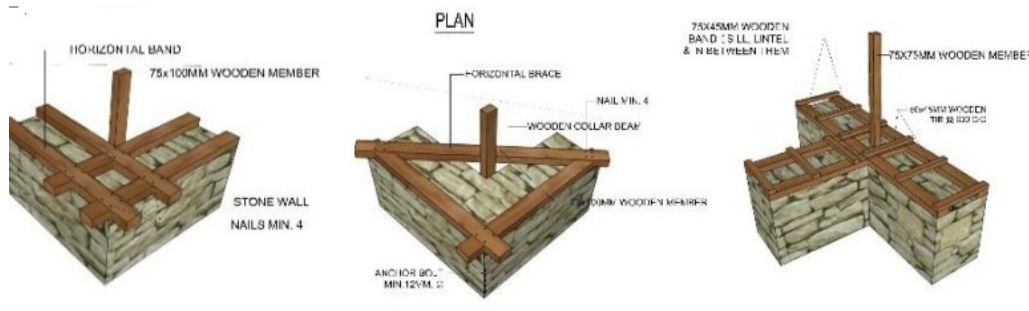
**Figure 3. Timber horizontal and vertical band at corner and T-junction**  
 [Source: (DUDBC, 2015)]

The design catalogue for earthquake resistance guidelines consists of the design specification for simple masonry building with minimum requirements that should be fulfilled for reconstructing buildings that could resist the damage caused by the earthquake in the near future using horizontal shear bands as shown in Figure 3. The main objective of reconstruction housing guidelines is to translate into a concept of safer settlement using the principles of Build Back Better (BBB) (DUDBC, 2015). This design catalogue was prepared to have more efficient approach for reconstruction work with the model design building with one or two storeys. The first design catalogue for reconstruction work has been prepared in a more conservative way by limiting one storey height for masonry with mud mortar however as per the NBC 203, the storey could be up to 2 storeys with an attic. The reason for this could be that people would be in a hurry to reconstruct their building leading to poor quality of work. Therefore, by limiting the single storey height for mud mortar masonry and up to two storeys with cement mortar masonry could ensure the safety of the building. The material for such horizontal shear band could be timber, concrete, or bamboo depending on their availability as per the guidelines. The dimension of the longitudinal timber member is 75 mm x 45 mm and that for transverse connection is 50 mm x 45 mm, which is placed at a spacing of 600 mm centre to centre. For cement mortar masonry wall, the mortar should not be leaner than 1:4 (1-part cement, 4-part sand).

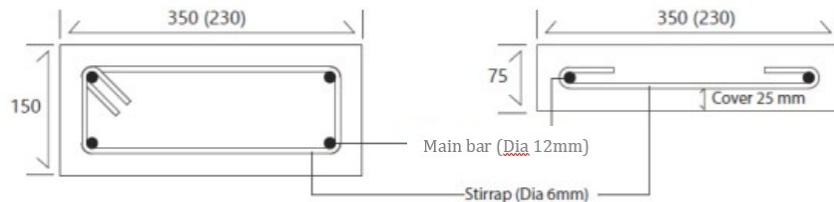
**Figure 4. Reinforcement bar detailing for concrete shear band**  
 [Source: (DUDBC, 2015)]

For the concrete shear band, the thickness should be minimum 75 mm for sill, corner stitch, roof, and gable band whereas for plinth and lintel level band; thickness should be minimum 150 mm with reinforcement bar as shown in Figure 4 below. The concrete mix for the seismic band should not be leaner than 1:1.5:3 (1-part cement, 1.5 parts sand, and 3 parts aggregate).

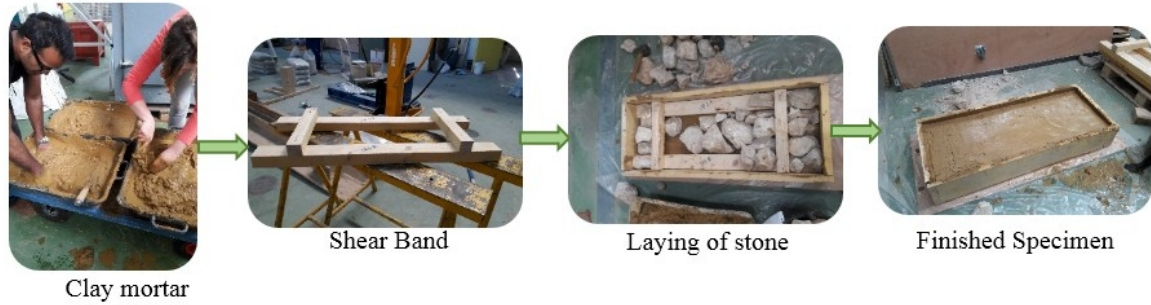
**Figure 5. Flow chart for preparation of specimen**

For the preparation of specimens, first, the clay mortar was prepared by adding water and left it for 4-5 days to have proper swelling of clay before using in the specimen. After that, the shear band was prepared using timber and bamboo, and for the concrete shear band, the reinforcement net as per the detail provided in the DUDBC guideline was prepared. For timber shear band type 1 and bamboo, the transverse ties were connected using nails whereas for timber shear band type 2; the notch was created in the main longitudinal section and a transverse member and connected properly as shown in above Table 1. The dimension of longitudinal timber member was 900mm x 75mm x 45mm, and that of the transverse member was 350mm x 50mm x 45mm. Flow chart as shown in Figure 5 outlines the steps used during the preparation of each specimen.

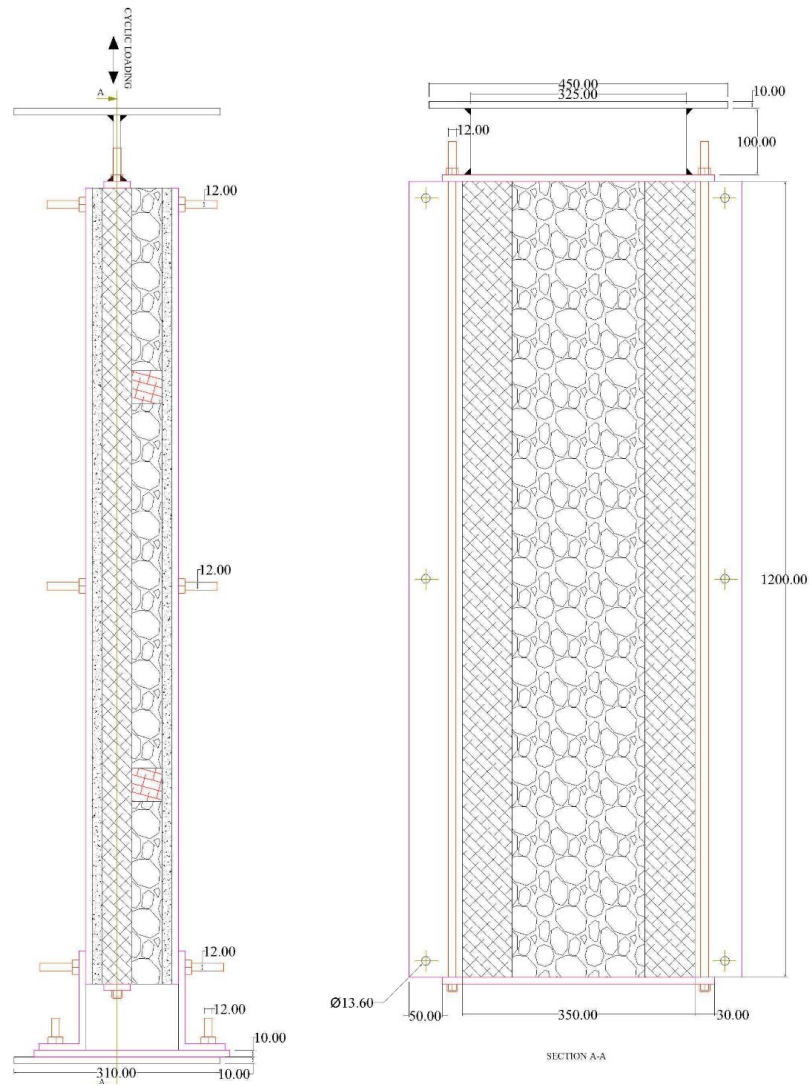
**Figure 6. Experimental set up for cyclic shear loading**

For the concrete shear band, a layer of clay mortar with thickness 15 mm was placed first, and after that, the reinforcement frame net was inserted. The M20 (Compressive Strength 20 MPa) grade (Bureau of Indian Standard, 1999) of concrete was prepared using 11kg of cement (Type: CEM I, 52.5 Normal [EN 197-1 (2001)]), 19 kg of fine aggregate and 30 kg of coarse aggregate with maximum size of 10mm for each specimen and poured in the frame. To have good bonding between the clay layers and concrete, some broken stone pieces both on top and on bottom were added while placing concrete. All the specimens were tested in the Schenck machine with the setup as shown in Figure 6 where cyclic loading was applied to the shear band using hydraulic jack. Only translational motion of shear band in vertical direction was allowed and other translational and rotational motions were restricted using steel plate connection as shown Figure 6.

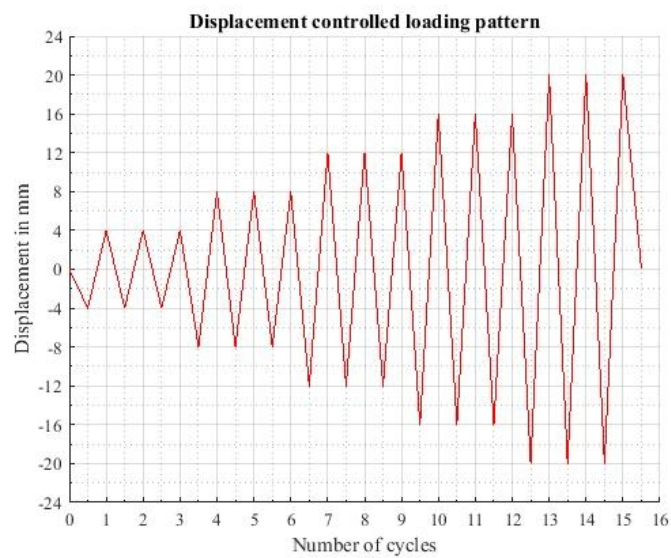
**Figure 7. Displacement controlled loading pattern**

The maximum horizontal displacement due to seismic force between two successive floors should not exceed 0.004 times the difference in levels between the floors (Bureau of Indian Standard, 1986) which makes for single 2.4 m storey height; the allowable displacement is 9.6 mm for reinforced concrete building but for masonry structures, the dissipation of energy is allowed by the displacement of elements and their elastic distortion. In order word, the inter storey drift must be less or equal to 0.4%. To set the limit of displacement for the test, the maximum limit of 20 mm for each specimen was selected except for the first timber shear type 1 specimen that was tested up to 10 mm displacement to see the behaviour as an interface and confirm that the experimental set up works correctly. For the first specimen with concrete shear band CSB1, with the hypothesis of getting higher resistance to the shear loading, the displacement limit was set to 5, 10, 15, 20 and 25 mm but later it was realized that the displacement beyond 20 mm was not of interest and the remaining specimen were tested with the limit of 20 mm final displacement limit or until failure. The test was carried out in displacement controlled pattern with displacement limit of 4, 8, 12, 16 and 20 mm for three cycles at each level in both direction of loading (Vieux-Champagne et al., 2014) as shown in Figure 7. The rate of displacement was 0.4 mm/sec for each of the test.

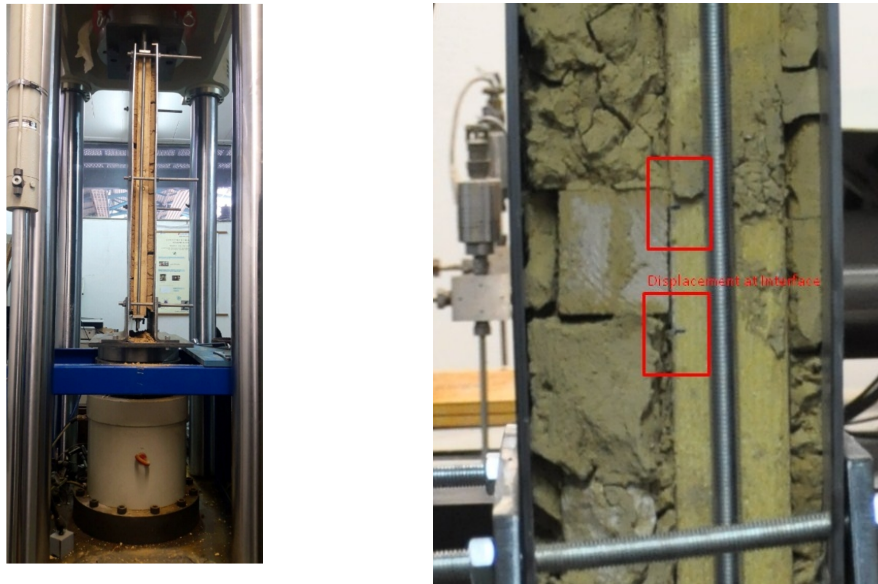
**Figure 8. Experimental setup (left) and displacement at the interface between shear band and mortar layer (right)**

Considering height above sill band 2 m for single storey building and 4.55 m for two-storey building, the maximum vertical load, acting at the shear band level has been computed as 15.2 kN and 33.36 kN respectively. To apply this pre-compression loading on the wall, a metallic plate was used on both sides of the sample with six bolts having 12 mm diameter. Each bolt was pre-compressed using 20 Nm torque wrench. The pre-compressive force in the bolt comes out to be 8.33 kN. With this experiment, the sliding behaviour of the shear band at the interface layer has been observed as shown in Figure 8. The loading head of a hydraulic jack was vertically aligned with the shear band, and the top and bottom plate was connected using long bolt rod without leaving any space between the shear band and connecting plate. Hence, the displacement records for the jack head and force applied were recorded and stored in an Excel-based format, which were further used in analyzing the results.

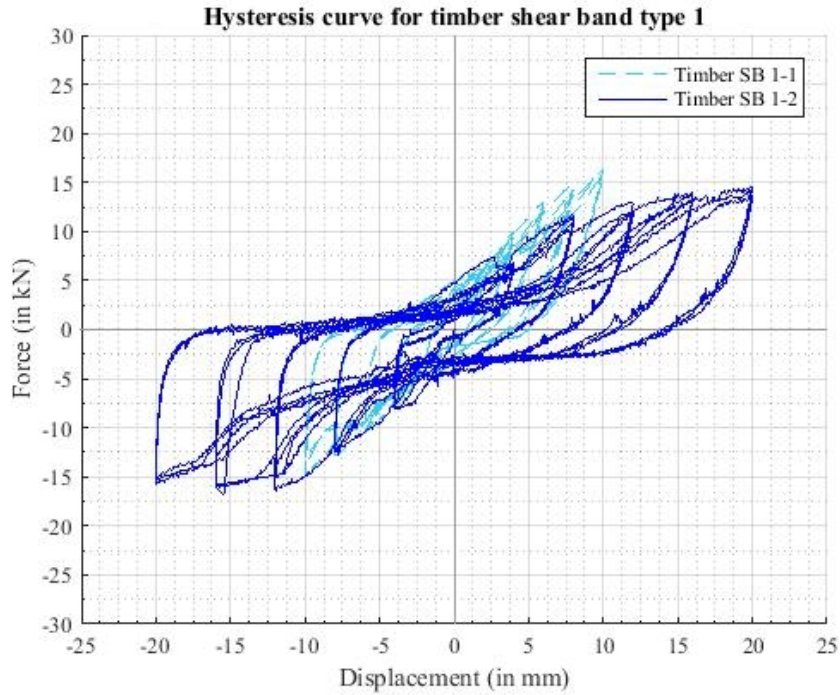
**Figure 9 Hysteresis curve for timber shear band type 1**

The result in Figure 9 shows the comparison of the hysteresis curve of two specimens of timber shear band type 1. At small displacement up to 4 mm, the first specimen seems to provide more shear resistance, which may be due to adhesive bonding between stone and clay however it can be observed from the plot that for dry stone beyond 8 mm displacement, the hysteresis loops become bigger resulting in more energy dissipation.

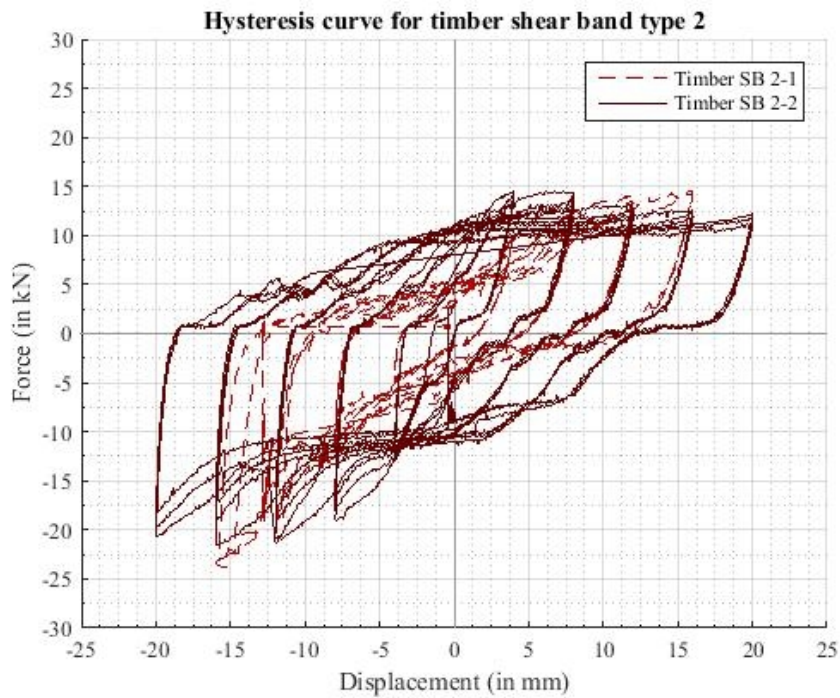
**Figure 10 Hysteresis curve for timber shear band type 2**

For timber shear band type 2 with the transverse tie connected by making a notch, higher shear resistance was observed as shown in Figure 10. The maximum shear force in the negative loading zone is higher than the positive loading zone that is because the beginning of each range of displacement cycle was started from negative loading. The two curves for same type of shear band have similar pattern of loading and displacement thus, the reproducibility of the sample was met up to some extent however a number of specimens is required to be tested for calculation of a mean and standard deviation. Likewise, the result for Timber SB2\_1 is only up to 16 mm which is due to the problem that the loading plate was about to touch the metallic plate of experimental setup while performing the test and the test was stopped beyond that limit.

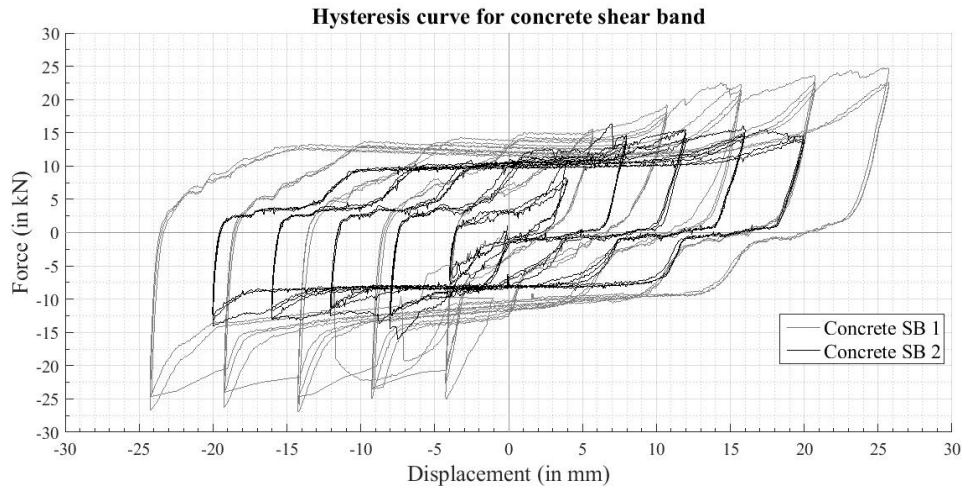
**Figure 11 Hysteresis curve for concrete shear band**

For proper bonding between concrete and clay mortar layer, few pieces of stone were used while placing concrete. As shown in the Figure 11, there is sliding behaviour observed both in positive and negative loading zone around 10 kN force which means at this level of loading the frictional resistance between the clay and concrete is broken down. The remaining load is carried on by the connecting stone between two layers which determines the extra loading capacity of the band which might be the reason for the different pattern of hysteresis loop as the number and size of stones were not exactly the same in two specimens with concrete SB. The nature of hysteresis loop which is wide resulting in more dissipation of energy can be observed in the plot. Also, in the case of bamboo shear (Figure 12), the hysteresis loop is thinner and comparable in both the specimen addressing the reproducibility requirement for validation of test method and results obtained.

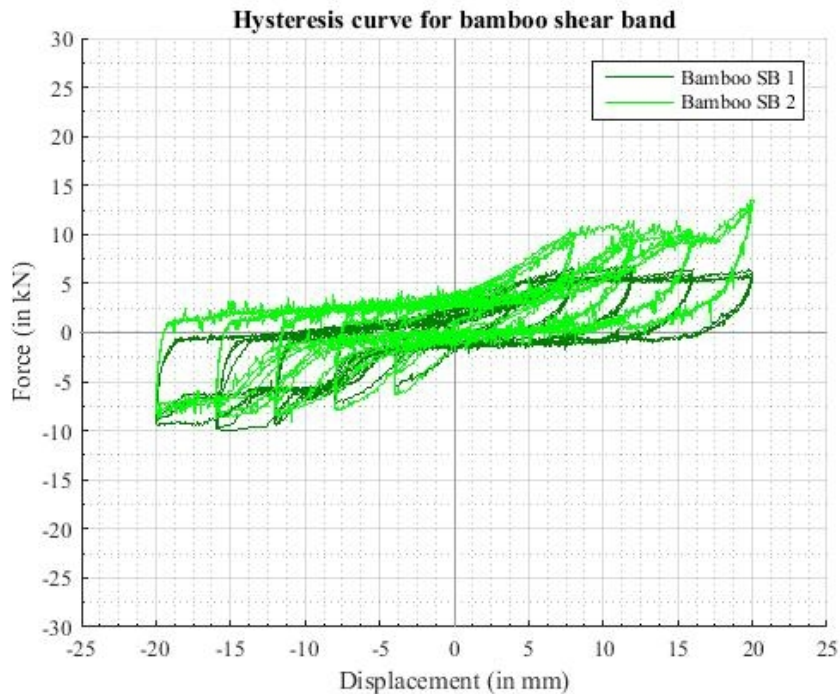
**Figure 12 Hysteresis curve for bamboo shear band**

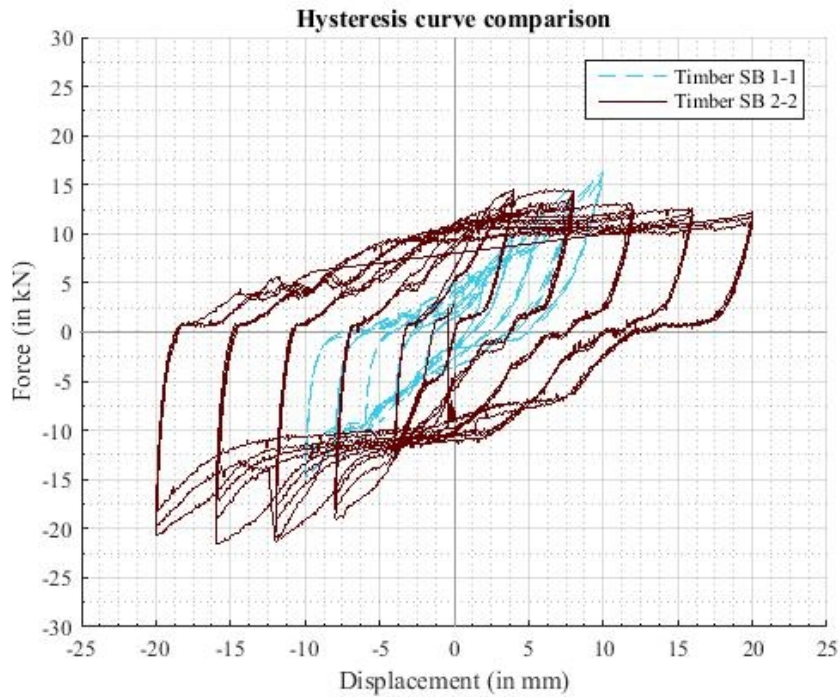
**Figure 13. Comparison between timber Shear Band Type 1 & 2**

While making a comparison between timber shear band type 1 and 2 as shown in Figure 13, SB type 1 has narrow hysteresis loop as compared to type 2. The reason could be due to the

connection of transverse ties using a nail in the case of type 1 which is easily bent and shifted with loading. Similarly, the curve with type 1 is symmetric which could be due to the equal force needed for bending of the nail connection (Figure 14) in both direction allowing similar displacement whereas with type 2, the loading in the compression zone that is on negative loading side is more than in the tension zone which could be due to the connection type which breaks during first compression cycle at each level of displacement. For timber SB type 2, the connection between the timber pieces is rigid that the stones which are in contact with the transverse member are also displaced. For the first cycle of displacement, there is friction resistance between shear band and mortar as well as the static resistive force from the stone layer in contact with transverse member and hence, more force is required to overcome it, but once the stones are displaced, it is easier to displace it after and less force for the following cycles.

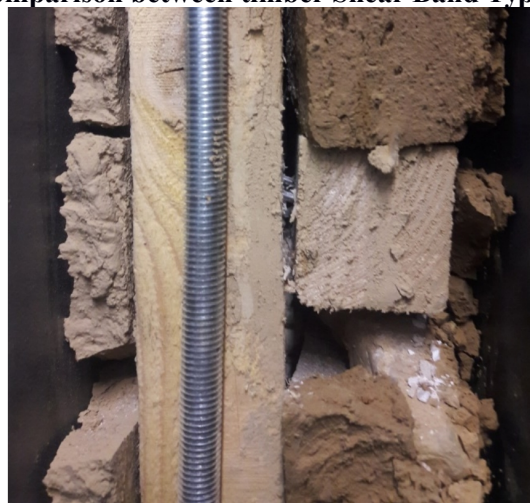
**Figure 14. Bending of nail connection in timber SB type 1 specimen**

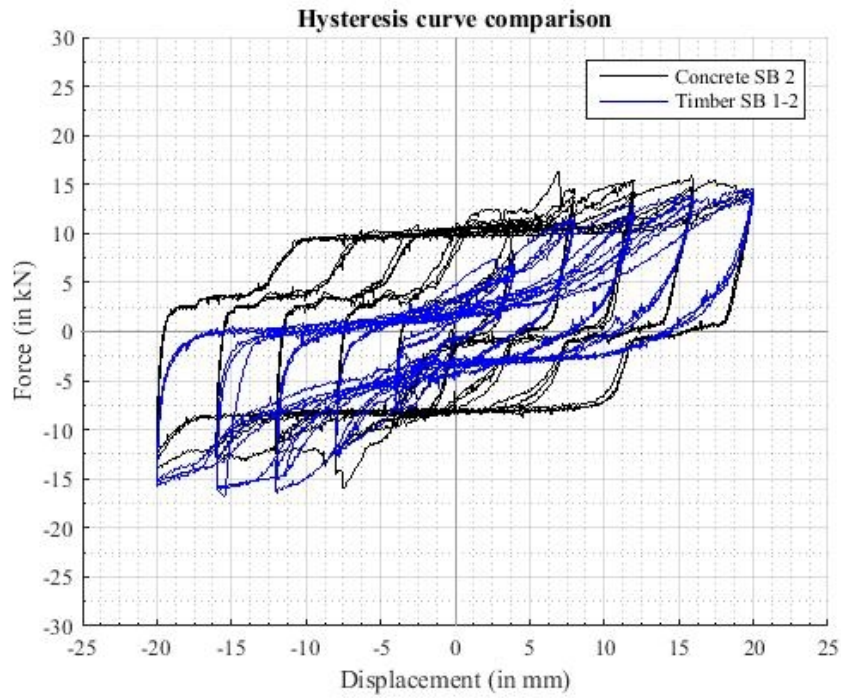
Figure 15 Hysteresis curve comparison of concrete SB with timber SB1\_2\_dry

While comparing the concrete SB2 with timber SB1\_2\_dry in Figure 15, the maximum shear load carrying capacity in case of timber is lower than in concrete and so is the nature for dissipation of energy. The reason for concrete shear band dissipating more energy could be the

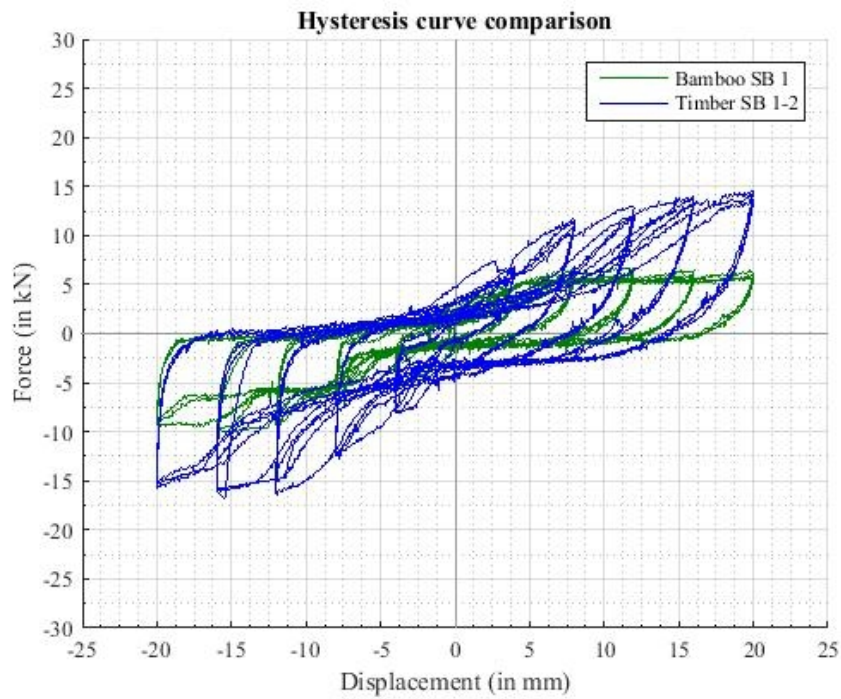
Figure 16 Hysteresis curve comparison of bamboo SB with timber SB1\_2\_dry

more surface area is in contact with the clay layer creating a more frictional loss of energy. In case of bamboo, there is sudden sliding behaviour observed at low shearing load and the hysteresis loop is also thinner as compared to timber shear band as shown in Figure 16.

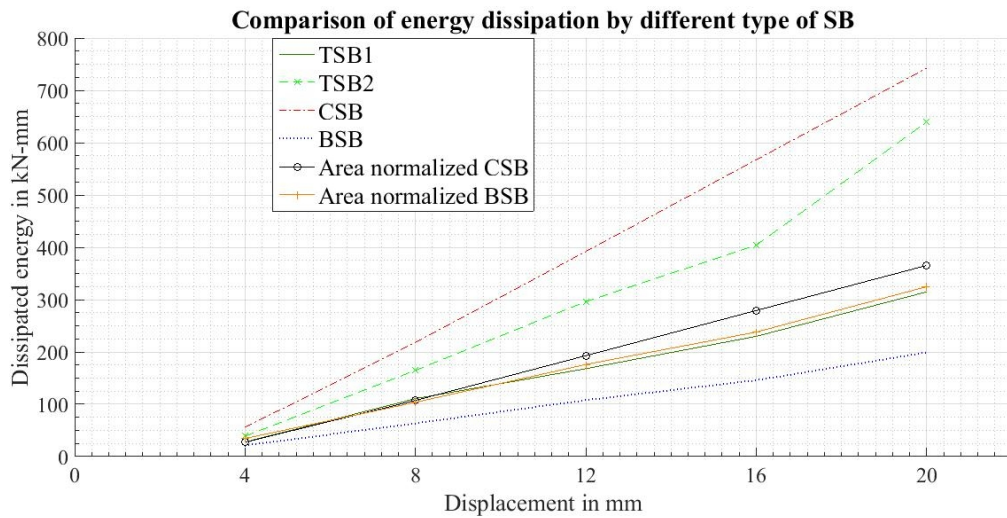
**Figure 17. Comparison of energy dissipation by different types of SB**

One of the use of shear band is to limit the propagation of a crack in the wall, confine all the wall together and dissipate energy by sliding friction caused during seismic action. For this purpose, the amount of energy dissipated by each cycle upon particular displacement was measured from the previous hysteresis loop curve using OriginPro 2017 software (<http://www.originlab.com/2017>) and taking the average between the results obtained from the similar type of shear band connection. Comparison of energy dissipation by various type of shear band is shown in **Figure 17**. From the comparison, it is observed that more energy is dissipated with Concrete SB as compared to other material and least energy is being dissipated by Bamboo SB. There is also a difference in the amount of energy dissipated with a different type of connection using timber as a shear band. Timber Shear Band type 2 (TSB2) could dissipate more energy than Timber Shear Band type 1 (TSB1). In order to observe the significance of the contact surface area, the results for the concrete and bamboo SB was normalized as that of timber shear band and as seen in the same plot, the energy dissipated by the normalized CSB and normalized BSB are just close enough to that of TSB1. The energy dissipation patterns obtained tend to follow linear form for each of the shear band material.

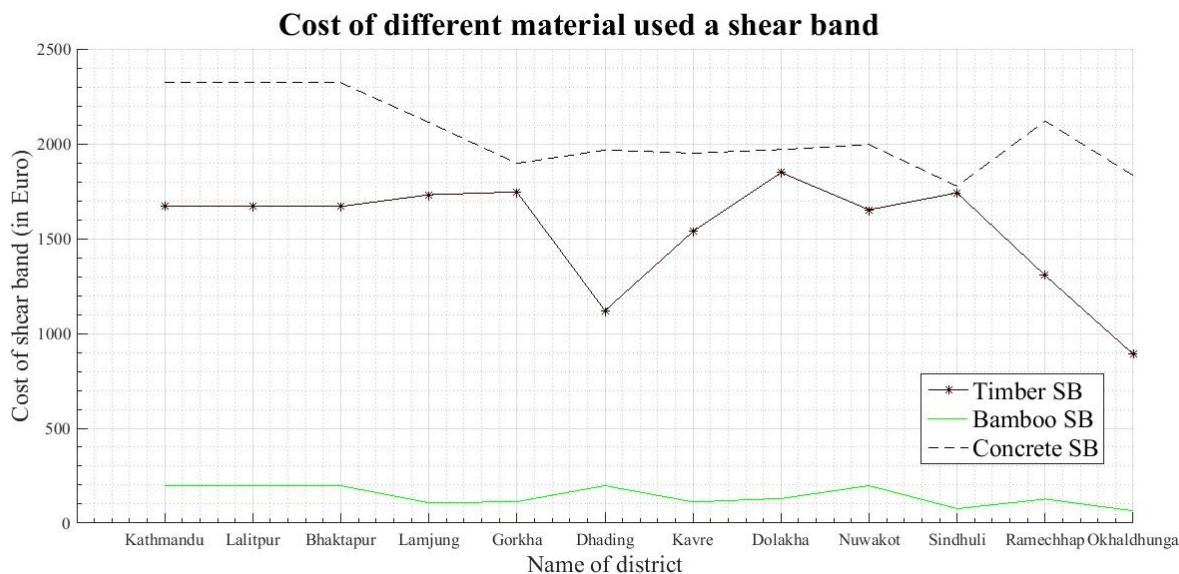
**Figure 18. Comparison of Different material used as Shear band**

In order to conduct a financial analysis of construction works of similar types of building in different affected districts of Nepal, a model with two and a half storey houses – which includes an attic that is used as a storage place – was chosen with mud mortar as guided in the Nepal National Building Code 203 and the dimension of the building was taken from the design catalogue developed by DUDBC. The detailed quantity of work and a bill of quantities were calculated to get the total cost of construction. The cost of construction ranges from € 17,000 up to € 22,000 (to compare with the state subsidies of € 2727). From the field construction work carried out by CRAterre in Dhading district, the cost for reconstruction was approximately € 15,000 with timber shear bands which corresponds with the theoretical cost estimation. The design catalogue for reconstruction and NBC has provision of using shear band using timber, concrete and bamboo, so the cost of only shear band when different material is used has been calculated for each affected district, which is given in Figure 18. The cost of bamboo is way cheaper than timber and concrete shear band. The cost of timber and concrete shear bands highly depends on the material and labour costs at each district. In Dhading and Okhaldhunga district, the cost of timber is cheaper when compared to other districts. Besides, fine and coarse aggregates are cheaper in Sindhuli and Okhaldhunga, which decreases the total cost of the

concrete shear band. The main reason of the variation in the price of material and labour cost in different districts is their availability. The unit cost is decided by the local authority of the Government along with the representative from suppliers and consumers.
