CONTRIBUTION TO THE CHARACTERIZATION OF CONSTRUCTION MATERIALS OF HISTORICAL MONUMENTS -CASE STUDY

Benkmil Rachid, Bahi Lahcen, Aakhssass Ahmed, Ouadif Latifa

Mohammed V University, Mohammadia School of Engineers (L3GIE), Rabat, Morocco

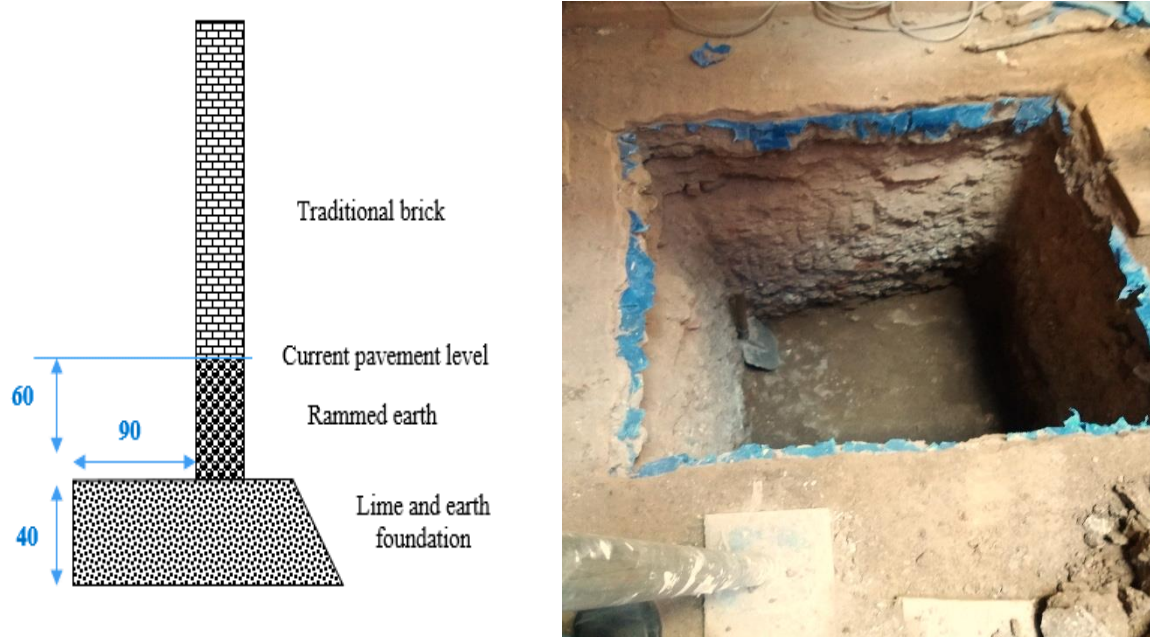
Figure 2 Foundation structure

The Ss 1 survey shows that the southeast and northwest peripheral walls of the prayer room are anchored at the level of silty-clay formation at a depth of 1m from the level of the pavement.

The walls are built of traditional solid bricks joined by a lime-based mortar, and rest on a base of a traditional rammed earth, Figure 2.

Surveys on the foundation floor have shown that the foundations of the building are generally in good condition.

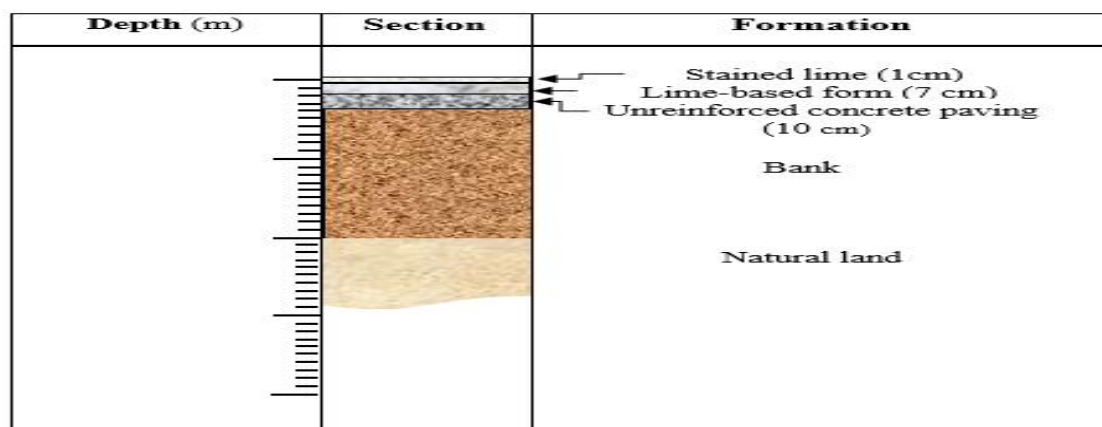
Figure 3 Lithological section

Identification tests were carried out on the materials collected from the excavations of the Ss1, Ss2 and Ss3 soundings, the sounding executed at the prayer room has exposed the composition of the soil, successively presented with a smooth screed composed of 1cm thick tinted lime, 7cm thick lime shape, 10 cm unreinforced concrete slab, resting on a very compact backfill laid on natural ground at a depth of 1 m from the current ground. the following figure shows the lithological section of the soil, Figure 3.

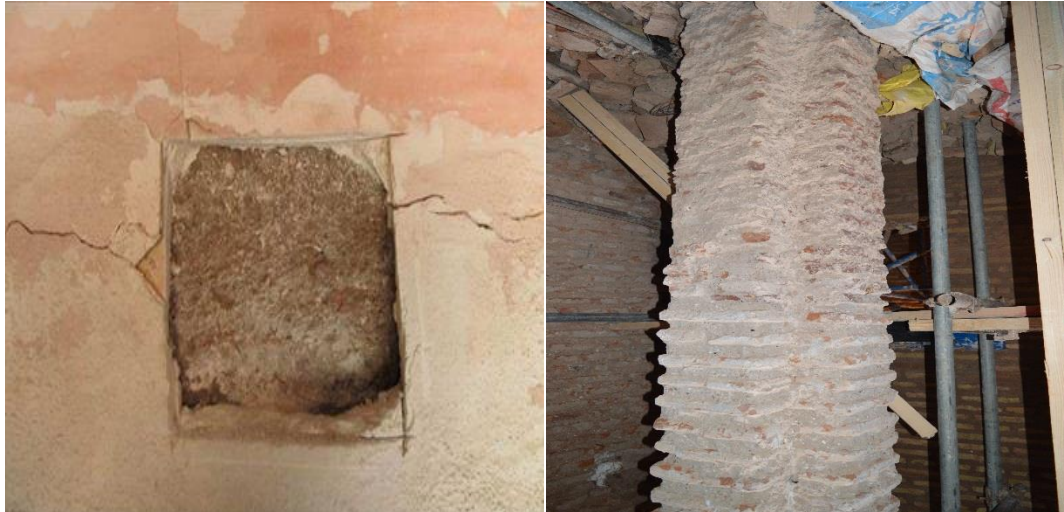
Figure 5 Rammed earth and solid brick wall

Also three holes were realized on the walls of the building, they showed the existence of two building materials for the load bearing walls namely the traditional solid brick with a traditional lime mortar and rammed earth, Figure 5.

As for the thickness of the walls, it varies between 30 cm and reaches up to 1 m in some places, while the columns are in solid brick.

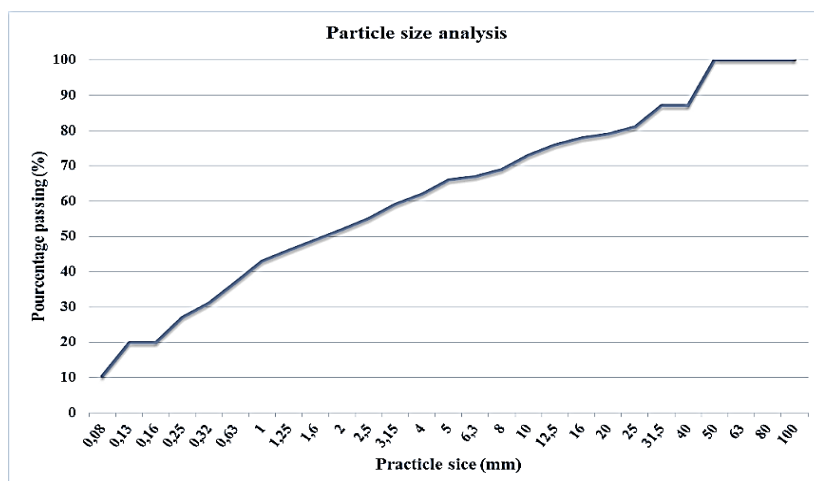
Figure 6 Particle size analysis of rammed earth

By studying the particle size analysis as well as the MBV listed in Figure 7 and Table 3, we can conclude that the material in question has a luminous character sensitive to water and a varied grain size. Table 3 Physical properties of rammed earth

Designation	Ref	Particle size analysis		
		%<80µm	%<2mm	D max
rammed earth	173/4	14,17	52,06	50
		MBV (MS 10.1.141)		
		0,11		
		Water content (%) (MS 10.1.272)		
		3,3%

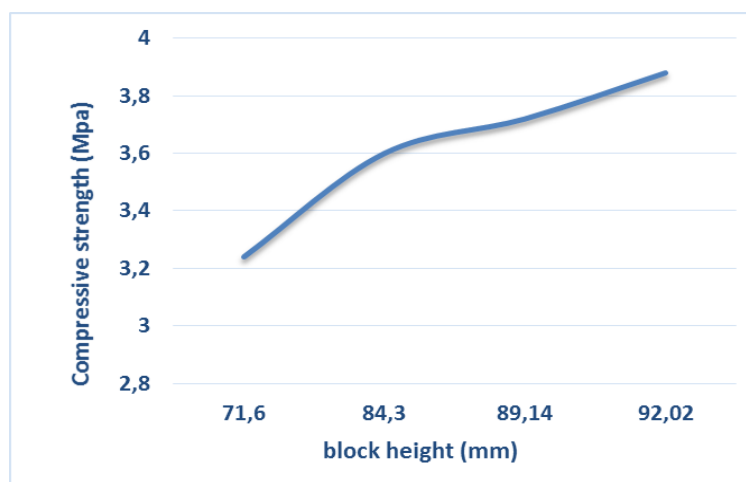
**Figure 7** Variation of the compressive strength according to the height of the block

- The compressive strength of solid bricks used in the construction of the building is relatively low compared to existing ones and currently marketed, the study carried out by us as part of our thesis on the full brick of Ksar Lakbir has shown that its compressive strength is in average equal to 13.4 MPa, the same remark applies to other physical characteristics.
- The compressive strength varies and increases with the height of the test piece this can mean the variation of the dry density gradient within the brick, in fact, several studies have shown that for the same composition of the material, the compressive strength increases with dry density (PKLA, 2002) Figure 7.
