## Contribution of acoustic emission to the understanding of sulfide stress cracking of low alloy steels

# Contribution of acoustic emission to the understanding of Sulfide Stress Cracking of low alloy steels

The Acoustic Emission technique was applied to standard tests devoted to evaluate sulfide stress cracking susceptibility of steels for oil and gas industry. The mapping of the density of AE signals vs. their location on the specimen gauge length as a function of time allowed early detection of cracking, and gave meaningful information on incubation times and propagation rates. Sulfide stress cracking initiation was correlated with the presence of critical surface defects. A mechanism involving plastic strain and/or metal dissolution was proposed to account for crack propagation.

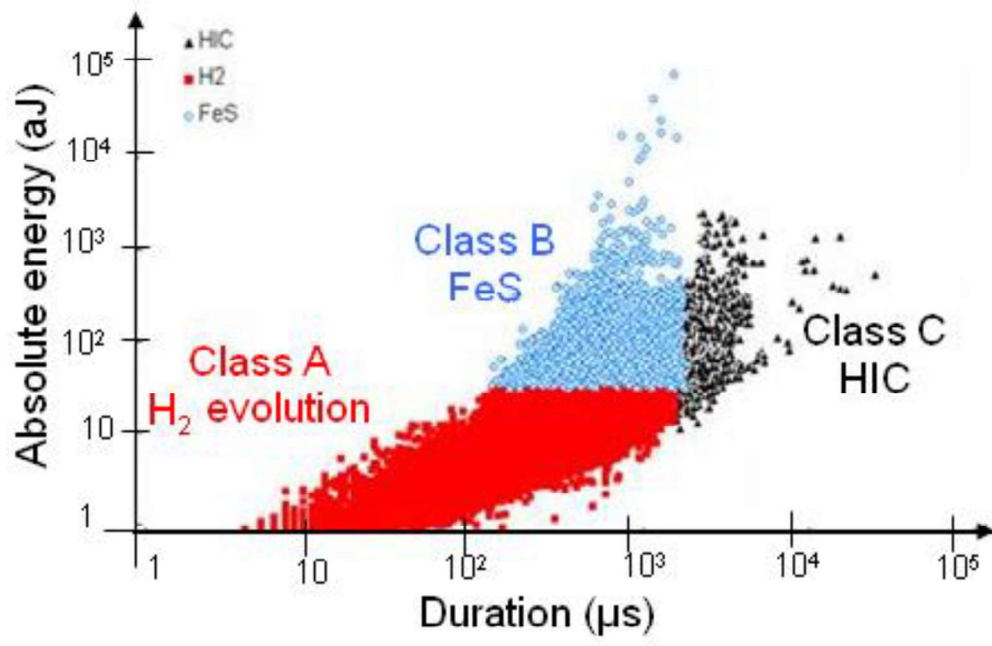
Fig.1

Figure 1. Correlation chart representing absolute energy as a function of signals duration for a test conducted in the EFC 16 solution at pH 4.5 under 1bar H<sub>2</sub>S, on a X65 SwS specimen [33].

electrochemical polarization procedures. The characteristics of the corresponding AE signals were identified. The most discriminating representation was obtained by plotting absolute energy of the signals as a function of their duration (Figure 1). On this correlation chart, it was possible to separate AE events related to HIC from those related to the corrosion reactions, allowing a better analysis of cracking associated signals. However, this discriminating analysis demonstrated that SSC development led to the emission of AE signals that could not be directly identified on the same energy-duration correlation chart [39]. For that particular process of HE, a specific analysis giving the evolution of the density of AE signals vs. their location and the time of test was necessary.

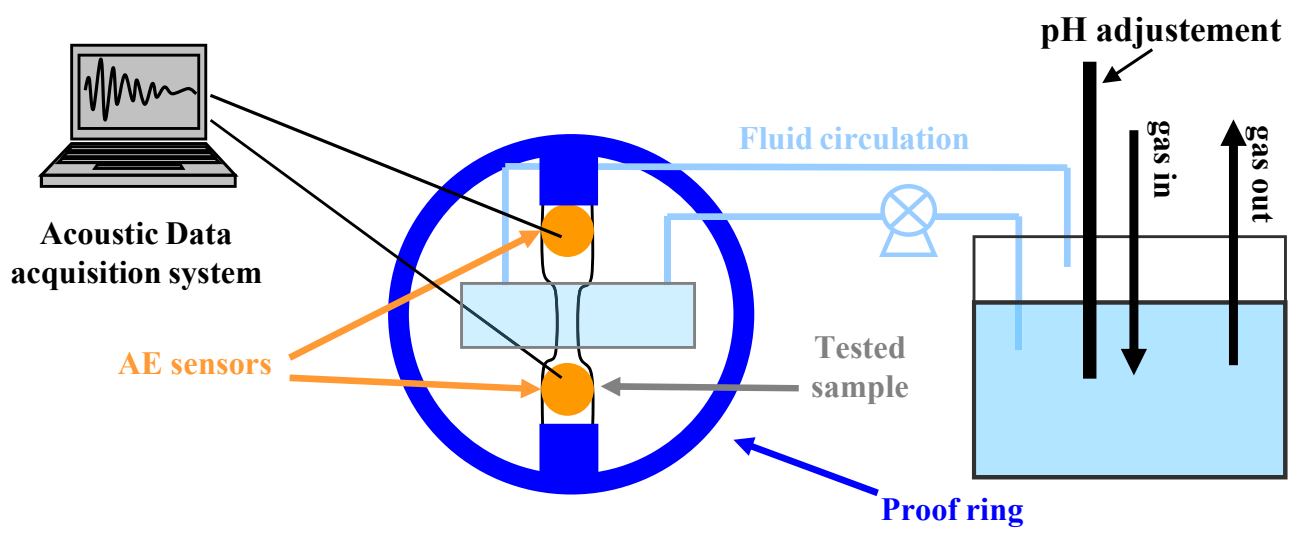
Fig.2

Figure 2. Experimental device.

The experimental set up (Figure 2) was based on the standard tensile test described in NACE TM0177-96 (method A) [38]. Constant load was applied with the proof ring. NACE standard specimens were adapted to allow positioning two AE sensors at the bottom of the specimen. The geometry of the gauge section of the standard specimen was unchanged (length = 25.4

mm, diameter = 6.35 mm). During the test, only this section was immersed in the corrosive solution. Tests were conducted in buffered solution according to EFC 16 [42] (50 mg/L NaCl and 4 mg/L CH<sub>3</sub>COONa in distilled water) and under 1 bar H<sub>2</sub>S. De-aeration of the solution was performed by nitrogen bubbling ensuring less than 15 ppb by weight dissolved oxygen before H<sub>2</sub>S introduction. The corrosive fluid (sour media) was circulated between the test cell and a separate glass vessel, in which H<sub>2</sub>S bubbling was maintained. This procedure avoided any interfering AE noise detection (e.g. gas bubbling in the test cell would result in AE) and to maintain constant electrochemical conditions in the cell during the test (easier pH control). The pH was measured with a pH meter located in this glass vessel and buffered every day by HCl or NaOH additions.

AE instrumentation consisted of a transducer, a preamplifier and an acquisition device (MISTRAS with AEWIN software from Physical Acoustic Corp.). The gain of the preamplifier was set to 40 dB. A band pass filter with frequency range from 100 to 400 kHz was used. In this study, the threshold was set to 28 dB. The transducers were Nano 30 type from PAC (piezo-electric disks). For each detected AE signal, several acoustic parameters were calculated and recorded, e.g. event amplitude, duration and energy. For each AE signal, the location of source on the specimen was determined by measuring the delay of event detection time between the two sensors. Spatial and temporal post-filtering treatments were also made on the AE data. Only the AE signals located on the gauge section and detected before failure are taken into account for the analysis. The analysis of AE data was first performed according to previous works [39], allowing identifying three typical sources: i/ HIC, ii/ H<sub>2</sub> evolution at the steel surface, iii/ FeS build-up (see Figure 1). In a second configuration, another procedure was applied by using source location. Because the two sensors were placed at either extremity of the specimen, it was possible to determine the position of the source for each AE signal detected on both sensors. This was achieved by comparing the times at which an identical AE signal was detected on each sensor. Then, knowing the distance between both sensors, the position of sources is obtained. Using AE source position as additional parameter, the analysis of AE data consisted in mapping the density of AE signals as a function of position on the gauge section of the specimen and as a function of the time during the test.

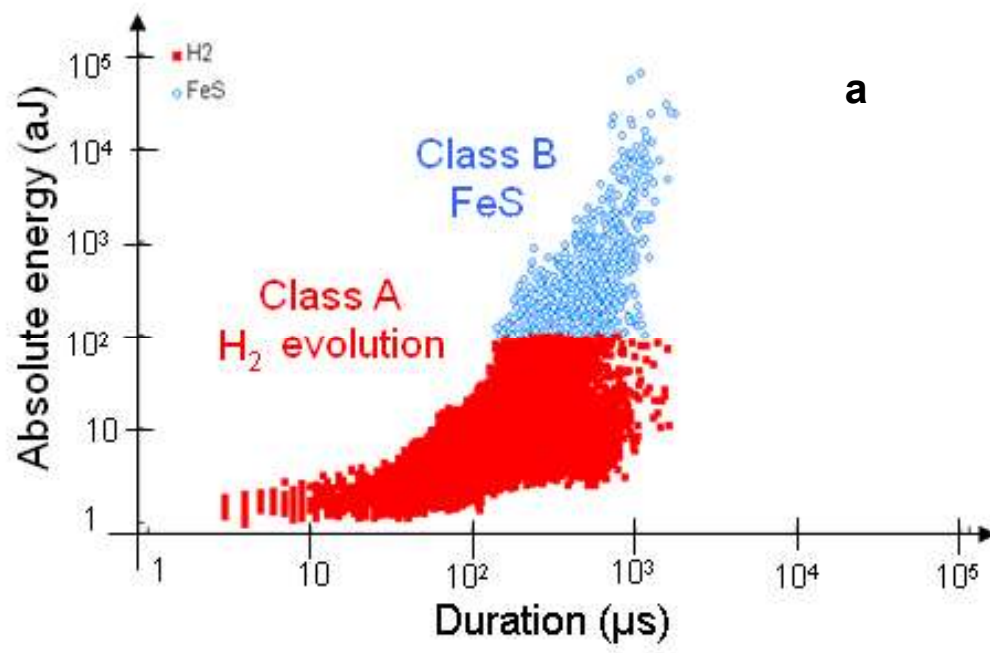
Fig.3a

Figure 3. Correlation chart representing absolute energy as a function of signals duration for a test conducted in the EFC 16 solution at pH 3.5 under 1bar H<sub>2</sub>S (a) on a C110 specimen without applied load – (b) with an applied stress of 90% YS on a C110 chemically polished specimen – (c) with an applied stress of 90% YS on a C110 standard polished specimen

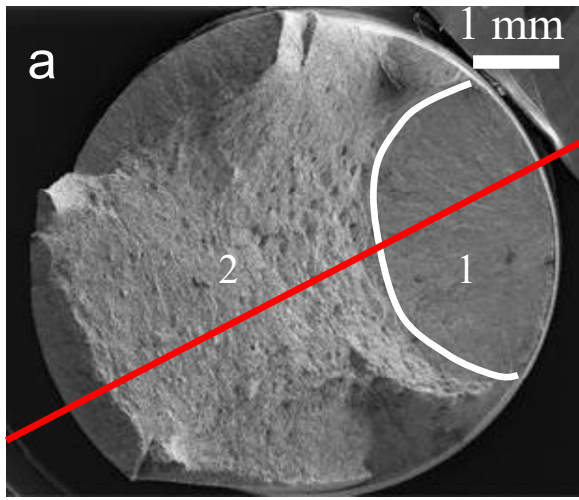
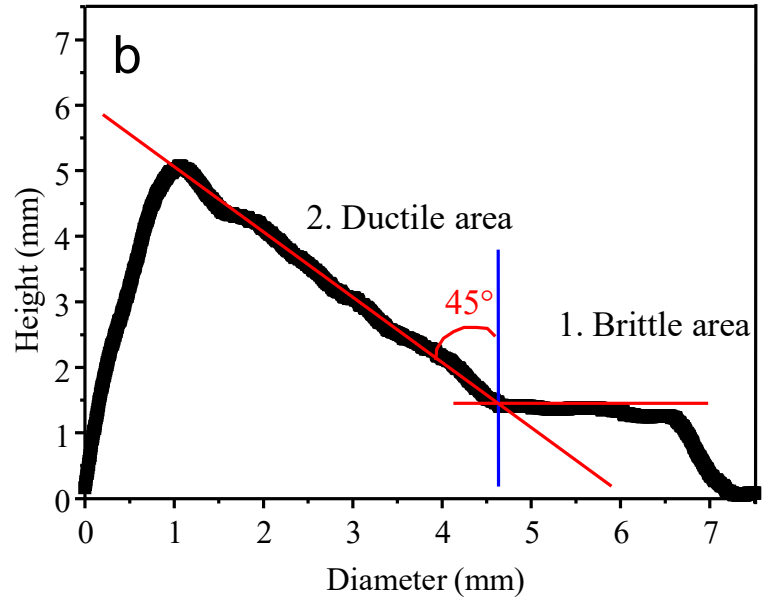
Fig.4

Figure 4. (a) Fracture surface of C110 steel tested in the EFC 16 solution at pH 3.5 under 1bar H<sub>2</sub>S with an applied stress of 90% YS – (b) Profile of the fracture surface (red line on figure 5a).

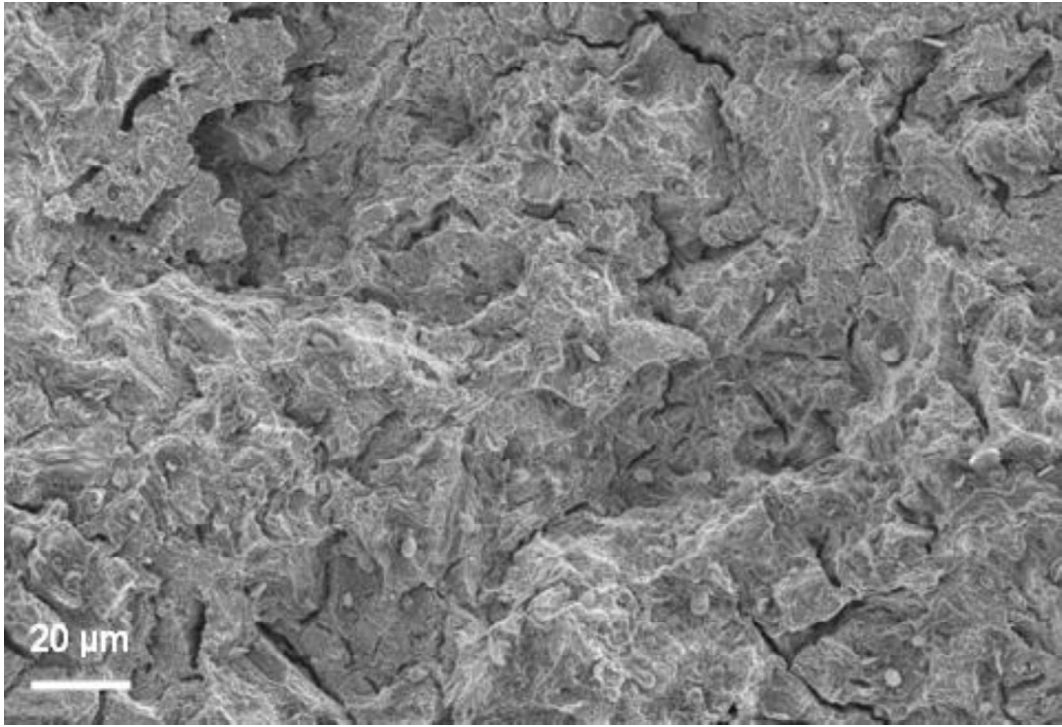
Fig.5

Figure 5. Detail of the brittle area (1) of C110 fracture surface.

From the representation of the location of the density of detected AE signals on the gauge length of the specimen versus the time of test (Figure 7), it is also possible to define the SSC incubation time as the time before signals density increases locally, together with the propagation time of the cracks until final failure. On the other hand, the observation of the brittle areas on the fracture surfaces of the failed specimens (Figure 5) allows measuring the

SSC depth and therefore calculating the SSC propagation rate. SSC propagation rates that can be evaluated with this methodology exhibit good reproducibility:  $2 \times 10^{-8} \pm 0.5 \times 10^{-8} \text{ m.s}^{-1}$ .

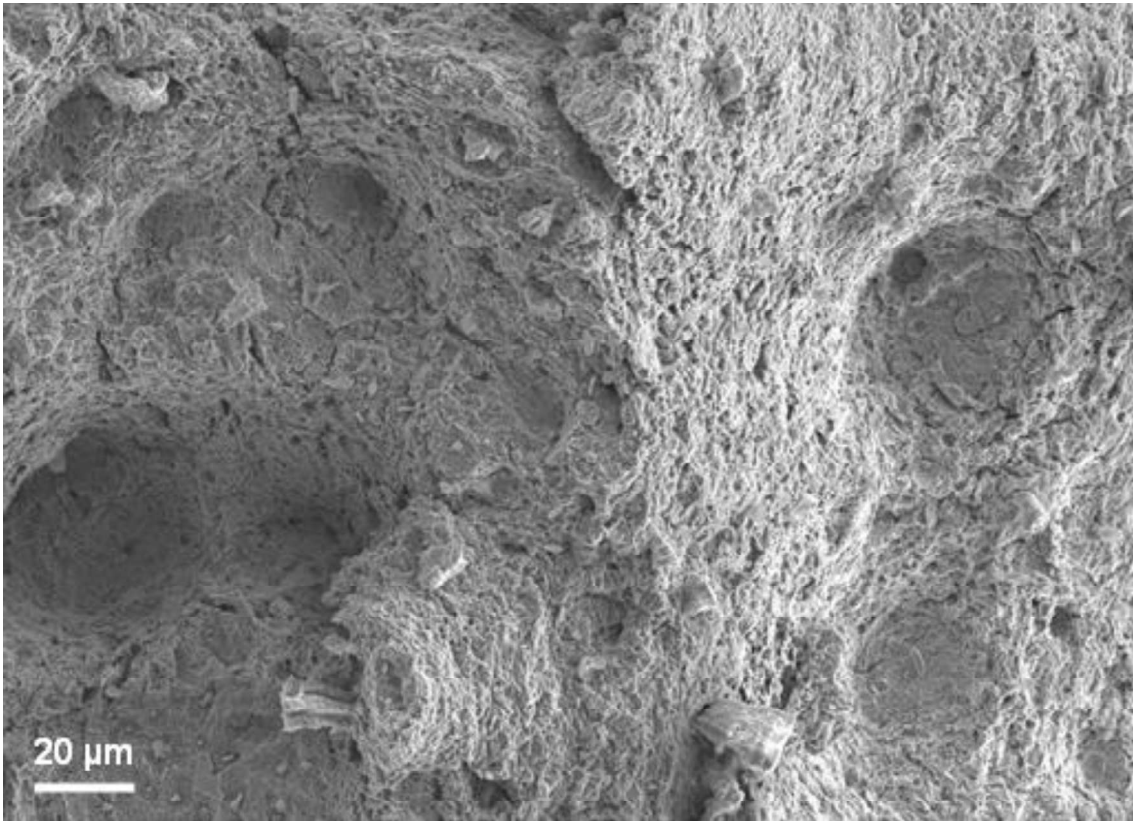
Fig.6

Figure 6. Detail of the ductile area (2) of C110 fracture surface.

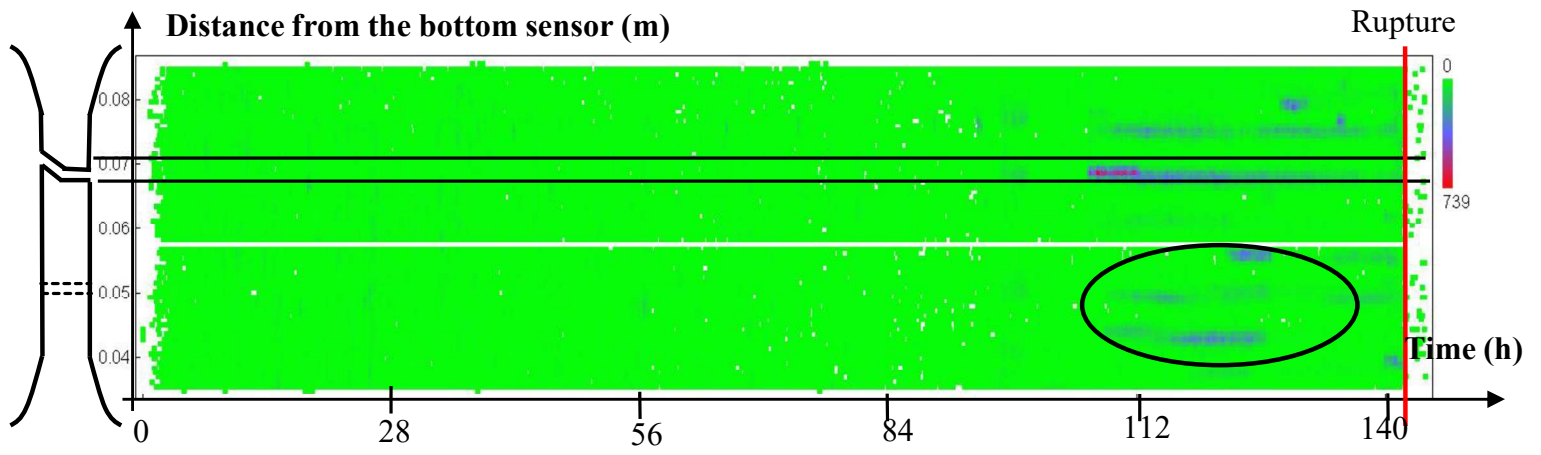
Fig.7

Figure 7. Density representation of the location of all the AE signals in function of time (C110 steel, pH 3.5, 1 bar H<sub>2</sub>S,  $\sigma=90\%$  YS).

Table 3 summarises the different sets of experimental conditions and the observed times to failure. Condition 1 consists of H<sub>2</sub>S exposure without applied load. Therefore, no SSC is expected. The goal of this test is to validate that the tested steel is not sensitive to HIC. Conditions 2 and 3 consist of 90 %YS strained specimens exposed to H<sub>2</sub>S, with two distinct surface preparations. Corresponding AE results, plotted on absolute energy vs duration correlation charts are shown on Figures 3a, 3b and 3c for conditions 1, 2 and 3 respectively. According to previous results [39], analysis of AE data for condition 1 (Figure 3a) suggests that the only active AE sources are hydrogen evolution and the FeS layer. Both metallographic examination and ultrasonic analysis of the specimens confirmed the absence of HIC phenomena. For condition 2 (Figure 3b), when a constant load is applied on an electropolished specimen, no failure was obtained after 800 h testing and no crack was detected by metallographic examination. AE results are in agreement with these observations: according to previous results [39], only populations of AE signals associated with H<sub>2</sub> and FeS are identified on the correlation chart. For condition 3 (Figure 3c), all of the mechanically polished specimens failed. Times to failure varied between 64 and 200 hours (Table 4). Figure 4a shows a typical fracture surface observed by SEM. Two areas can be identified. Fracture seems to be initiated on the surface of the sample perpendicular to the loading direction (area 1). A brittle type transgranular fracture is observed in area 1, (Figure 5) while microvoids typical of a ductile failure are identified only in area 2 (Figure 6). A profile of the fracture surface along the line drawn on Figure 4a can be extracted from a 3D reconstruction of the surface using a 3D microscope (Figure 4b). Area 1 which is brittle-like corresponds to a flat surface perpendicular to the direction of applied load. Area 2, identified as ductile, corresponds to the 45° region. This profile is typical of a SSC rupture: initial hydrogen assisted crack corresponds to the 90° brittle area. Then, as the cross-sectional area of the loaded part is reduced, the applied stress reaches the UTS and the sample fails by 45° ductile fracture. Corresponding AE results are plotted in the energy vs. duration plane on Figure 3c. In this correlation chart, we cannot distinguish any new population of signal which would correspond to SSC. Either there is no specific acoustic emission related to SSC, or the corresponding signals do not differ from H<sub>2</sub> and FeS signals by energy and duration characteristics. This result is in agreement with previous results providing evidence that SSC signals can not be discriminated from H<sub>2</sub> and FeS signals on absolute energy-duration correlation charts [39]. Therefore, other approaches were tested to extract AE information related to SSC. The best results were obtained by mapping the density of AE signals as a function of position on the gauge section of the specimen and of the time of the test (Figure

7). The density of AE signals is quite homogeneous on the whole gauge length, except in well defined zones where it is higher for a certain period of time. The direct reading of this figure indicates that an AE activity well above the background level was detected at some location and after a certain time. More remarkably, such intense AE activity was always found at the position corresponding to the final failure. Surface examination was also performed at other areas where high AE activity was found, and crack initiation was detected (Figure 8). It could therefore be concluded that these high density signals could be associated with SSC initiation, as previously demonstrated [39].

From the representation of the location of the density of detected AE signals on the gauge length of the specimen versus time (Figure 7), it is also possible to define the SSC incubation time as the time before signal density increases locally, together with the propagation time of the cracks until final failure.

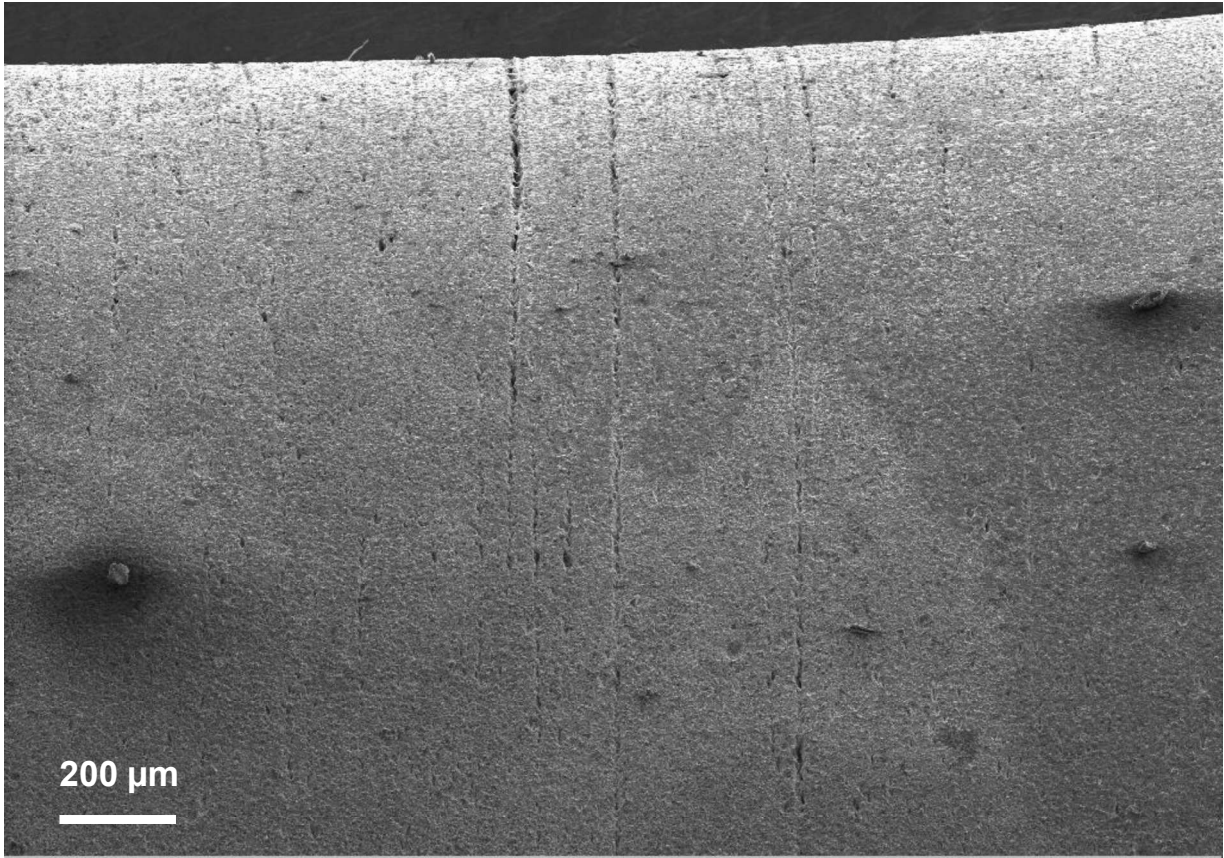
Fig.8

Figure 8. SEM observation of the area identified by a circle on the figure 10.

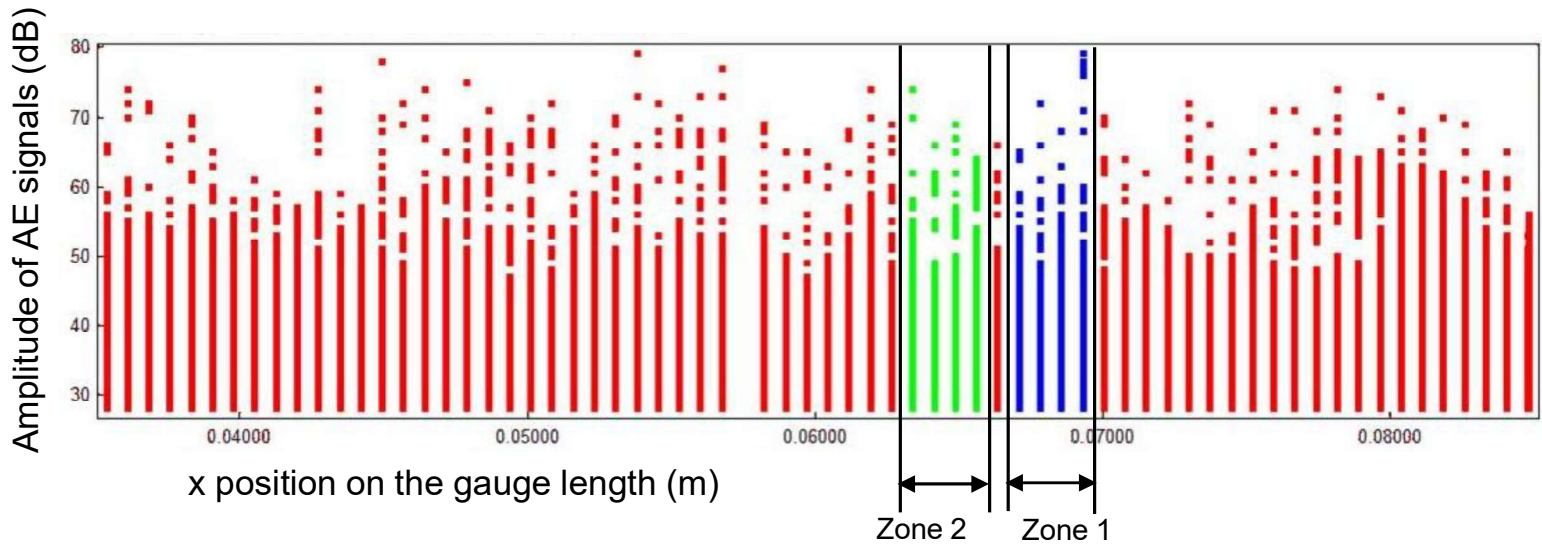
Fig.9

Figure 9. Amplitude of AE signals vs. their location on the gauge length of the specimen: identification of AE signals located on the final rupture area of the gauge length (zone 1 - x between 6.7 and 7.0 cm reported from the position of the sensor located at the bottom of the specimen) and AE signals located just above the final rupture area, where no crack neither no increase in AE signals density were detected (zone 2 - x between 6.3 and 6.6 cm).

In order to obtain time and energy information on AE signals associated with SSC, characteristics of AE signals located on the final rupture area (zone 1 on Figure 9) are compared with those of signals located just above the final rupture area, where neither cracking nor increase in AE signals density were detected (zone 2 on Figure 9). Both zones have a surface area of  $60 \text{ mm}^2$ . For each zone, both number and energy of AE signals are plotted versus time (Figure 10). During the first part of the test, signals recorded on both areas (zone 1 and zone 2) exhibit the same evolution. From the start of the test to 370 ks, the same cumulative AE activity is recorded for both areas of the specimen. However, from 370 ks until final fracture, the number and energy of AE signals increase drastically on the area of the specimen corresponding to the final fracture (zone 1). At the same time, AE activity of the other area continued to increase at the same rate (zone 2). At the end of the test,  $2.5 \times 10^4$  signals have been recorded on zone 2 with a cumulative energy of  $5 \times 10^5 \text{ aJ}$ , with a constant increase, compared to  $10^5$  signals and  $8.2 \times 10^5 \text{ aJ}$  on zone 1, where the final rupture is located, with a sharp increase of both parameters when SSC initiates. Comparing the evolution of signals recorded on both areas, it can be assessed that a signal related to hydrogen or FeS layer evolution (the only signal type that is detected on zone 2) carries an average energy of 20 aJ, whereas a signal associated to SSC development (detected on zone 1, together with  $\text{H}_2$  and FeS layer evolution signals after SSC initiation) carries an average energy that is 5 times lower ( $(8.2-5):(1-0.25)$ , see Figure 10). SSC propagation is therefore associated with a sharp increase in AE signals density, but SSC associated AE signals have low energies.

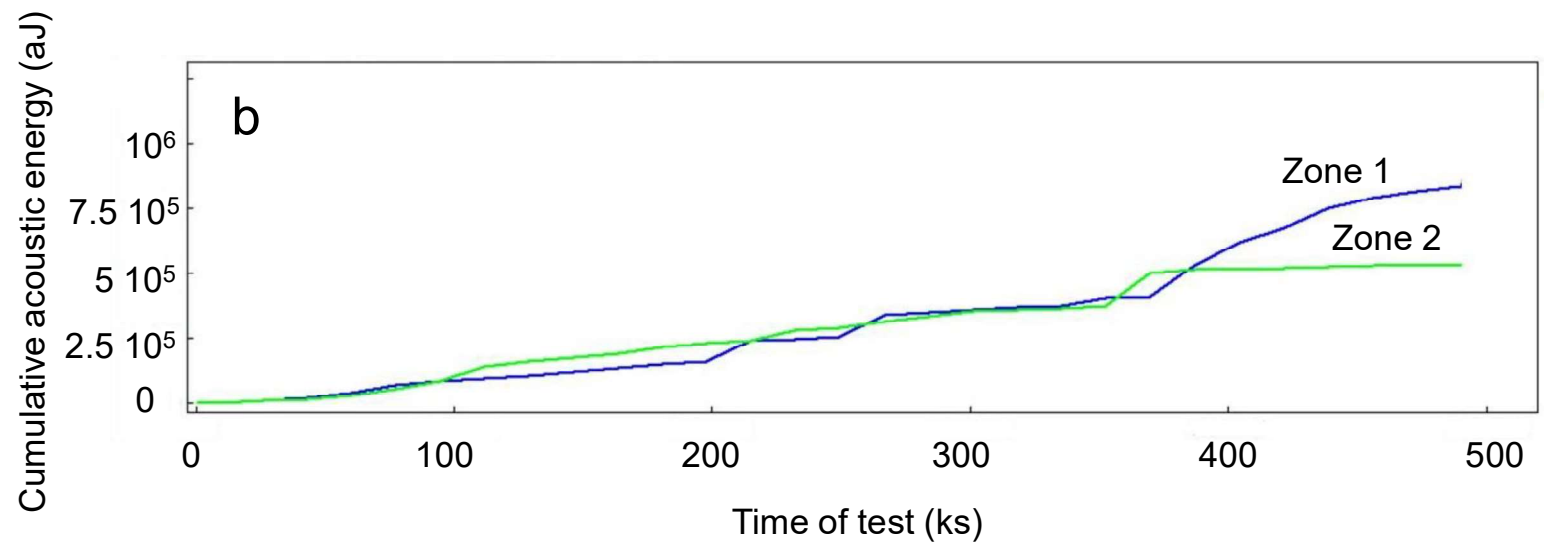
Fig.10

Figure 10. (a) Number and (b) cumulative energy of AE signals vs. time of test for zones 1 and 2.

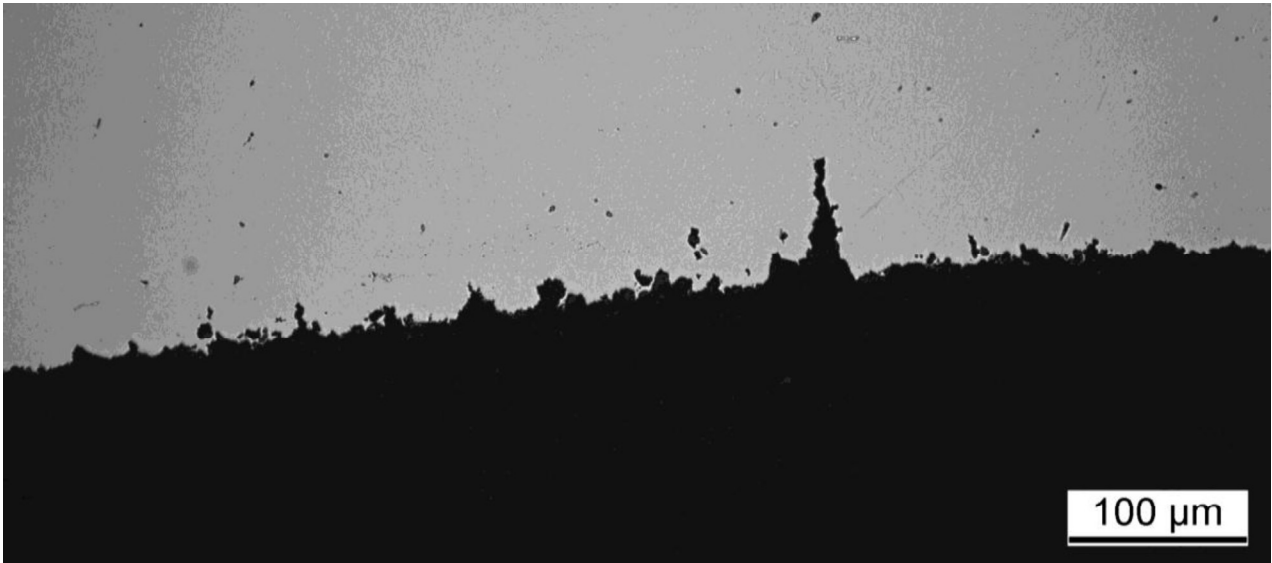
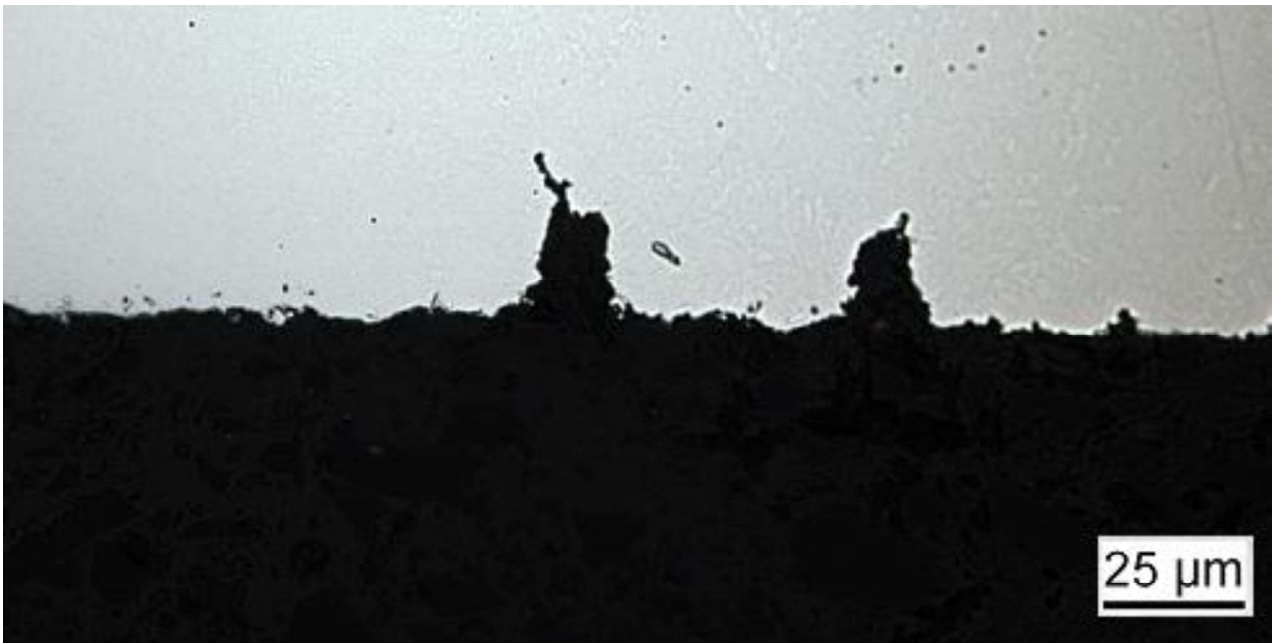
Fig.11

Figure 11. Cross section observations of high AE density areas.

At the beginning of exposure tests, homogeneous AE data was recorded on the whole specimen surface. This AE activity could be linked with a randomly distributed localised corrosion. Indeed, cross section observations of specimen areas exhibiting a high AE signal density revealed the presence of pits prior to crack propagation (Figure 11). After a certain exposure time, higher AE activity at specific locations at the steel surface was detected. This was associated with crack initiation. The time before such local increase of AE activity was detected was scattered between replicate experiments. This suggests that initiation is not linked with the accumulation of a certain level of absorbed hydrogen. It is more likely that initiation starts at surface defects. Indeed, initiation can occur after more than 100 hours testing, whereas estimations of hydrogen charging kinetics have shown that a HIC standard massive specimen (X65 grade) is saturated with H<sub>2</sub> in about 10 hours in similar experimental conditions [43]. On the contrary to HIC initiation, hydrogen charging time of the material is therefore not the limiting factor for SSC initiation. This explains the importance of surface preparation for SSC specimens. Cernoky et al. [44] demonstrated the importance of specimen surface preparation when tested in acidic H<sub>2</sub>S media under constant load. The steel specimens exhibited an increasing resistance to SSC when chemically polished compared to mechanical polishing, itself compared to as-machined surface state. According to Cernoky [44], machining was responsible for the existence of a sub-surface strain-hardened zone, at the origin of SSC susceptibility. Another author [45] also observed that cracking hardly initiated on smooth surfaces in the presence of hydrogen. According to this author, a localized corrosion enhancing pitting would promote crack initiation. Indeed, mackinawite scale growth involves the formation of FeSH<sub>ads</sub><sup>-</sup> which can generate a porous sulfide layer and increase the localized corrosion of the steel [11]. It was reported elsewhere that the formation of such a porous sulfide deposit could retain the pit electrolyte within the pits and propagate pit growth [46]. Moreover, immersion of steel in H<sub>2</sub>S containing solutions leads to the formation of a rough surface [11]. In the present case, pitting initiation could be enhanced by the presence of H<sub>2</sub>S, as reported for martensitic stainless steel [47], or the presence of a relatively rough surface could constitute occluded cells and play the part of initiating pits in which acidic electrolyte can be retained.
