## Monitoring of a sediment replenishment operation: The case of the Saint-Sauveur dam in the Buëch River (Southern Alps, France)

Guillaume Brousse, Mélanie Bertrand, Gilles Arnaud-Fassetta, Frédéric Liébault, Laurent Borgniet, et al.. Monitoring of a sediment replenishment operation: The case of the Saint-Sauveur dam in the Buëch River (Southern Alps, France). *I.S.Rivers 2018 (Integrative sciences and sustainable development of rivers)*, Jun 2018, Lyon, France. hal-01814406

## **Monitoring of a sediment replenishment operation: The case of the Saint-Sauveur dam in the Buëch River (Southern Alps, France)**

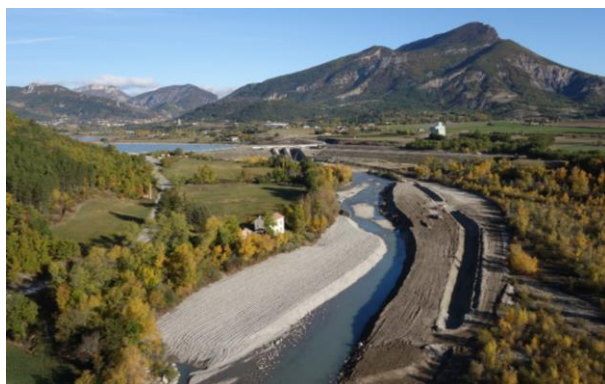
Figure 1 : The replenishment site at the end of the restoration (source: EDF).

deposited along a 400 m reach downstream from the dam, by the creation of two artificial gravel berms according to “point bar stockpile method” (Ock et al., 2013; fig.1). To facilitate the remobilization of the left-side berm, a trench was cut into the deposit. In addition, new rules of hydraulic transparency are established in order to increase sediment input in the restored reach. The general objective of the restoration project is to improve the hydromorphological conditions of the degraded reach downstream from the dam. A complementary objective is to reduce the flooding risk upstream from the dam.

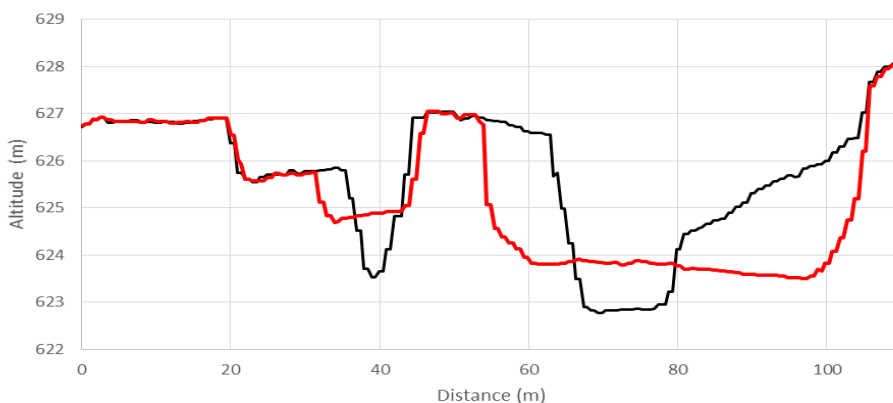
Figure 2: Eroded cross section after Q<sub>10</sub> flood.

This graph is obtained by DEM differencing (after restoration in black and after flood in red). See the right and central erosion of artificial berms. Left berm was not really eroded because of not flooded surface and low energy in the trench.

Only three weeks after restoration a ten-year flood allows us to analyze geomorphological change and efficiency of the replenishment operation (Brousse, 2017). This flood with good hydraulic transparency has eroded 47% of the total artificial sediment recharge. Erosion is very important on the right berm

(6100 m<sup>3</sup>) and on the central berm (13,000 m<sup>3</sup>) but very low on the left berm (1100 m<sup>3</sup>, fig.2). The trench has been strongly shortened (380 m to 198 m). Its relative elevation from the main channel increased and its slope decreased from 0.54 to 0.2%.
