# Monitoring of a sediment replenishment operation:

## The case of the Saint-Sauveur dam in the Buëch River (Southern Alps. France)

G. Brousse ; M. Bertrand ; G. Arnaud-Fassetta ; F. Liébault ;  
L. Borgniet ; G. Melun ; R. Loire ; J.R. Malavoi ; G. Fantino

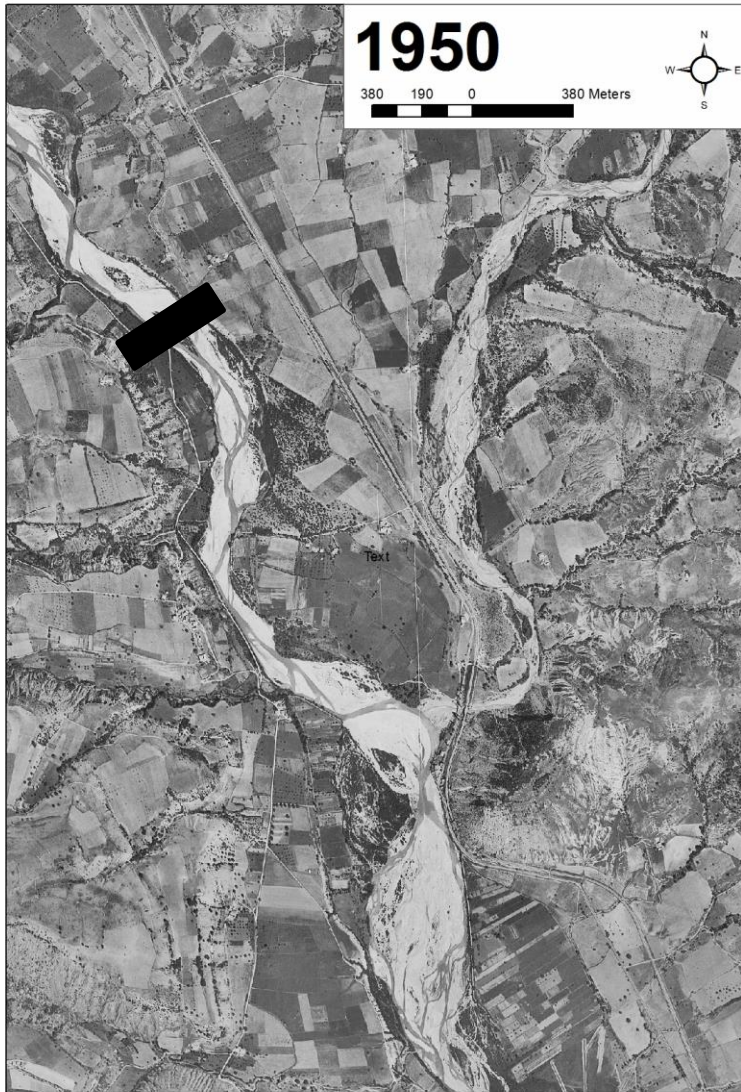
## Human alterations of the physical fluvial corridor :

- **Gravel mining**
  - > 3 Mm<sup>3</sup> in the upper catchment
  - > 6 Mm<sup>3</sup> in the lower catchment
- **Flood protection and hydropower equipments**

River regulation (before 20<sup>th</sup> century)

Saint-Sauveur dam (1991 and 1992) => dredging of 600,000 m<sup>3</sup> of sediment

- **Bedload has been strongly impacted**

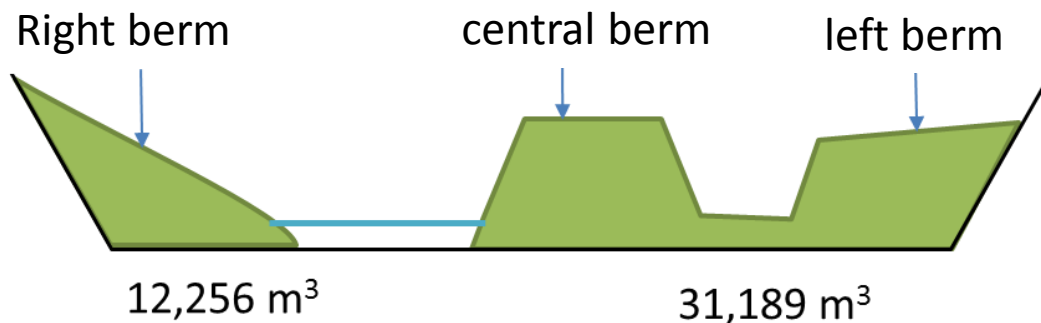
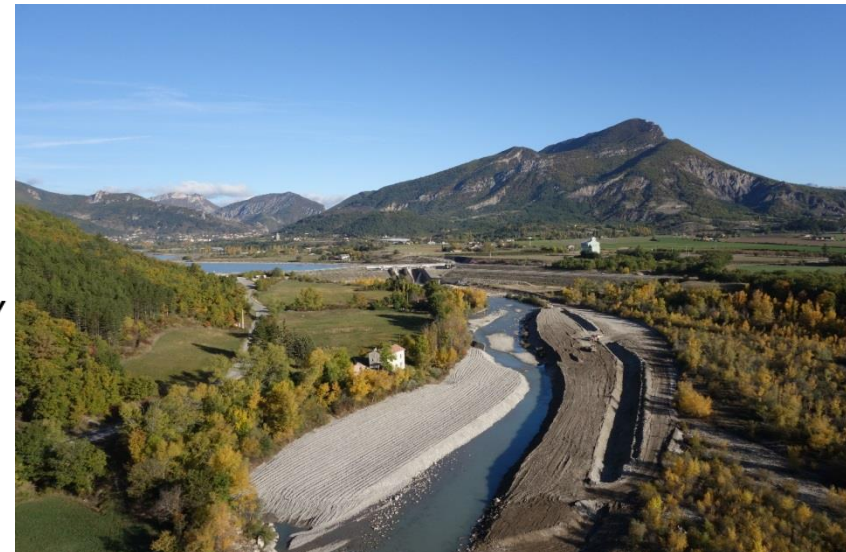
« Point bar stockpile method » (Ock *et al.* 2013)

- September 2016: 1 million euros
- Dredging the alluvial fan of the Saint-Sauveur reservoir
- Clearing alluvial bar
- Sediment replenishment downstream of the dam (**44,000 m<sup>3</sup>**)
- 2,500 m<sup>3</sup> by day (7 tip-truck)
- **Limiting flood risk**
- **Stop incision**

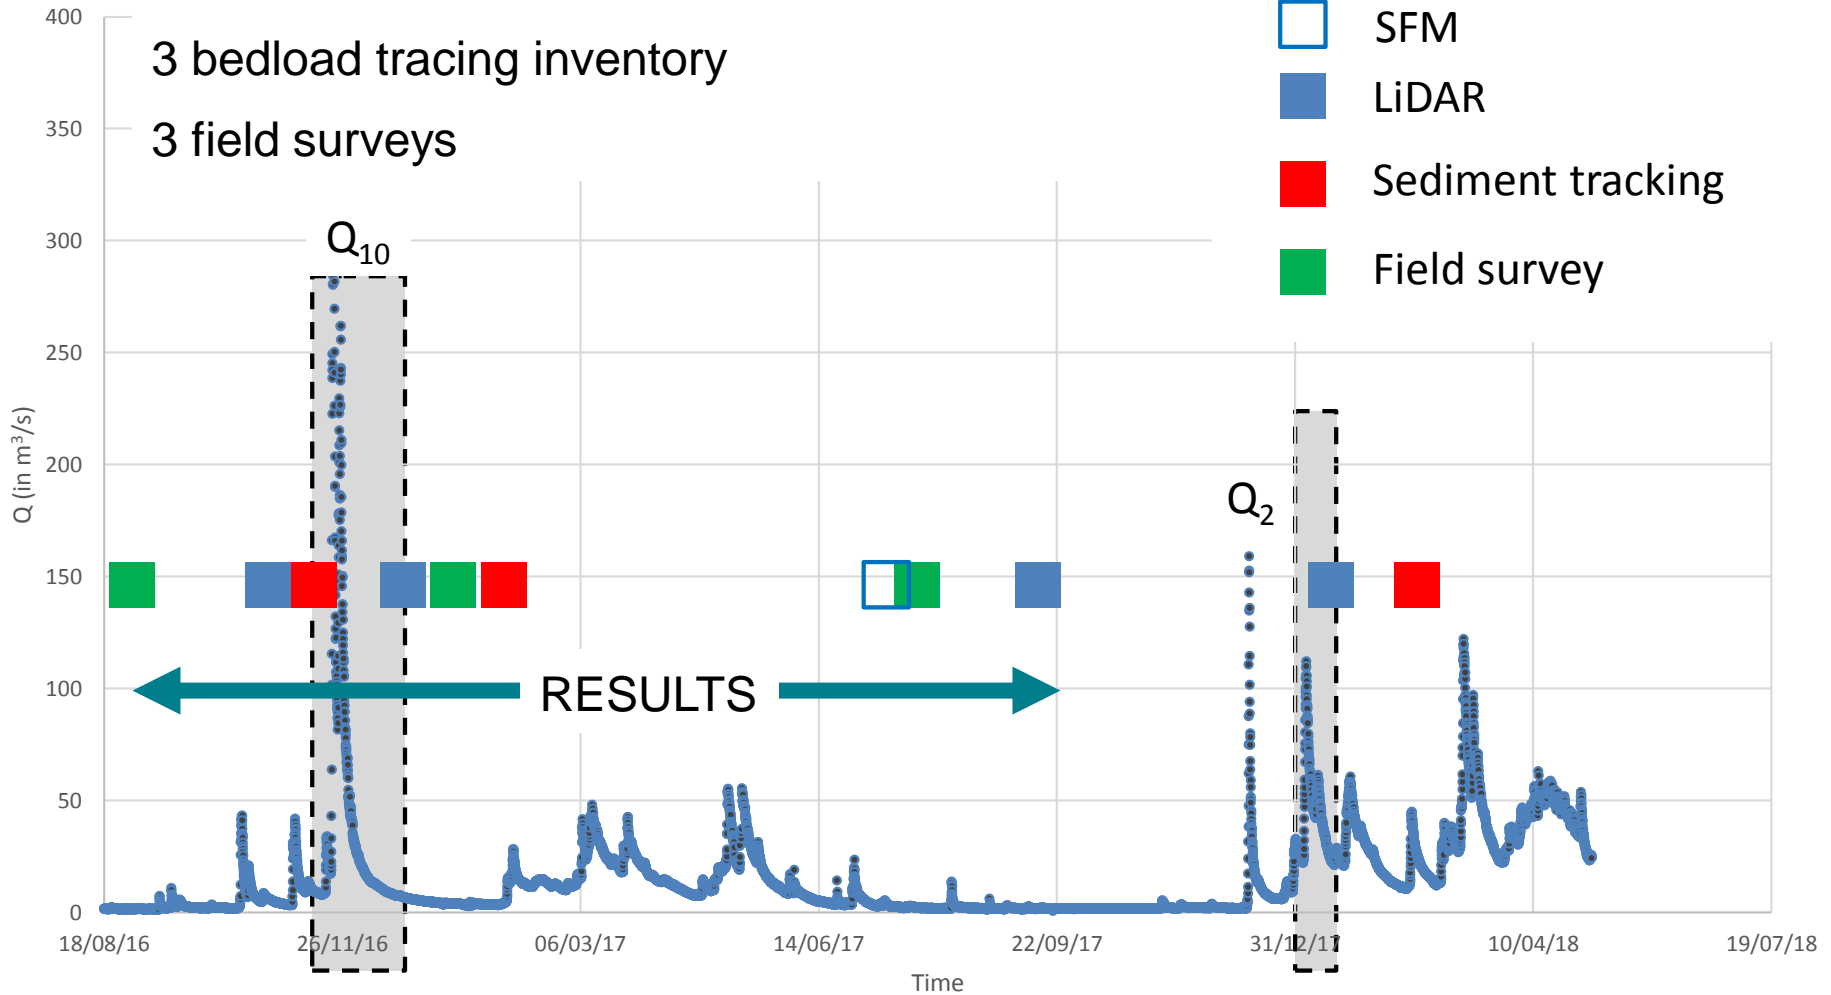
# REPETITIVE DATA ACQUISITION

5 Airborne LiDAR

1 SfM

3 bedload tracing inventory

3 field surveys

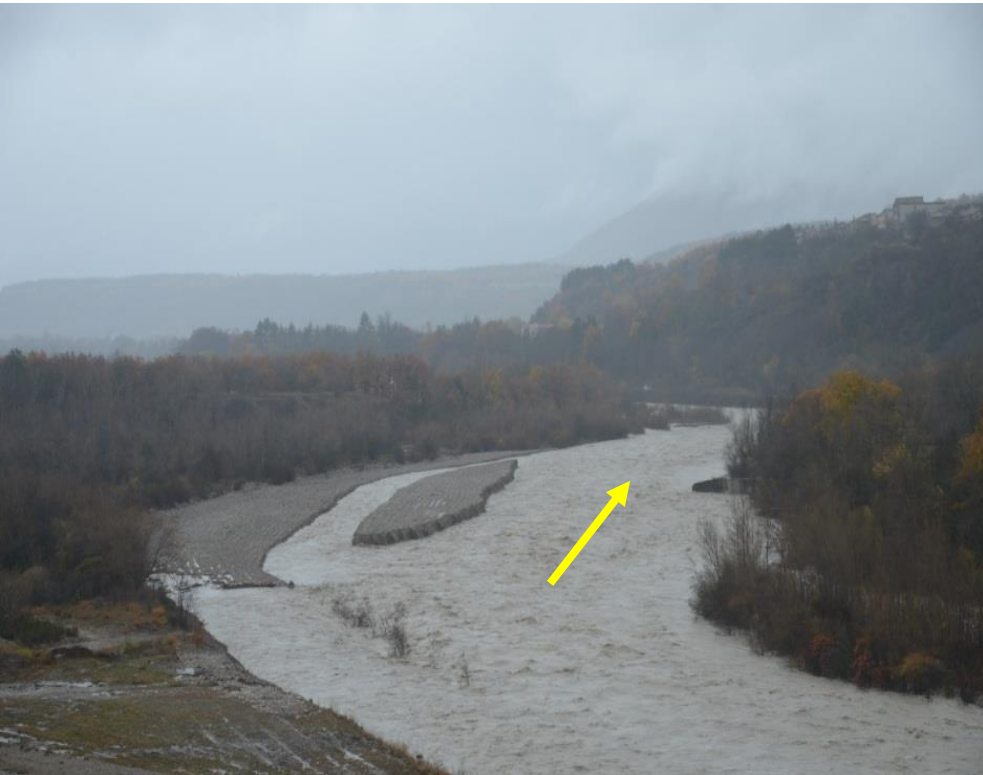
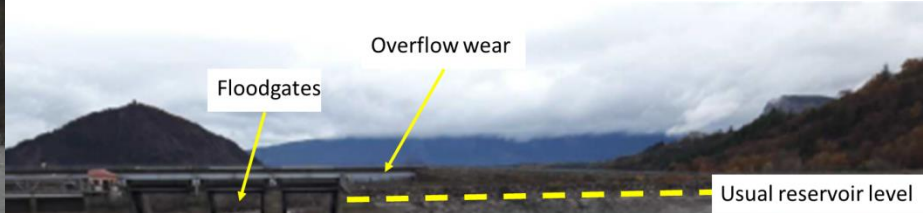
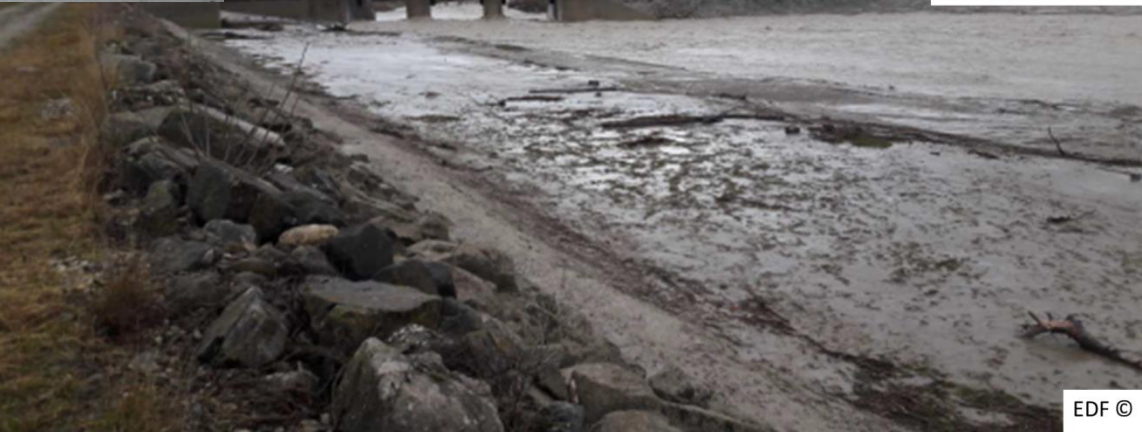
# CHARACTERIZATION – During flood (November 2016)

Berms erosion

Hydraulic transparency

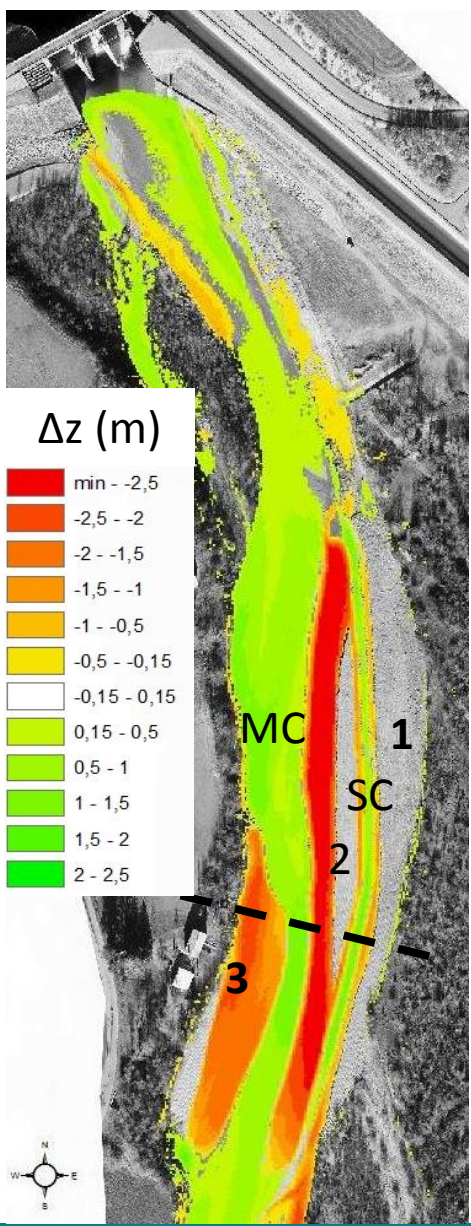
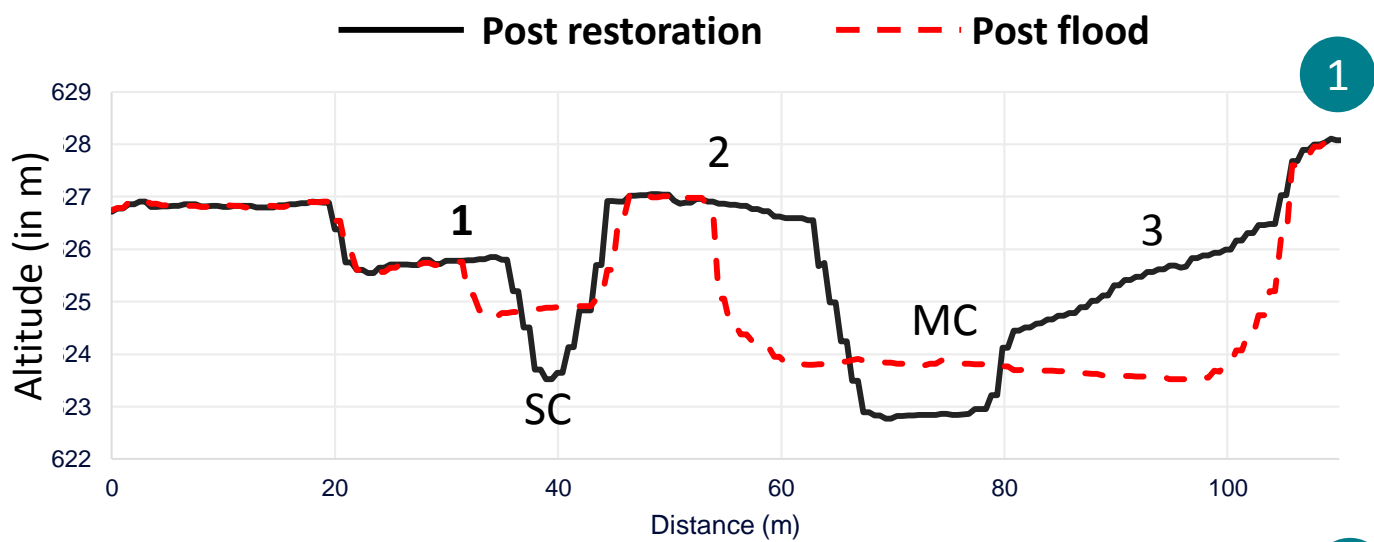
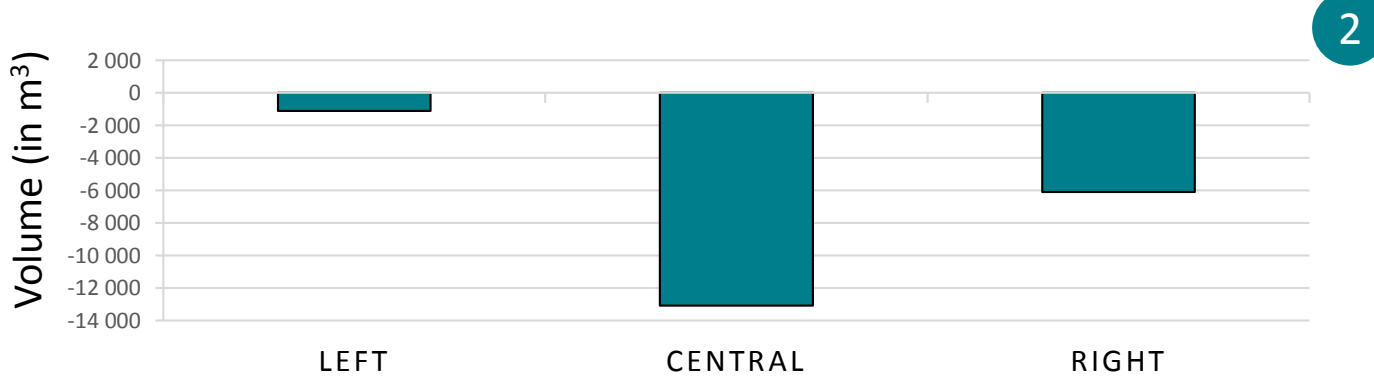
# THE REPLENISHMENT SITE – Post flood (December 2016)

**Very high erosion on the central and on the right berm during flood**  
**→ 20,000 m<sup>3</sup> (46% of initial berms)**  
**Net sediment budget → -11,000 m<sup>3</sup>**

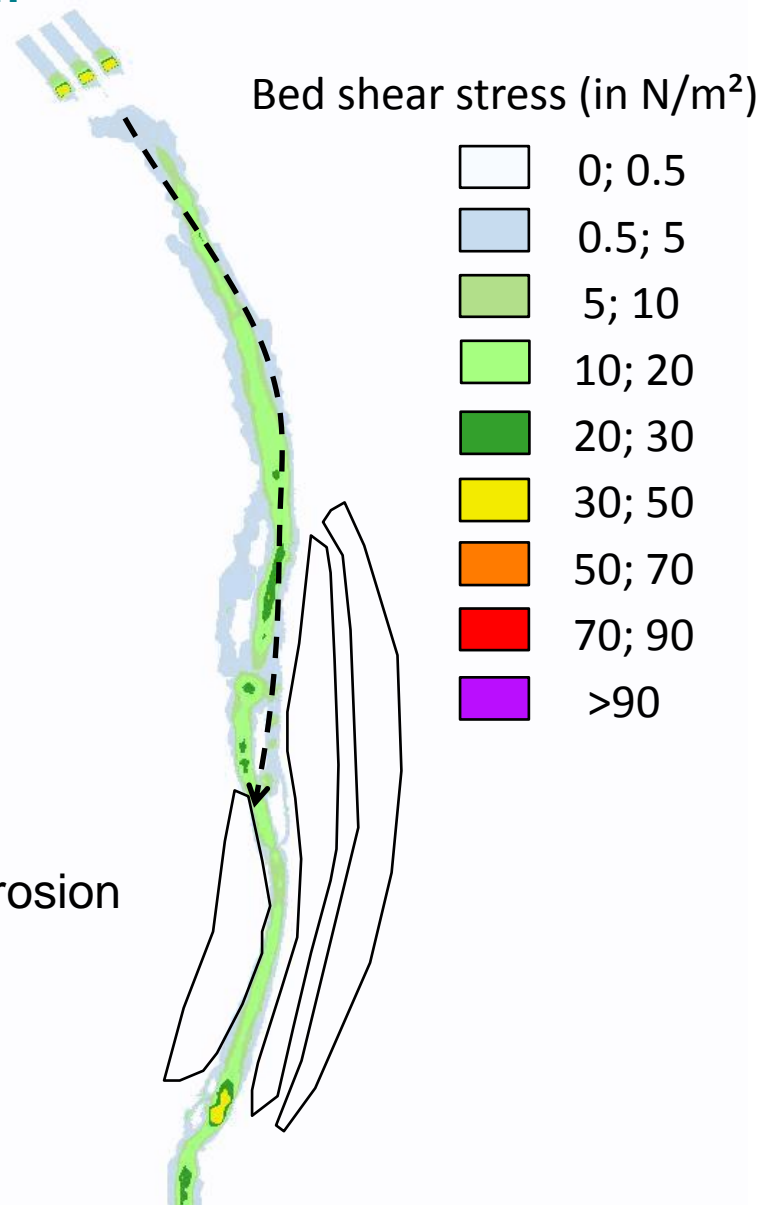
# THE REPLENISHMENT SITE – Flood modelization

- 2D Telemac model of the  $Q_{10}$  flood (Durand-Gasselin. 2017)
- Field calibration (grain size and flood marks)

## Shaping of the secondary channel?

- A net limit between MC and SC
- Flow dividing
- Minimize erosion in SC
- Erosion of SC du to lateral and regressive erosion
- No linear erosion
- Too far of the flow axis

- Shaping of a secondary channel is not a good solution in this site
- Left berm are now non erodable for frequent flood

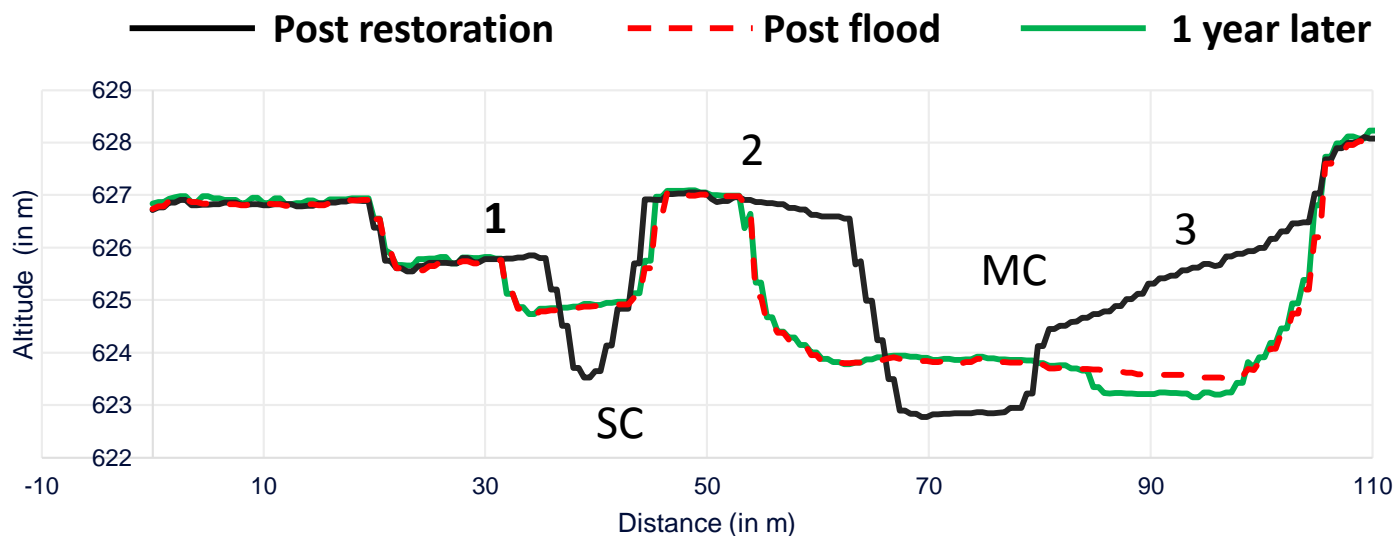
# THE REPLENISHMENT SITE – One year later (September 2017)

**Very small evolution during last year But the main channel erode the right bank**

**Net sediment budget → -150 m<sup>3</sup>**

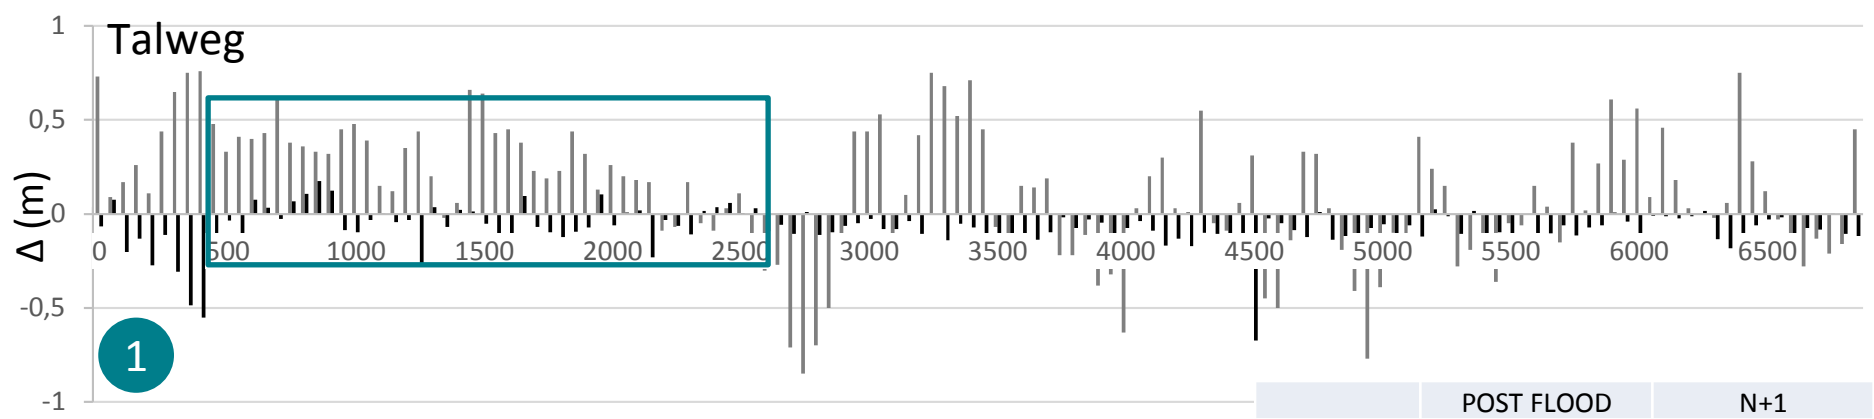
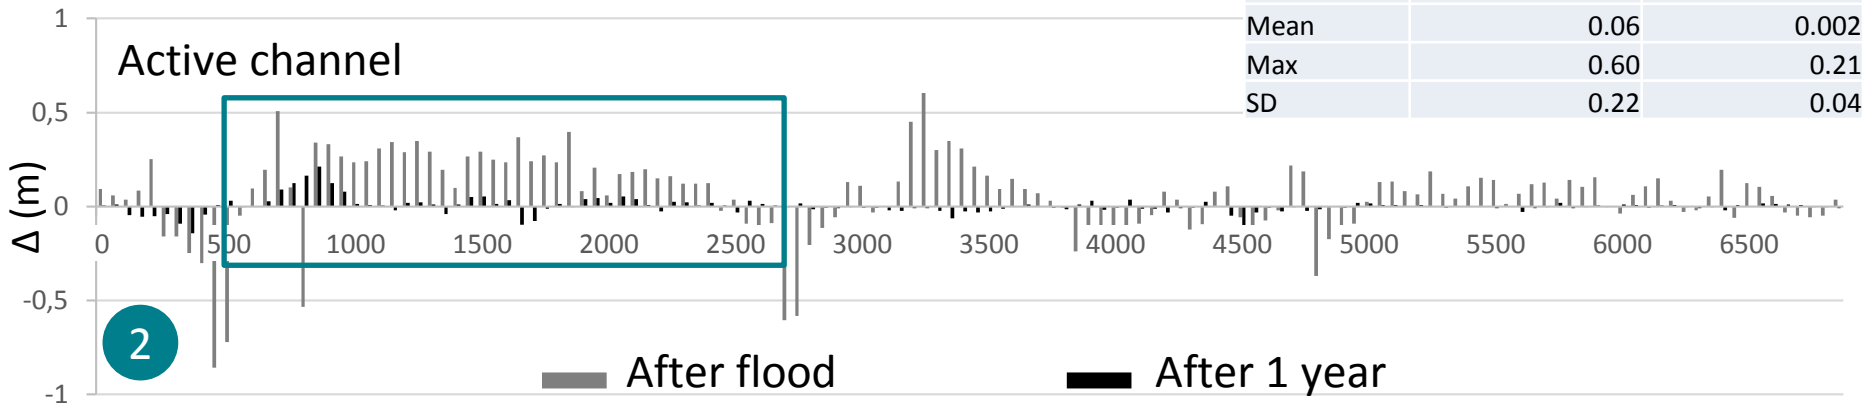
# THE DOWNSTREAM REACH – Longitudinal profile

**Aggradation max in the 2.5 km downstream reach**  
**Global net deposition**

- Great erosion of initial berms → sediment input to the downstream reach
- Net aggradation on the 6 km downstream reach (main channel and active channel)
- Change are more important in the upper part (2.5 km)
  - Aggradation is greater
  - Main channel erosion

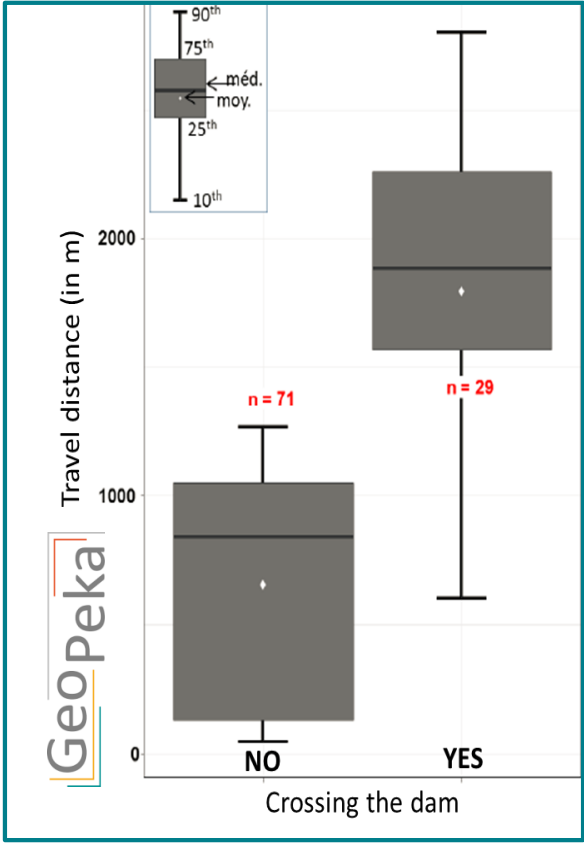
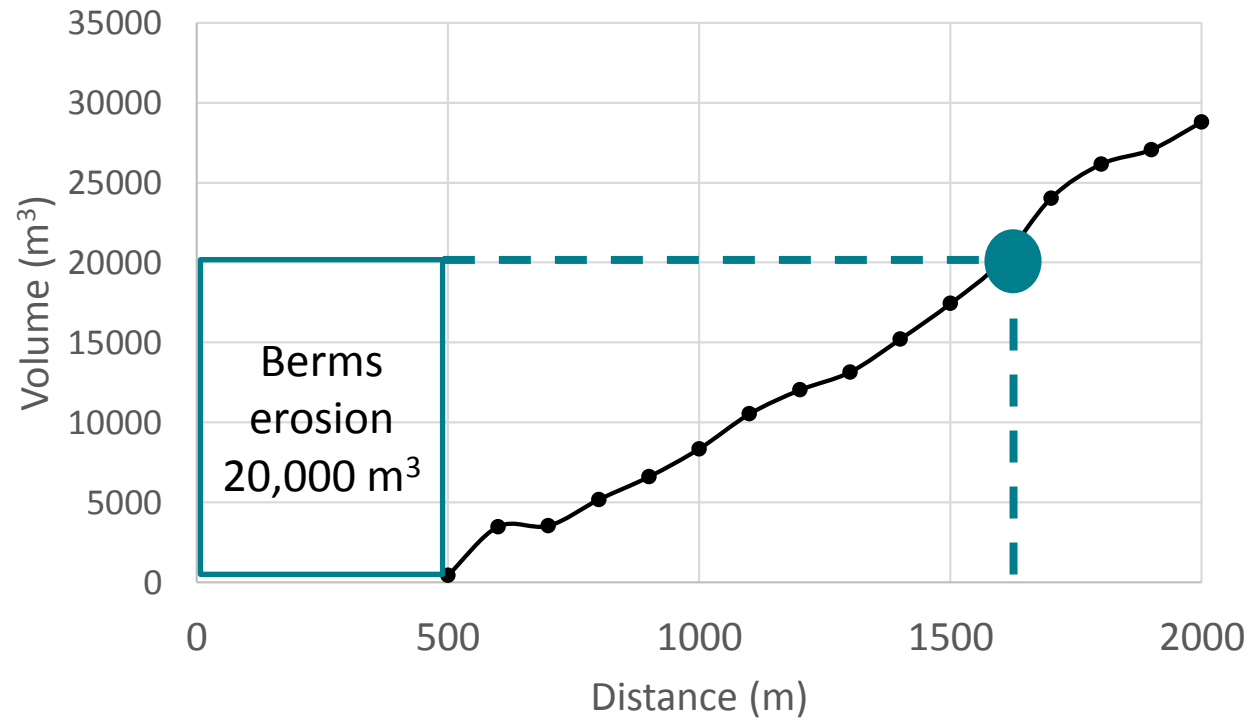
# THE DOWNSTREAM REACH – Travel distance from berms erosion

Only informations upstream the dam

**Distance travel from berms erosion: [0; 1600] m**

n = 148  
 Recovery rate = 68%  
 Mean travel distance = 1,150  
 Max = 3,240 m
