# Fatigue performances of FSW and GMAW aluminum alloys welded joints: Competition between microstructural and structural-contact-fretting crack initiation

Damien Texier, F. Atmani, Philippe Bocher, F. Nadeau, Jianqiang Chen, Yasser Zedan, Nicolas Vanderesse, Vincent Demers

To appear in: *International Journal of Fatigue*

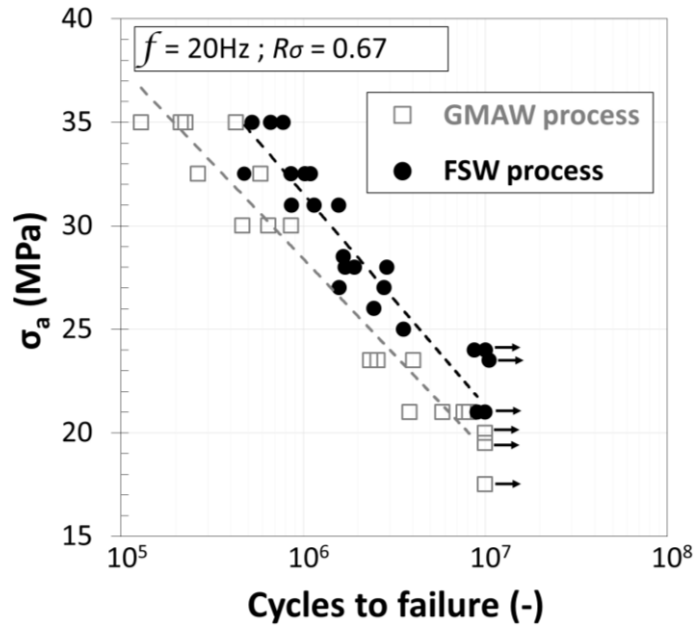
**Fig. 3: S-N curves for GMAW (white marks) and FSW (black marks) welded assemblies.**

The fatigue results performed on the two welding configurations are presented in Fig. 3. In this HCF regime, the fatigue performance of welded joints is dependent on the welding process. The FSW configuration demonstrates a higher fatigue resistance compared than that obtained with the GMAW configuration. The fatigue strength, corresponding to the run-out condition, is approximately 25% higher for the FSW configuration than for the GMAW configuration. At a high stress amplitude ( $\sigma_a = 35 \text{ MPa}$ ), the assemblies produced by FSW process exhibit a lifespan about three times higher than that of the GMAW process.

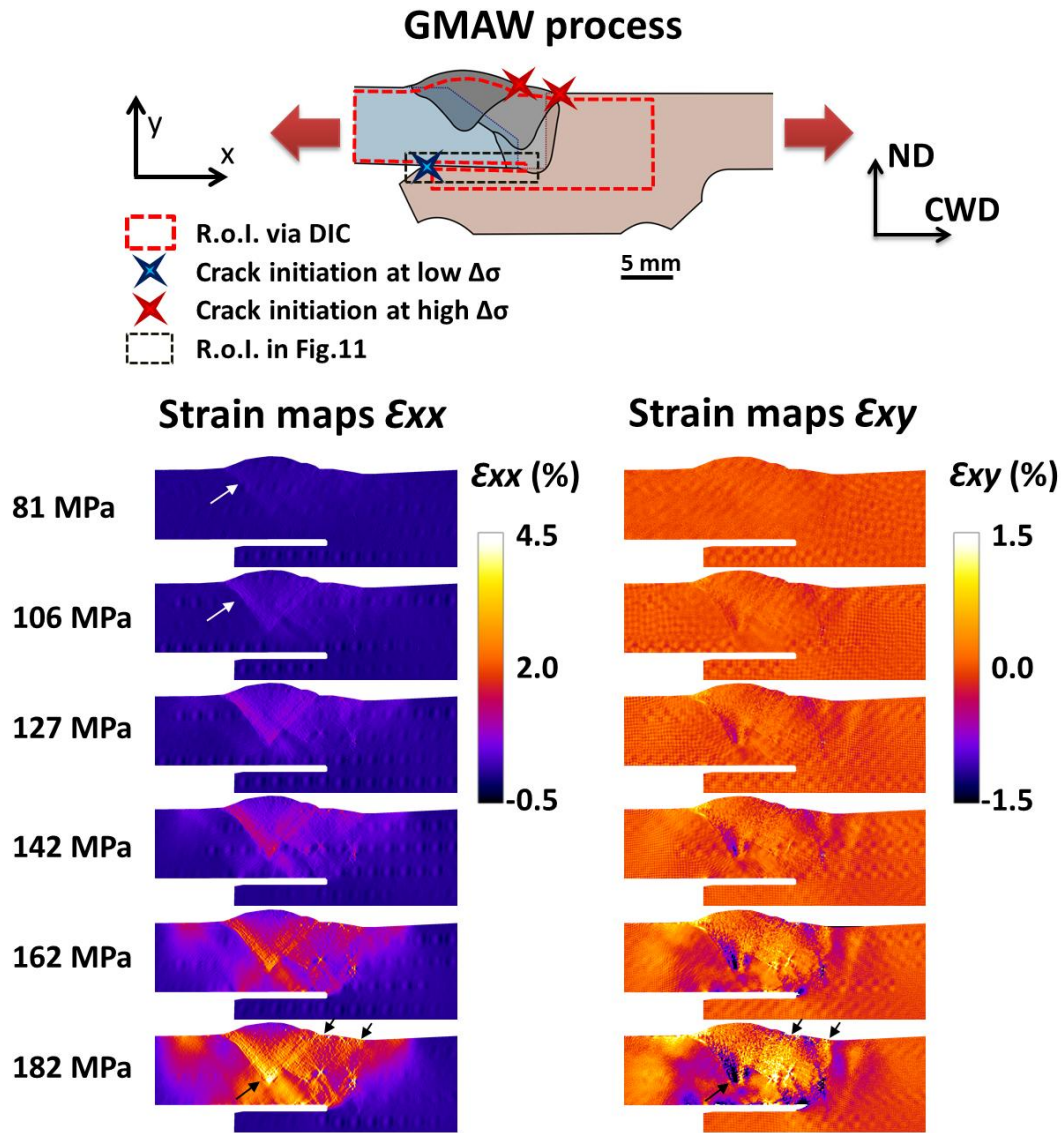
*Fig. 10: Schematic illustration of the region of interest for DIC experiments performed on the GMAW configuration and strain maps ( $\epsilon_{xx}$  and  $\epsilon_{xy}$ ) for different loading conditions. Strain localization occurred near the pass interfaces, within pass #3, in the high porosity regions of the weld passes, in the HAZ, and at the notch root depicted by black arrows for the 182 MPa loading condition.*

III.5. Local strain field characterization via optical digital image correlation technique  
 Ex-situ digital image correlation (DIC) tests were conducted on GMAW and FSW configurations to assess the local plastic strain fields of the welded assemblies subjected to a mechanical loading (Fig. 10 and Fig. 12). As aforementioned, the local strain was evaluated after incremental loading up to specific loads and unloading. In this respect, local deformations calculated from the displacement measurements correspond to the irreversible local plastic deformation after specified axial loadings. Strain fields measured in the principal direction strain component  $\varepsilon_{XX}$  and in the shear strain component  $\varepsilon_{XY}$  are reported in Fig. 10 and Fig. 12. Cold and hot colors for  $\varepsilon_{XX}$  correspond to non-deformed and highly deformed regions (*i.e.*, 0.0% [blue] <  $\varepsilon_{XX}$  < 4.5% [yellow]), respectively, whereas cold and hot colors for  $\varepsilon_{XY}$  both correspond to highly deformed regions, while local non-deformed regions are depicted in orange. The DIC technique was successfully used in this study to demonstrate how the local strain fields were very heterogeneous and sensitive to local microstructural features and defects.

underestimated in Fig. 10, particularly in the vicinity of the crack initiation sites (as represented by red and orange marks in Fig. 4.a). At high stress levels, there was significant deformation at the notch tip and the notch root, the latter region being a crack initiation site in the low stress amplitude regime (as represented by a blue mark in Fig. 4.a).
