## **Influence of anodizing process on fatigue life of a machined aluminium alloy**

Fatigue 2010

## Influence of Anodizing Process on Fatigue Life of Machined Aluminium Alloy

M. Shahzad \* - M. Chaussumier - R. Chieragatti -C. Mabru - F. Rezai-Aria

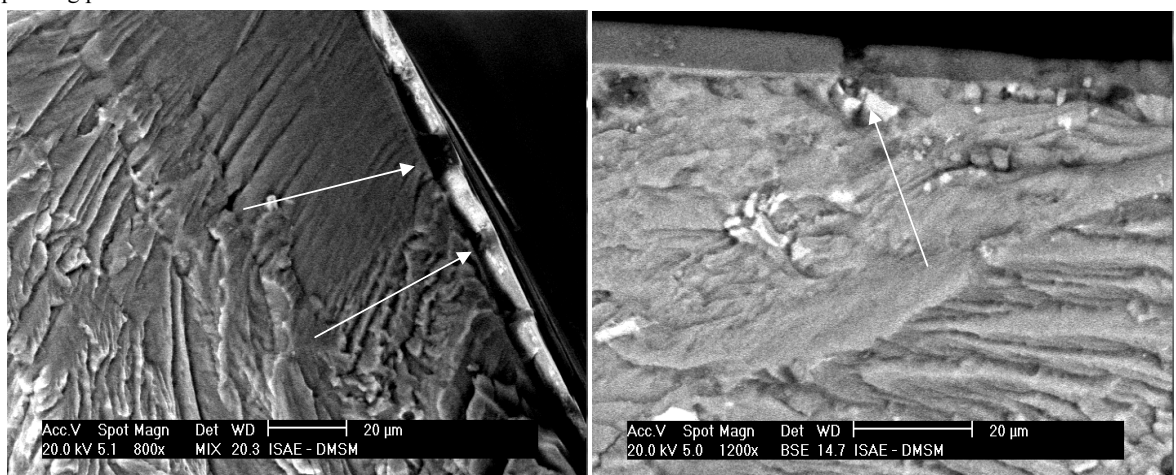
Figure 10: (a) Partial delamination of coating from substrate

(b) Irregularities found in the coating

Although anodized coating was found to be quite uniform in most regions around the specimen, SEM examination showed that in some region there was partial delamination; figure 10a indicated by arrows, at the interface of coating and substrate and this delamination is related to the interfacial shear strength [9]. Also the presence of irregularities (figure 10b) in the coating is important consideration affecting crack nucleation and propagation. Local stress concentration due to the irregularities may have provocative effect on the crack nucleation as well as on the delamination. The presence of these irregularities in the coating can be correlated to the presence of pickling pits and inclusions.
