Technical study of Germolles' wall paintings: the input of imaging technique

Christian Degriigny, Francesca Piqué, Nutsa Papiashvili, Julien Guery, Alamin Mansouri, et al.. Technical study of Germolles' wall paintings: the input of imaging technique. *Virtual Archaeology Review*, 2016, 7 (15), pp.1-8. 10.4995/var.2016.5831 . hal-01864025

TECHNICAL STUDY OF GERMOLLES' WALL PAINTINGS: THE INPUT OF IMAGING TECHNIQUES

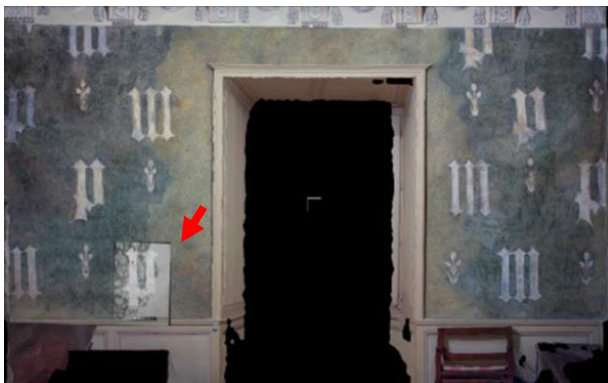
Figure 15: Snapshot from the SIVT application tested on Germolles case study data. The rectified and registered IR image of the “P” (red arrow) is displayed on top of the orthophotograph of room dn south wall ©Wefers and Reich.

Another promising application (SIVT – Spatial Image analysis and Viewing Tool – Wefers, Reich, Tietz, & Boochs, 2016) was tested to contribute to a combined visualization and analysis of images displaying details of Germolles wall paintings. The orthophotograph of room dn south wall (Fig. 3) and other 3D datasets (a 2.5D image, a normal image and a difference image) were generated from the five high dynamic range photographs of the wall. They were all registered and integrated into SIVT as basemaps. Applying the shading functionality onto these datasets, the irregularities of the wall surface were better visualized to aid conservation analysis. Additionally, images displaying details of the wall painting (such as an IR image of the same “P” as on Fig. 14) were semi-automatically registered allowing a combined visualization of the orthophotograph and detailed images (Fig. 15). For this task corresponding information between the orthophotograph and the detailed images need to be taken at hand. As this can be problematic for displaying the spectral images IR, reflected IRr, UV-induced visible fluorescence (UVf), and IR false colour (IRfc) information, matching points of all spectral images taken from the same position with the same device were compiled. Through this approach all spectral images including those with low correspondence could be rectified and registered using one transformation.
