## Technical study of Germolles' wall paintings: the input of imaging technique

## TECHNICAL STUDY OF GERMOLLES' WALL PAINTINGS: THE INPUT OF IMAGING TECHNIQUES

The *Château de Germolles* is one of the rare palaces in France dating from the 14<sup>th</sup> century. The noble floor is decorated with wall paintings that are a unique example of courtly love spirit that infused the princely courts of the time. After being concealed sometime in the 19<sup>th</sup> century, the paintings were rediscovered and uncovered in the middle of the 20<sup>th</sup> century and partly restored at the end of the 1990s. No scientific documentation accompanied these interventions and important questions, such as the level of authenticity of the mural decorations and the original painting technique(s) used in the medieval times remained unanswered. The combined scientific and financial supports of COSCH Cost Action and DRAC-Burgundy enabled to study Germolles' wall paintings using some of the most innovative imaging and analytical techniques and to address some of the questions raised. The study provided significant information on the material used in the medieval times and on the conservation condit

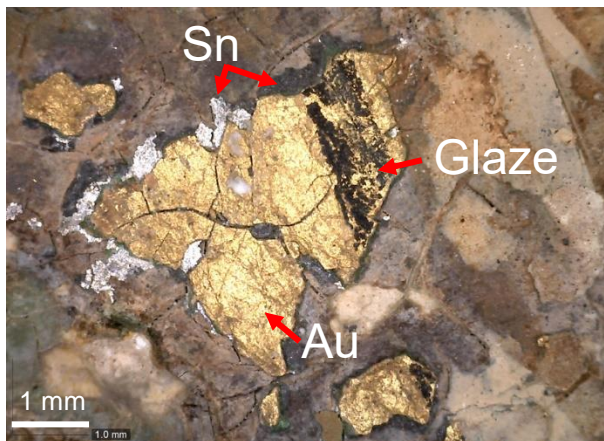
**Figure 9:** Micro-photography of a gold leaf from a thistle in the upper parts of room dn showing traces of a black glaze or paint layer © Piqué.

Further close observation of the metallic remains on the thistles of room dn showed the presence of black glaze or paint layer on top of the gold foils that was certainly applied to give some relief to the gold background (Fig. 9) (Mounier, 2010).

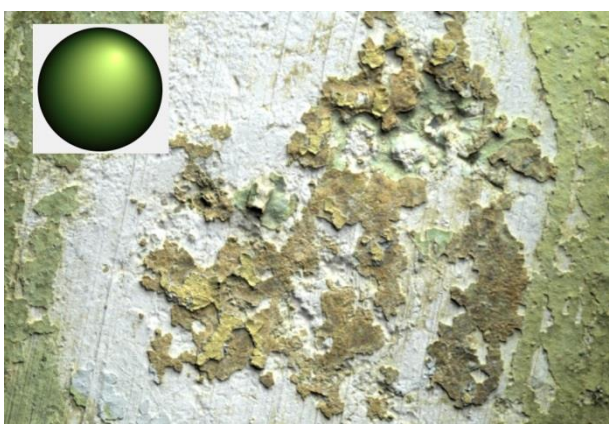
**Figure 10:** H-RTI snapshots under different illumination angles and application of diffusion gain. Gold remains are evident on picture a) but not so much the stratigraphy of layers. The reverse is observed when the surface is illuminated from the opposite direction b) © Germolles.

Raking light is certainly one of the best way to observe the stratigraphy of layers on the thistles. However, shadows are problematic and difficult to avoid. Therefore Highlight-Reflectance Transformation Imaging (H-RTI) using a Nikon D 7100 digital camera equipped with a variable focal (DX-VR, AF-S 18-140) used with maximum magnification (140 mm), at a working distance of approximately 25 cm, was tested as an alternative to raking light to better visualise details and stratigraphies of these paintings illuminated with a torch equipped with a LED of a power of white light (XM L2) (Duffy, 2013).

H-RTI data processing can be done with open source softwares available to end-users (RTIBuilder® and RTIViewer®), making this imaging technique a low-cost accessible one. Fig. 10 shows two snapshots of an H-RTI recording of a thistle. The remains of the gold foils are clearly visible on Fig. 10a while the layers' stratigraphy is more legible on Fig. 10b.

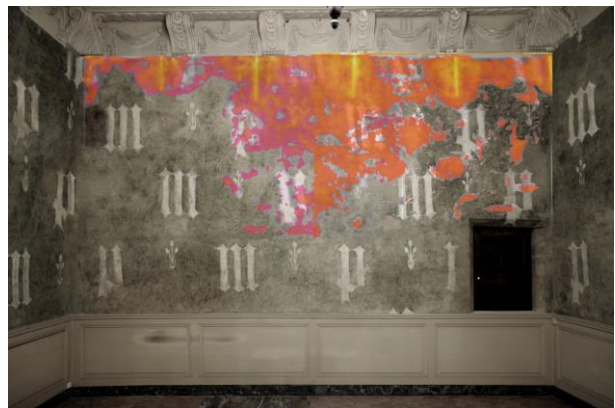
**Figure 13:** Representation of areas of detachment detected by IRT on room dn west wall © Tedeschi & Cucchi.

Investigation with IR Thermography (IRT) using a thermocamera testo 890 equipped with IR-FPA (focal-plane array) detector was carried out to assess large cracks observed on the 19<sup>th</sup> century cornice of the room. IRT was accompanied by tactile assessment to detect delaminated areas. Fig. 12 shows (on the IR basemap of Fig. 4) the location of detachments perceived by touch (knocking tests). As shown on Fig. 13, the results obtained by IRT and by knocking were similar.

The wall paintings are generally in stable condition even though the IRT campaign showed that the top part of the walls are suffering from delamination processes. In addition the painting surface, particularly the metallic remains, suffer from flaking.

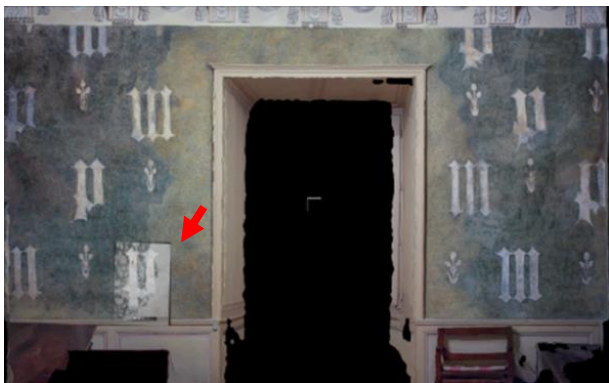
**Figure 15:** Snapshot from the SIVT application tested on Germolles case study data. The rectified and registered IR image of the “P” (red arrow) is displayed on top of the orthophotograph of room dn south wall ©Wefers and Reich.

Another promising application (SIVT – Spatial Image analysis and Viewing Tool – Wefers, Reich, Tietz, & Boochs, 2016) was tested to contribute to a combined visualization and analysis of images displaying details of Germolles wall paintings. The orthophotograph of room dn south wall (Fig. 3) and other 3D datasets (a 2.5D image, a normal image and a difference image) were generated from the five high dynamic range photographs of the wall. They were all registered and integrated into SIVT as basemaps. Applying the shading functionality onto these datasets, the irregularities of the wall surface were better visualized to aid conservation analysis. Additionally, images displaying details of the wall painting (such as an IR image of the same “P” as on Fig. 14) were semi-automatically registered allowing a combined visualization of the orthophotograph and detailed images (Fig. 15). For this task corresponding information between the orthophotograph and the detailed images need to be taken at hand. As this can be problematic for displaying the spectral images IR, reflected IRr, UV-induced visible fluorescence (UVf), and IR false colour (IRfc) information, matching points of all spectral images taken from the same position with the same device were compiled. Through this approach all spectral images including those with low correspondence could be rectified and registered using one transformation.
