TECHNICAL STUDY OF GERMOLLES' WALL PAINTINGS: THE INPUT OF IMAGING TECHNIQUES

Christian Degriigny^{a,*}, Francesca Piqué^b, Nutsa Papiashvili^b, Julien Guery^c, Alamin Mansouri^d, Gaetan Le Goïc^d, Vincent Detalle^e, Dominique Martos-Levif^e, Aurélie Mounier^f, Stefanie Wefers^g, Cristina Tedeschi^h, Marco Cucchiⁱ, Jean-Marc Vallet^j, Anthony Pamart^k, Matthieu Pinette^l

Key words: Germolles, wall paintings, documentation, imaging techniques, painting techniques, data management

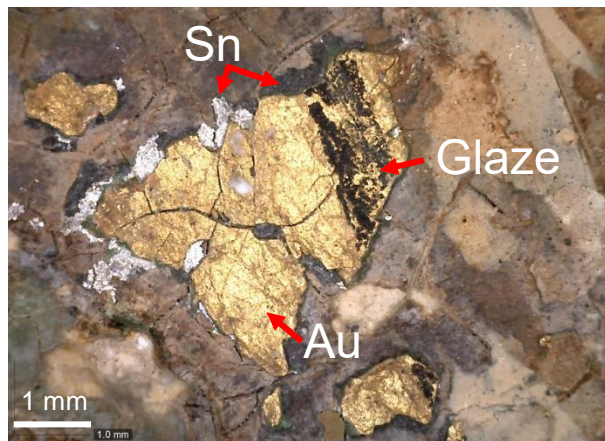
Figure 9: Micro-photography of a gold leaf from a thistle in the upper parts of room dn showing traces of a black glaze or paint layer © Piqué.

Further close observation of the metallic remains on the thistles of room dn showed the presence of black glaze or paint layer on top of the gold foils that was certainly applied to give some relief to the gold background (Fig. 9) (Mounier, 2010).

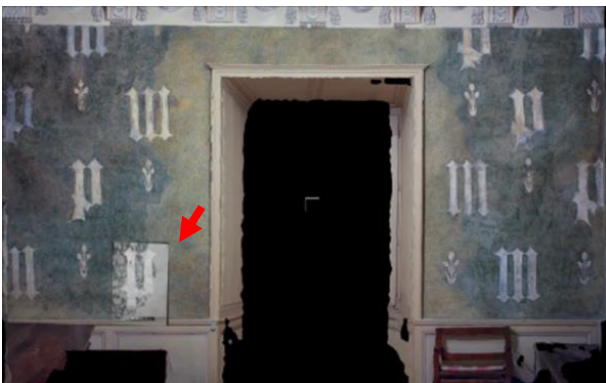
Figure 15: Snapshot from the SIVT application tested on Germolles case study data. The rectified and registered IR image of the “P” (red arrow) is displayed on top of the orthophotograph of room dn south wall ©Wefers and Reich.

Another promising application (SIVT – Spatial Image analysis and Viewing Tool – Wefers, Reich, Tietz, & Boochs, 2016) was tested to contribute to a combined visualization and analysis of images displaying details of Germolles wall paintings. The orthophotograph of room dn south wall (Fig. 3) and other 3D datasets (a 2.5D image, a normal image and a difference image) were generated from the five high dynamic range photographs of the wall. They were all registered and integrated into SIVT as basemaps. Applying the shading functionality onto these datasets, the irregularities of the wall surface were better visualized to aid conservation analysis. Additionally, images displaying details of the wall painting (such as an IR image of the same “P” as on Fig. 14) were semi-automatically registered allowing a combined visualization of the orthophotograph and detailed images (Fig. 15). For this task corresponding information between the orthophotograph and the detailed images need to be taken at hand. As this can be problematic for displaying the spectral images IR, reflected IRr, UV-induced visible fluorescence (UVf), and IR false colour (IRfc) information, matching points of all spectral images taken from the same position with the same device were compiled. Through this approach all spectral images including those with low correspondence could be rectified and registered using one transformation.
