Eugénie Crété, Santosh Yadav, Yannick Sieffert, Majid Hajmirbaba, Julien Hosta, et al.. Promoting vernacular architecture, a basis for Building Back Safer? A Case study from Nepal. SAHC 2018, Sep 2018, Cusco, Peru. hal-01877189

Promoting vernacular architecture, a basis for Building Back Safer? A Case study from Nepal

Keywords: vernacular architecture, aseismic design, seismic bands, Building Back Safer, Nepal

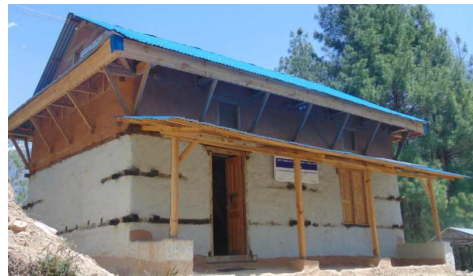
Figure 6. The demo house built in Magapauwa (credit: CRAterre)

As part of the reconstruction projects in Magapauwa and Katunje, ASF-Nepal and CRAterre provide technical support for all new constructions, retrofitting and repairing works in the villages. Moreover, two training sessions took place in November 2016 and May 2017. The demo houses that were constructed had three main functions: as a support for hands-on sessions during the training sessions, as a record of what trainees learned and as a showcase to share this knowledge with the other inhabitants.
