Promoting vernacular architecture, a basis for Building Back Safer? A Case study from Nepal

Eugénie Crété, Santosh Yadav, Yannick Sieffert, Majid Hajmirbaba, Julien Hosta, et al.. Promoting vernacular architecture, a basis for Building Back Safer? A Case study from Nepal. SAHC 2018, Sep 2018, Cusco, Peru. <hal-01877189>

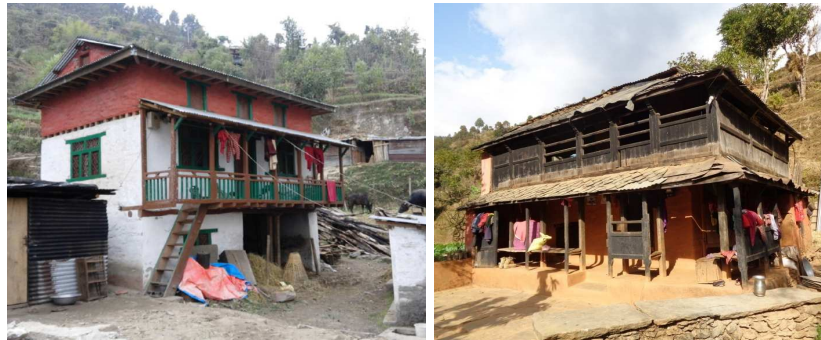
Figure 1. Traditional houses that resisted 2015 earthquakes with minor damage, in Magapauwa (left, credit: CRATERRE) and Katunje (right, credit: ASF Nepal)

The load-bearing external walls are made of stone and mud mortar masonry and are 40 to 50cm thick. Dressed stones are often used to reinforce corners. Internal partition walls are made of wood. Roofs are duo-pitched with an all-around eave. Traditional slates roofing are being replaced by Corrugated Galvanized Iron (CGI) sheets. This change started more than 20 years ago due to cost, ease of installation, and the inhabitants fearing heavy roofing in case of earthquakes. Several more specific traditional aseismic features were noticed:

- Doors and windows have a double timber frame which acts as an extra lintel when the masonry wall fails.
- Most of the remaining houses present wooden reinforcement at floor joists and awnings levels, and sometimes full timber seismic bands regularly spaced. In Katunje, several traditional buildings walls include stone bands spaced approx. 50cm.
- According to the connections between the awnings, they sometimes reduce the slenderness of the gable walls and confine the earthquake-sensitive upper part of the wall. However, this confinement is all the more efficient as the roof is heavy, which is becoming scarce with the replacement of slates by CGI.
- In Magapauwa, most houses are built with a double load-bearing system that is oversized for static loads, with masonry walls doubled by a post and beam timber structure.

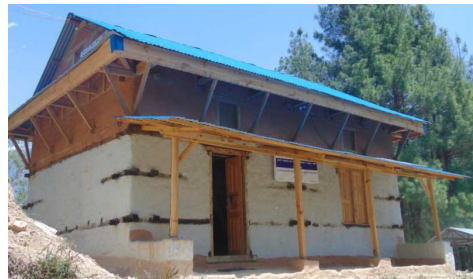
Figure 6. The demo house built in Magapauwa (credit: CRAterre)

As part of the reconstruction projects in Magapauwa and Katunje, ASF-Nepal and CRAterre provide technical support for all new constructions, retrofitting and repairing works in the villages. Moreover, two training sessions took place in November 2016 and May 2017. The demo houses that were constructed had three main functions: as a support for hands-on sessions during the training sessions, as a record of what trainees learned and as a showcase to share this knowledge with the other inhabitants.
