Promoting vernacular architecture, a basis for Building Back Safer? A Case study from Nepal

Eugénie Crété, Santosh Yadav, Yannick Sieffert, Majid Hajmirbaba, Julien Hosta, et al.. Promoting vernacular architecture, a basis for Building Back Safer? A Case study from Nepal. SAHC 2018, Sep 2018, Cusco, Peru. hal-01877189

Keywords: vernacular architecture, aseismic design, seismic bands, Building Back Safer, Nepal

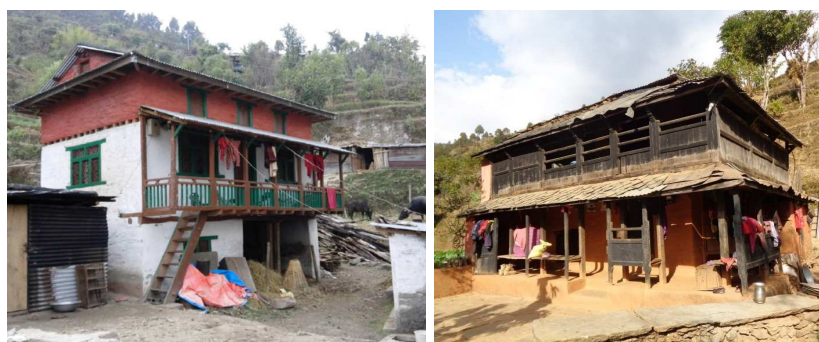
Figure 1. Traditional houses that resisted 2015 earthquakes with minor damage, in Magapauwa (left, credit: CRATERRE) and Katunje (right, credit: ASF Nepal)

The load-bearing external walls are made of stone and mud mortar masonry and are 40 to 50cm thick. Dressed stones are often used to reinforce corners. Internal partition walls are made of wood. Roofs are duo-pitched with an all-around eave. Traditional slates roofing are being replaced by Corrugated Galvanized Iron (CGI) sheets. This change started more than 20 years ago due to cost, ease of installation, and the inhabitants fearing heavy roofing in case of earthquakes. Several more specific traditional aseismic features were noticed:

- Doors and windows have a double timber frame which acts as an extra lintel when the masonry wall fails.
- Most of the remaining houses present wooden reinforcement at floor joists and awnings levels, and sometimes full timber seismic bands regularly spaced. In Katunje, several traditional buildings walls include stone bands spaced approx. 50cm.
- According to the connections between the awnings, they sometimes reduce the slenderness of the gable walls and confine the earthquake-sensitive upper part of the wall. However, this confinement is all the more efficient as the roof is heavy, which is becoming scarce with the replacement of slates by CGI.
- In Magapauwa, most houses are built with a double load-bearing system that is oversized for static loads, with masonry walls doubled by a post and beam timber structure.

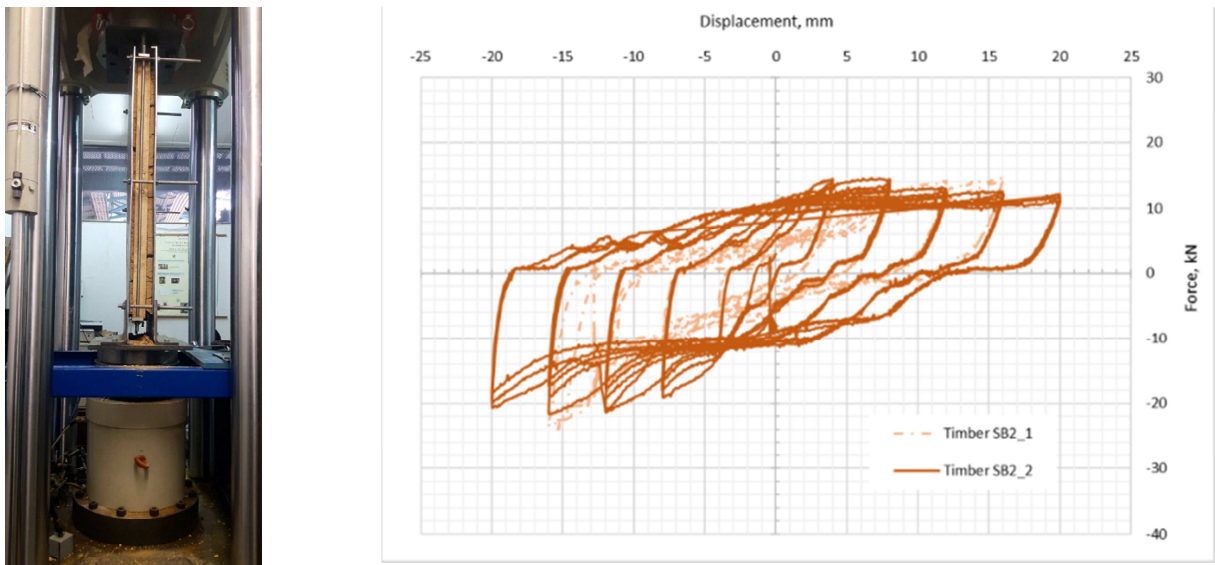
Figure 4. Experimental setup using Schenck machine (left) and hysteresis curves of the TSB2 under cyclic loading (right)

During the tests, the shear band is directly loaded to analyze the energy dissipation at the interface of the shear bands. The test is carried out in displacement controlled pattern with displacement up to 20 mm for three cycles at each level in both direction of loading [14]. The rate of displacement is 0.4 mm/sec for each test. In order to take into account the pre-compressive load acting at the shear band level due to dead load of wall and live load from occupancy, a pre-compression is applied by confining with metallic plate connected by six bolts. Applied loads and displacements are recorded. Comparing the hysteresis curves for identical specimen (see **Figure 4**), the reproducibility requirement is addressed. To assess the amount of energy dissipated at each step, the area under the curve is calculated using OriginPro 2017 software. The comparison of energy dissipation by various types of shear bands is shown in **Figure 5**.

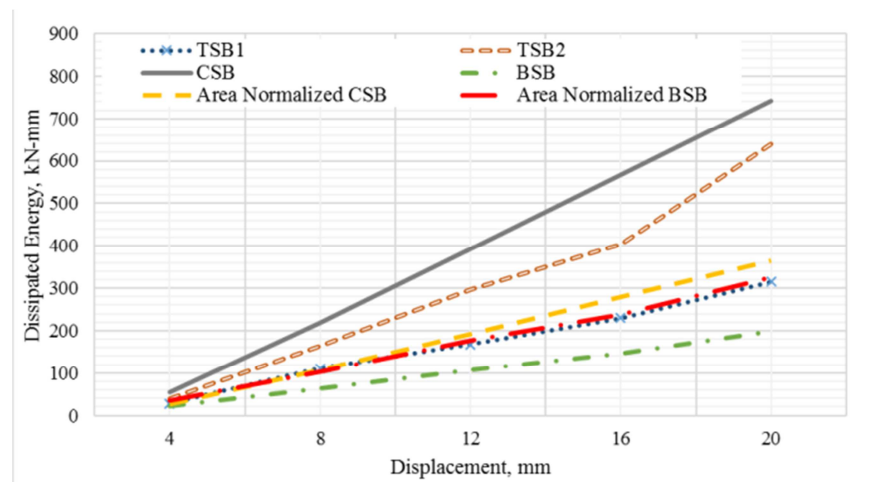
Figure 5. Comparison of energy dissipation by different types of shear bands

It shows that most energy is dissipated with concrete shear band (CSB) and least energy is dissipated with bamboo shear band (BSB). Moreover, it shows that the amount of energy dissipated is affected by the type of connection as Timber Shear Band type 2 (TSB2) dissipates more energy than Timber Shear Band type 1 (TSB1). Finally, to observe the significance of the shear band surface area, the results for the concrete and

bamboo shear bands were normalized with respect to timber shear band area: the energy dissipated by the normalized CSB and normalized BSB are close to that of TSB1. The energy dissipation patterns tend to follow linear form for all different shear band configurations.

- Timber shear band with notched transverse ties has better response property for shear loading and the energy dissipated is nearly twice as much as with nail connections. Moreover, type 2 is also probably performing much better regarding wall out-of-plane solicitation.
- The energy dissipation by the concrete shear band was highest among other materials because of its larger contact area.
- Bamboo shear band provides low energy dissipation as there is low friction and its contact area is small.

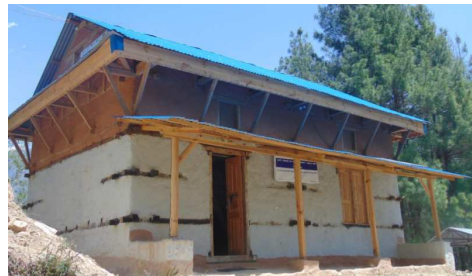
Figure 6. The demo house built in Magapauwa (credit: CRAterre)

As part of the reconstruction projects in Magapauwa and Katunje, ASF-Nepal and CRAterre provide technical support for all new constructions, retrofitting and repairing works in the villages. Moreover, two training sessions took place in November 2016 and May 2017. The demo houses that were constructed had three main functions: as a support for hands-on sessions during the training sessions, as a record of what trainees learned and as a showcase to share this knowledge with the other inhabitants.
