# NONCIRCULAR CFRP BICYCLE'S CHAINRING. PART I: STATIC AND LOW-VELOCITY IMPACT ANALYSIS

*The paper presents an experimental analysis to determine the teeth failure of noncircular composite chainring. A noncircular carbon/epoxy chainring with a specific stacking of 11 plies is studied. In a first step, a quasi-static tensile test is realized on the chain and on the chainring to determine their strength. As the damage of composites is a major concern, as a second step the low-velocity/low-energy impact drop tests are performed. Five levels of impact energy are investigated in order to study the energy effect on the teeth damage, and the damage localization is analyzed using C-Scan. Quasi-static results show that the metallic chain fails first. Experimental impact results reveal that teeth damage is presented only for an impact higher than 1.6 J. Finally, the total teeth failure appears for an energy close to 2.5 J.*

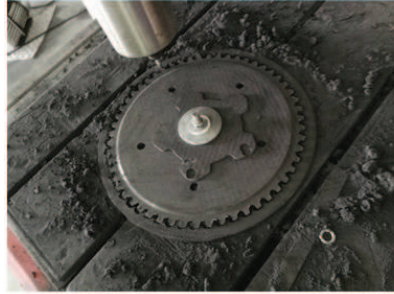
FIG. 4: Teeth cutting process on typical carbon/epoxy chainring

The chain is made from steel (Table 2), while carbon 2/2 twill woven/epoxy is used for the chainring (Table 3). The chainring consists of 11 plies of 0.23 mm each with the following stacking: [30/60/0/60/30/0/30/60/0/60/30], given a chainring thickness of 2.53 mm after manufacturing. The chainring is manufactured through oven under 1 bar of pressure with a curing cycle of 80°C for 1 h followed by a hold step at 120°C during 3 h. Finally, teeth are cut thanks to a CNC with a carbide end mills — style 4 Flute ( $\varnothing$  4 mm) and with a rotational speed of 15,000 rpm and a cutting speed of 5 mm/min (Fig. 4).
