NONCIRCULAR CFRP BICYCLE'S CHAINRING. PART I: STATIC AND LOW-VELOCITY IMPACT ANALYSIS

The paper presents an experimental analysis to determine the teeth failure of noncircular composite chainring. A noncircular carbon/epoxy chainring with a specific stacking of 11 plies is studied. In a first step, a quasi-static tensile test is realized on the chain and on the chainring to determine their strength. As the damage of composites is a major concern, as a second step the low-velocity/low-energy impact drop tests are performed. Five levels of impact energy are investigated in order to study the energy effect on the teeth damage, and the damage localization is analyzed using C-Scan. Quasi-static results show that the metallic chain fails first. Experimental impact results reveal that teeth damage is presented only for an impact higher than 1.6 J. Finally, the total teeth failure appears for an energy close to 2.5 J.

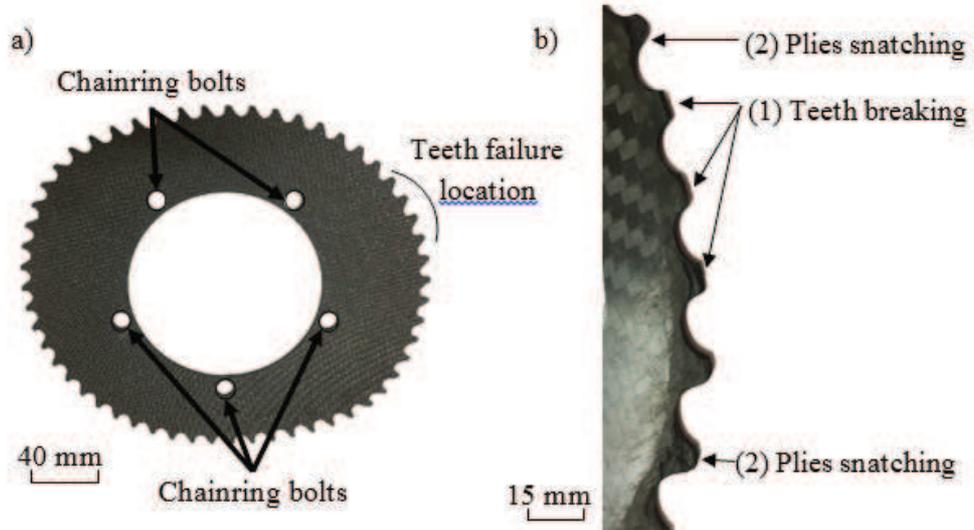
FIG. 1: Typical shape (a) and teeth failure (b) of noncircular CFRP chainring

Many sports take advantage of composites to increase the specific strength of the equipment. CFRP replace wood for tennis racquets and baseball bats (Brody, 1997) and replace steel for golf clubs to reduce the weight and to increase the ball exit velocity (Slater et al. 2010). Boardsports as snowboarding, surfing or skateboarding take advantage of composite material to increase the bending and torsion stiffness of the board (Clifton et al., 2010). CFRP are largely used in competition cycling especially for the frame to obtain a high stiffness and strength structure at low weights (Jin-Chee and Wu, 2010). Experiments show that the mountain bikes are impacted by stones with an energy lower than 3 mJ (Höchtel et al., 2012). Chainring can be manufactured of either an aluminum alloy or CFRP (Fig. 1a) and can be circular or not (Bini and Dagoese, 2012). Indeed, the average crank power output can be increased by using noncircular chainrings (Rankin and Neptune, 2008). B. Wiggins won the Tour de France in 2011 with a metallic oval rings and C. Froome with an osymmetric chainrings since 2013[Q2]. However, the noncircular carbon composite chainring is not yet habitually used. Indeed, a noncircular carbon woven/epoxy chainring with a thickness of 2.5 mm had shown teeth failure during professional cycling. Moreover, the teeth failure always appears in the same place (Fig. 1a). Two types of failure were observed (Fig. 1b), teeth breaking through its cross section (1) and plies snatching (2).

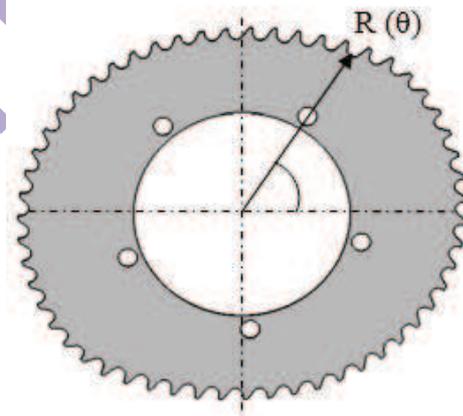
FIG. 2: Geometry of noncircular chainring

Noncircular composite chainring with 53 teeth are studied in this paper (Fig. 2). The radius of the noncircular chainring depended on the angle θ (Table 1). The teeth de-

TABLE 1: Radius R of the noncircular chainring as a function of the angle θ

Angle, θ [°]	R [mm]
0	93.97
10	95.23
20	96.77
30	98.59
40	100.54
50	102.50
60	104.25
70	105.58
80	106.38
90	106.73
100	106.90
110	106.94
120	105.79
130	101.24
140	97.05
150	94.11
160	92.99
170	93.13
180	93.97

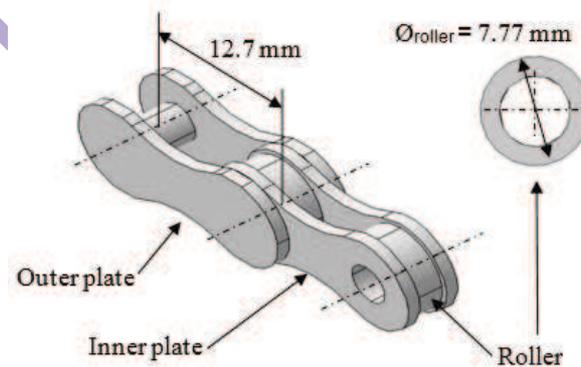
**FIG. 3:** Chain geometry

sign proposed by Wang is used in this research (Wang et al., 2016). The chain consisted of rollers, inner and outer plates (Fig. 3), and it is provided by SRAM (reference

PC-991). Failure of the chain is noted for a force of 9000 N by the manufacturer (SRAM, 2018). Rollers diameter is 7.77 mm (0.306 in) and the chain pitch is 12.7 mm (0.5 in).

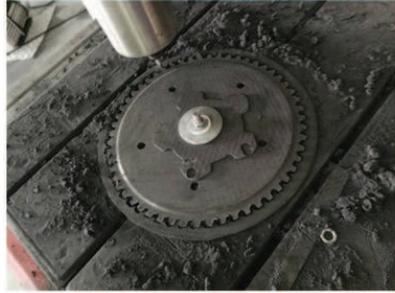
FIG. 4: Teeth cutting process on typical carbon/epoxy chainring

The chain is made from steel (Table 2), while carbon 2/2 twill woven/epoxy is used for the chainring (Table 3). The chainring consists of 11 plies of 0.23 mm each with the following stacking: [30/60/0/60/30/0/30/60/0/60/30], given a chainring thickness of 2.53 mm after manufacturing. The chainring is manufactured through oven under 1 bar of pressure with a curing cycle of 80°C for 1 h followed by a hold step at 120°C during 3 h. Finally, teeth are cut thanks to a CNC with a carbide end mills — style 4 Flute (\varnothing 4 mm) and with a rotational speed of 15,000 rpm and a cutting speed of 5 mm/min (Fig. 4).

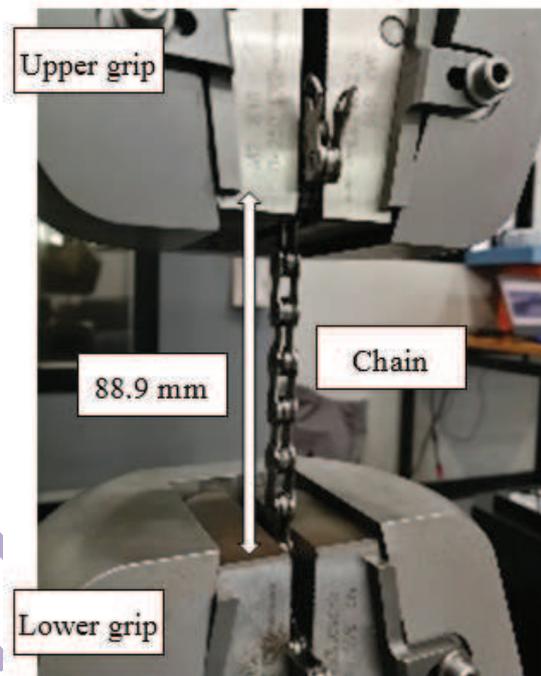
FIG. 5: Chain tensile test

The chain is firstly tested under tension in order to obtain its behavior and failure load. Seven pitches of the chain are studied corresponding to a length of 88.9 mm (Fig. 5). To determine the quasi-static mechanical behavior of the noncircular composite chainring, a specific bench is designed (Fig. 6). The chainring is clamped between two metallic plates thanks to 5 bolts, and the bench is fixed to the lower table

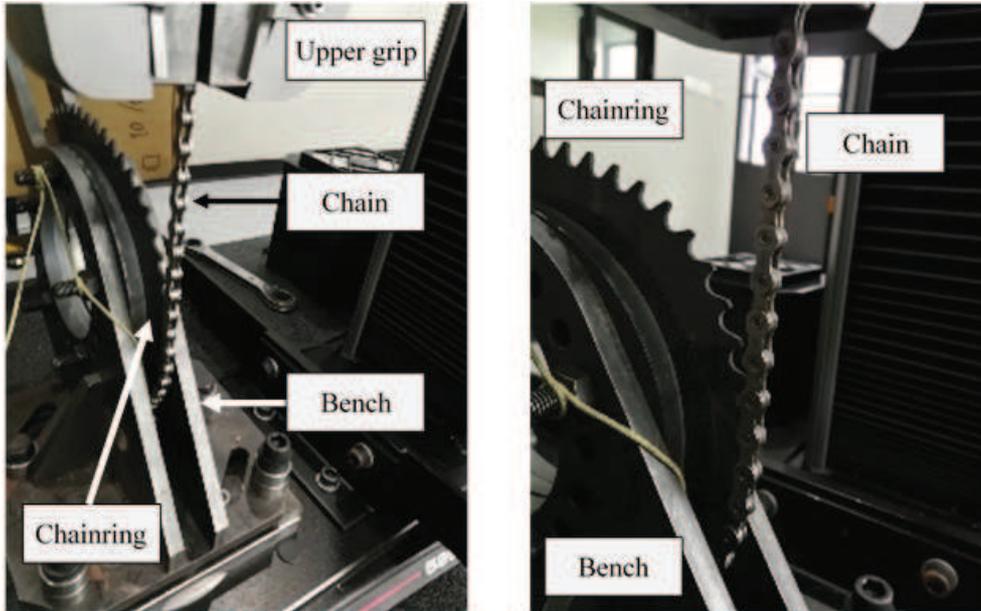
FIG. 6: Chainring tensile test

of the tensile machine. The noncircular chainring position is chosen in such a way that the broken teeth observed on the part used in the bike were tested (Fig. 1). The chain is then installed and the free extremity is pulled thanks to the upper grip of the tensile machine. A pretension of 50 N is firstly applied in order to assure the position of the chain with the chainring. For both chain and chainring, a constant velocity of 0.5 mm/min is used, and the force and displacement are tracked during the test with an acquisition rate of 10 acq/s.

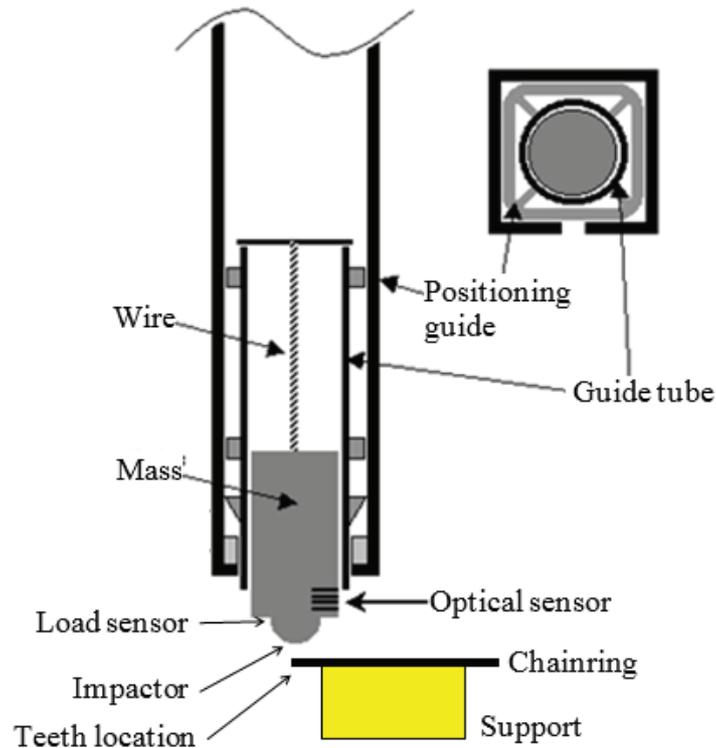
FIG. 7: Impact test design

Composite chainring can be subjected to impact from two main origins. Firstly, during off-road biking the chainring can be hit by stones and the maximum energy of such impact was experimentally measured at 2.43 mJ (Höchtel et al., 2012). Secondly, during the storage or maintenance of the chainring, hand tool or other objects can be dropped, and the chainring can be impacted. To represent such impacts, tests are performed on a drop weight testing rig with a hemispherical shape indenter of 8-mm diameter (Fig. 6). A mass of 0.585 kg is attached to the impactor. The impact located on the teeth is the most dramatic location as the damage could reduce their strength and so decrease the composite chainring final failure load. Therefore, a low-velocity impact test is performed at the centre of the teeth and to avoid influence of other impact tests, only one tooth of three is impacted (Fig. 7)[Q1]. Moreover, as quasi-isotropic stacking is used, the noncircular shape has no influence on the impact results. The chainring is clamped through 5 bolts on a lower circular support to represent the bicycle sprocket. To study the effect of the impact energy on the teeth damage, five levels of energy are used: 0.5 J, 1 J, 1.5 J, 2 J, and 3 J. The contact force is measured with a piezoelectric sensor during the test. Moreover, the initial impact velocity is obtained from an optical sensor. After impact, delamination is measured with a C-Scan system provided by the TESTIA company.

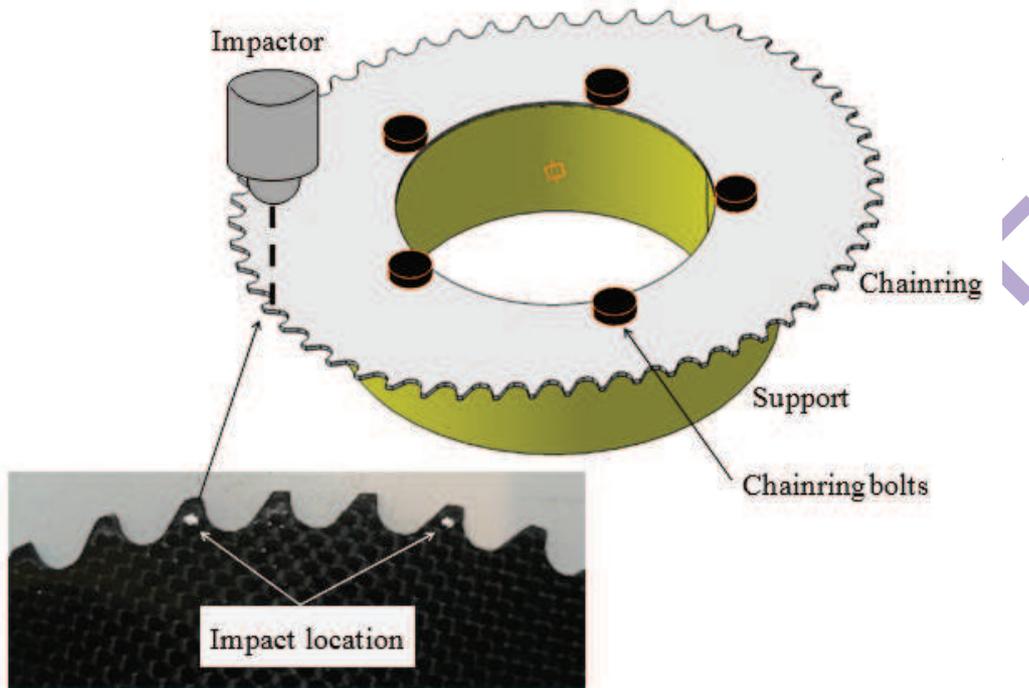
FIG. 8: Chainring impact test design

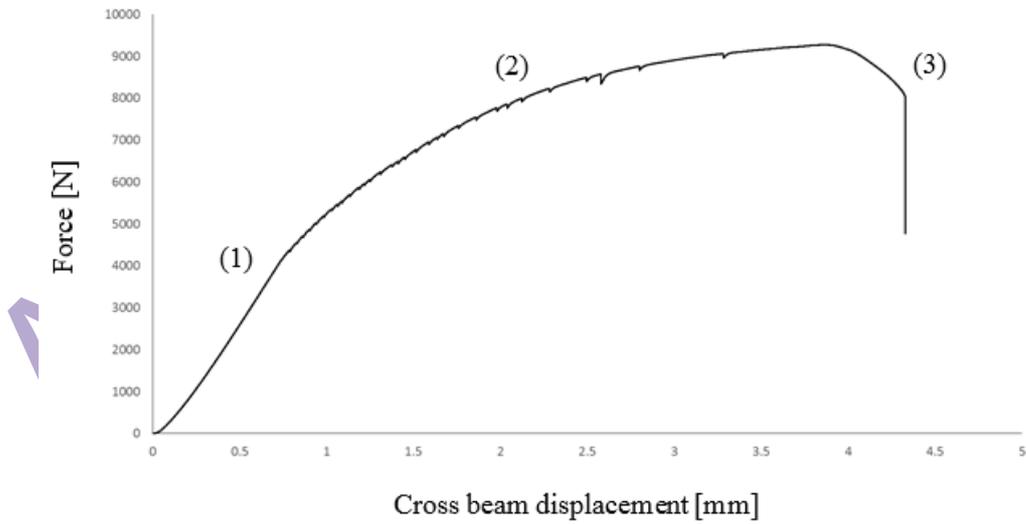
FIG. 9: Force–displacement of the chain

Firstly, the chain has been tested in order to verify its failure load (Fig. 9). The force–displacement curve consists in a first by the linear behavior until 4000 N (1)[Q3]. Then, the plasticity of the metallic chain starts and propagates (2) until the final fail at a load of 9200 N (3), as given by the manufacturer (26) [Q4].

Two noncircular composite chainrings are tested. The force–displacement curve consists of three steps (Fig. 10). Firstly, linear behavior (1) is observed until a force of 4500 N (2) that corresponds to the beginning of the chain damage (Fig. 9). Then, the damage of the chain propagates (3) until the failure of the chain that happens for a load of 8100 N and 9100 N (4). Therefore, the observed failure of noncircular composite chainring is certainly due to the impact damage.

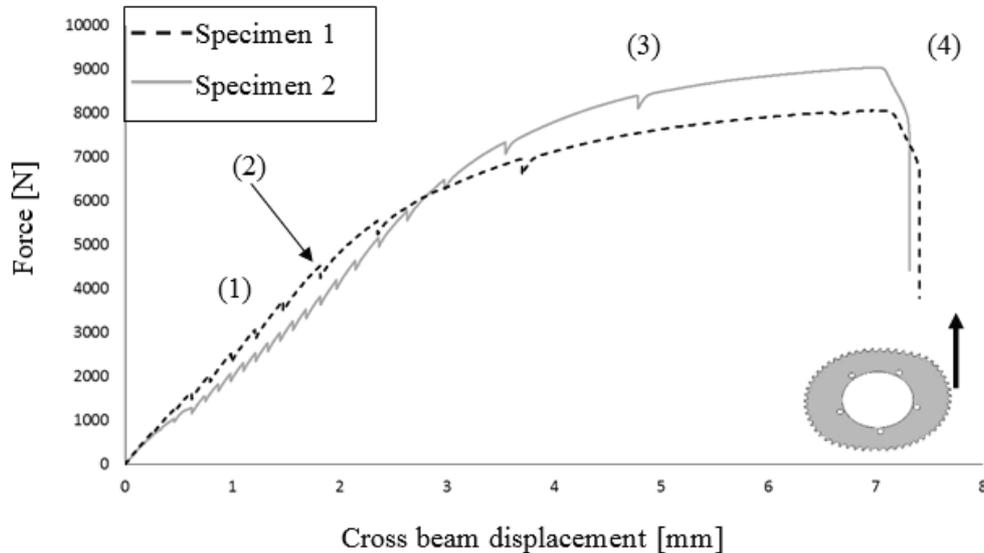
FIG. 10: Force–displacement of the composite noncircular chainring

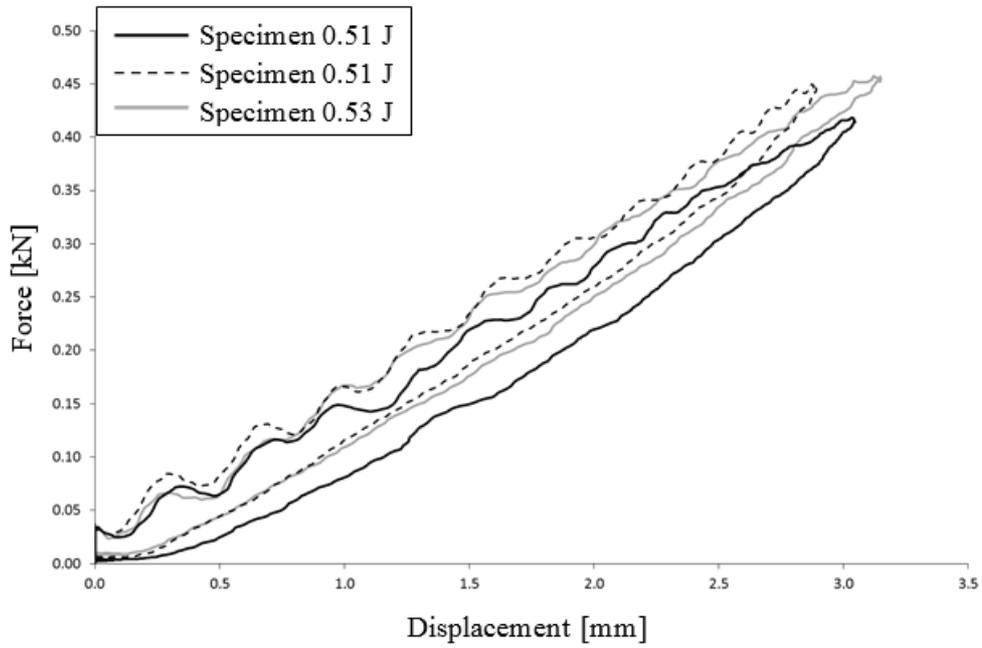
FIG. 11: Evolution of force–displacement curves for an impact of 0.5 J

Figures 11 to 14 show the impact force–displacement curves of the noncircular composite chainring. Except for impacts of 2 J and 3 J, three impact tests are performed, and the results show that they are quite reproducible (Figs. 11–13). Two tests are carried out for an impact of 2 J and only one for 3 J (Fig. 14). One of the 2 J tests shows tooth break, while for the highest impact energy, the tooth failure was observed. Finally, the tooth should totally fail for an impact energy close to 2.5 J.

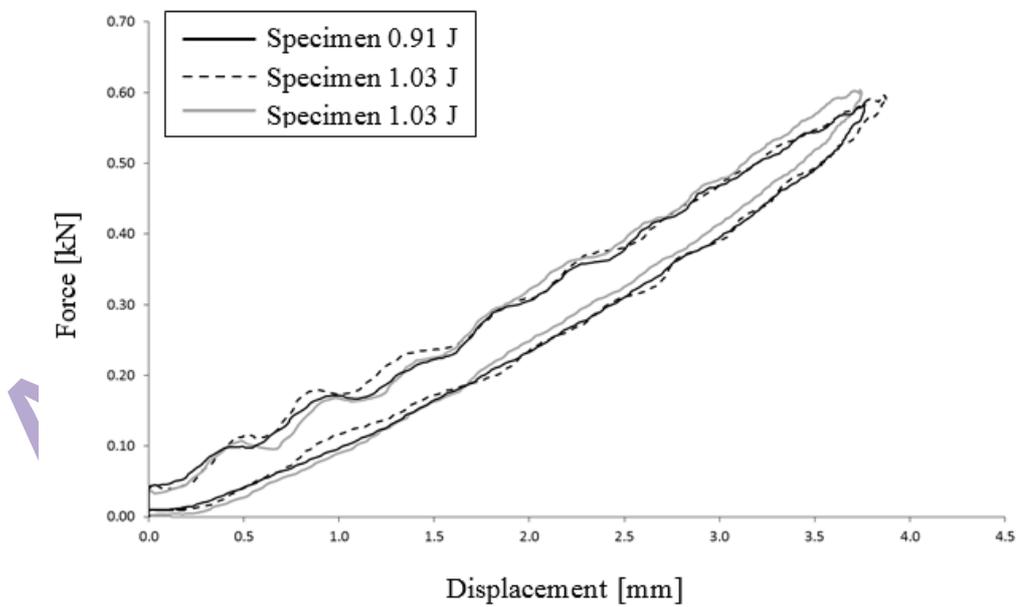
FIG. 12: Evolution of force–displacement curves for an impact of 1.0 J

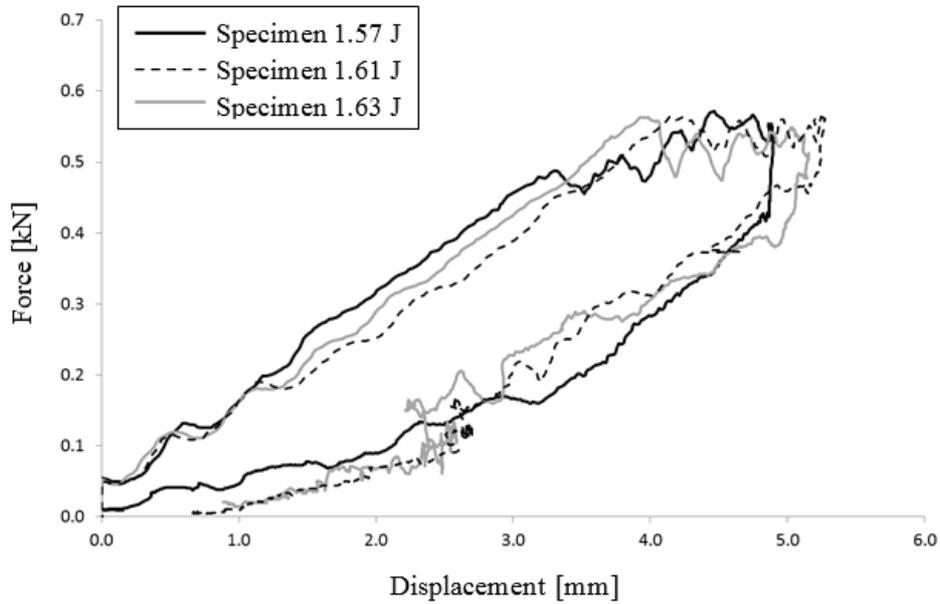
FIG. 13: Evolution of force–displacement curves for an impact of 1.5 J

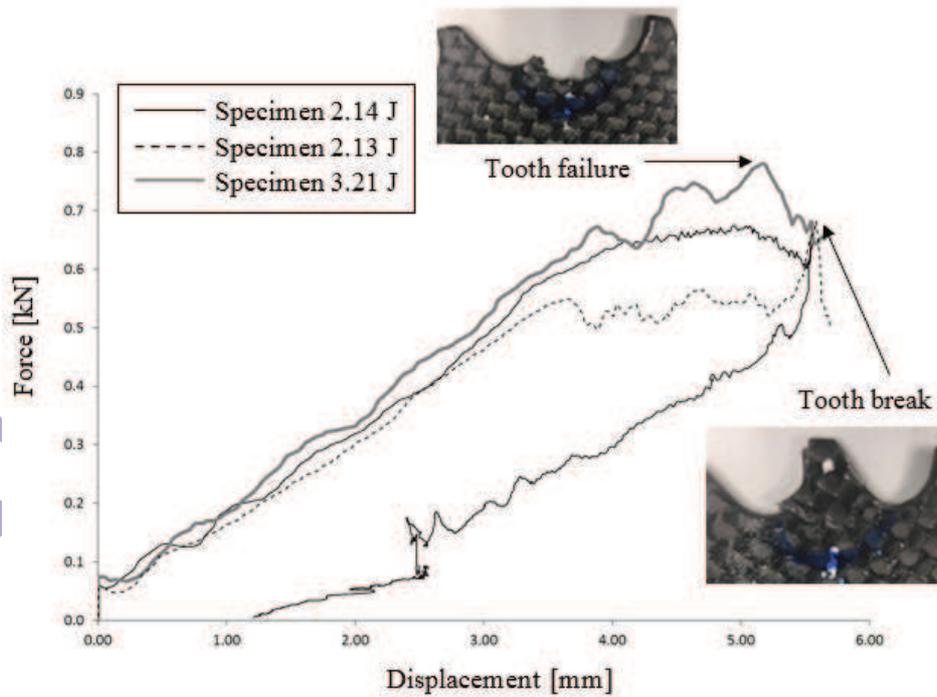
FIG. 14: Evolution of force–displacement curves for an impact of 2.0 and 3.0 J

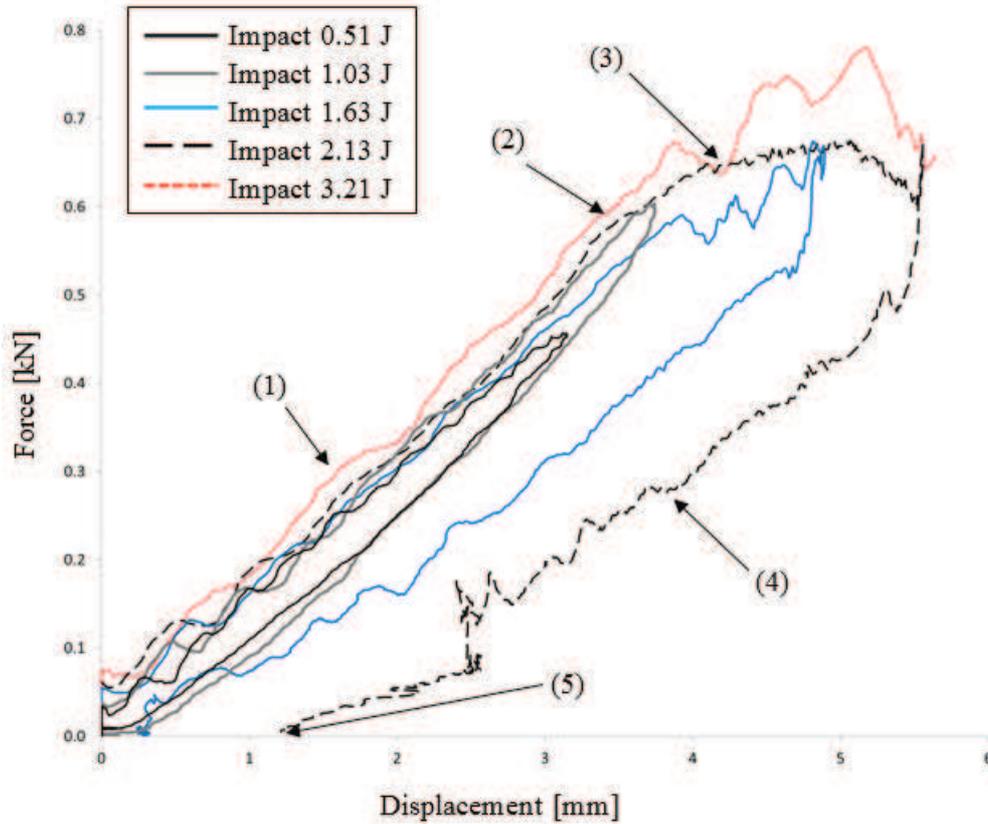
FIG. 15: Force–displacement of the composite noncircular chainring

The force–displacement curves of the five different impact energies are plotted in Fig. 15 for comparison. Specimen’s curves are very similar to the respective corresponding impact energy. The impact phases, from the damage mechanism point of view, are reflected in the changes of the force–displacement curve. Three major phases can be distinguished. Firstly, the force increases linearly with the same slope (1) corresponding to the initial teeth stiffness. According to the force curves, the onset of important damage is at around 0.58 kN (2). Moreover, damage is only observed for energy higher than 1.5 J. For specimens impacted with an energy of 1.5 J, 2 J, and 3 J, the second phase of the impact is characterized by the damage propagation, and it is determined by a stable force (3). Finally, except for the impact of 3 J, which presents tooth failure (Fig. 14), the impactor rebounds, and so the force and displacement decrease (4). For the impact energy 0.5 J and 1 J the displacement comes back to the initial position, while for a higher energy residual displacement is observed (5). This difference between the initial and final position corresponds to the residual indentation characterizing teeth damage (Table 3).

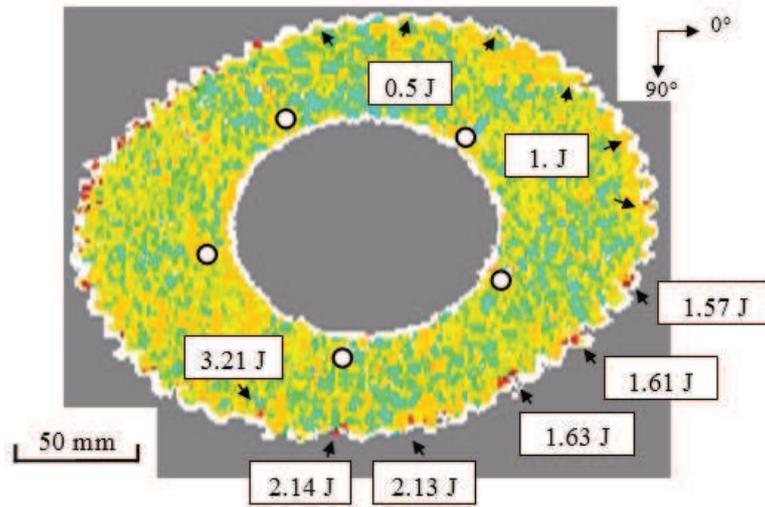
FIG. 16: C-Scan from the impacted side of noncircular composite chainring of specimen impacted at 0.5 J, 1 J, 1.5 J, 2 J, and 3 J

A Non Destructive Test (NDT) of an ultrasonic system is widely used for identifying the impact damage in CFRP laminates. It can provide information regarding both the damage area and thickness localization of material discontinuities like the debonding of interfaces. C-Scan is performed from the impacted face of the noncircular composite chainring thanks to Phased Array Probe 64 elements 5 MHz from TESTIA (Fig. 16). A summary of the impact results is presented in Table 4. For each test, data is presented in terms of: the maximum filtered impact force during the test and the residual indentation. Also provided is the projected delamination size area obtained. Firstly, for an impact energy lower than 1.57 J no delaminations are noted that would confirm observations made from the force–displacement curves (Figs. 11 and 12), while first damages are observed for 1.61 J and 1.63 J. Thus, the first damage should appear for an energy impact of about 1.6 J. Moreover, the C-Scan shows that the delamination are located between the ply 4 and 6 (Fig. 17). As the energy increases, larger delamination is observed, in particular, the length expanding largely until the attainment of a maximum of 15 mm for an impact energy of 2.13 J. Contrariwise, the

Impact energy [J]	Peak Force [kN]	Residual Indentation [mm]	Damage Length [mm]	Damage Width [mm]	Through Thickness Damage Location [mm]
0.51	0.42	—	—	—	—
0.51	0.46	—	—	—	—
0.53	0.45	—	—	—	—
0.91	0.60	—	—	—	—
1.03	0.59	—	—	—	—
1.03	0.60	—	—	—	—
1.57	0.55	—	—	—	—
1.61	0.56	0.70	10	9	0.96–1.10
1.63	0.56	0.97	12	8	0.96–1.09
2.13	0.68	1.24	15	10	0.95–1.30
2.14	0.68	Tooth break	11	11	0.90–1.82
3.21	0.78	Tooth failure	15	11	> 0.94

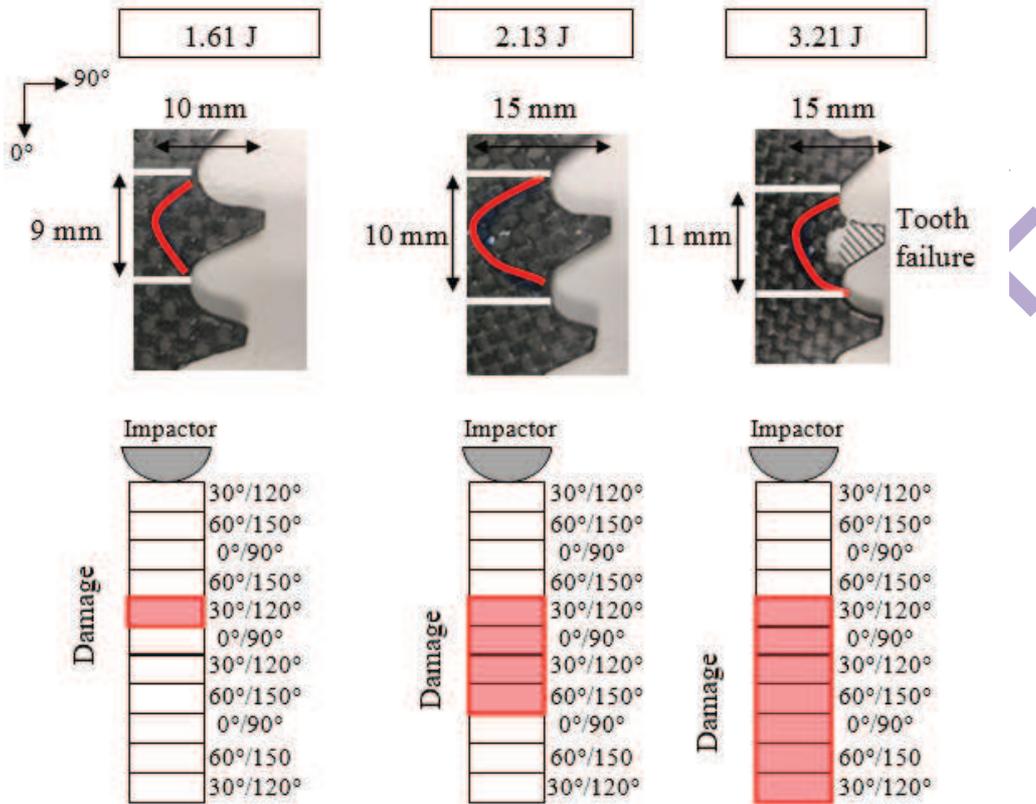
FIG. 17: Details of delamination location of specimen impacted at 1.61 J, 2.13 J, and 3.21 J

width is less influenced by the impact energy. Moreover, higher is the impact energy, deeper is the delamination location. For an impact energy of 2.13 J delaminations are located between the ply 4 and 6 and for 2.14 J between the ply 4 and 9 (Fig. 17).
