Towards a rapid automatic detection of building damage using remote sensing for disaster management

The 2010 Haiti earthquake

Paper type Research paper

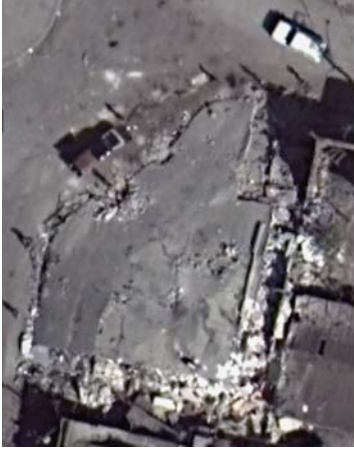
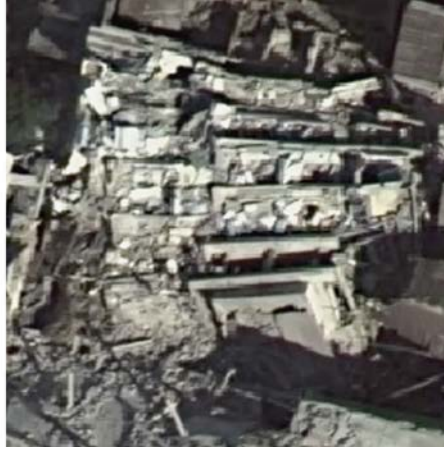
Notes: (a) Pancake collapse (symmetrical structural destruction); (b) inclined layers (inclined structural destruction)

Plate 1.
Examples of two types of collapse that are difficult to detect from vertical images

Second, the difference in spatial resolution of the optical and LiDAR data sometimes generates a spatial discrepancy and thus errors in classification. Moreover, most omissions are on the symmetrical or inclined building collapses: this is true with the automatic approach as well as with a manual one as also mentioned by previous authors (Spence and Saito, 2010; ImageCat and EERI, 2010). The high density of construction in the city of Port-au-Prince and the significant variation in the height of buildings within a single neighbourhood, even in a single block, makes the detection of damage difficult.
