Experimental Analysis of a Shake Table Test of Timber-Framed Structures with Stone and Earth Infill

F. Vieux-Champagne, Y. Sieffert, S. Grange, C Belinga Nko'Ol, E. Bertrand, et al.. Experimental Analysis of a Shake Table Test of Timber-Framed Structures with Stone and Earth Infill. *Earthquake Spectra*, 2017, 33 (3), pp.1075 - 1100. 10.1193/010516EQS002M . hal-01899533

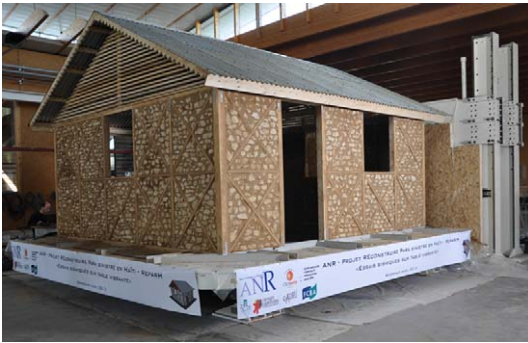
| Dimensions | 6 × 6 | m ² |
| Weight | 6 | tons |
| Max. dis. | ± 0.125 | m |
| Max. vel. | 0.75 | m/s |
| Max. acc. | 4 | g |
| Frequency range | 0 - 30 | Hz |

Figure 4. Shake table characteristics.

These dynamic tests were performed at the uniaxial earthquake simulation facility in the Mechanical Laboratory of the French Institute FCBA. The shake table is composed of a $6 \times 6 \text{ m}^2$ aluminum platform moved by a 250 kN servo-hydraulic actuator (Figure 4).

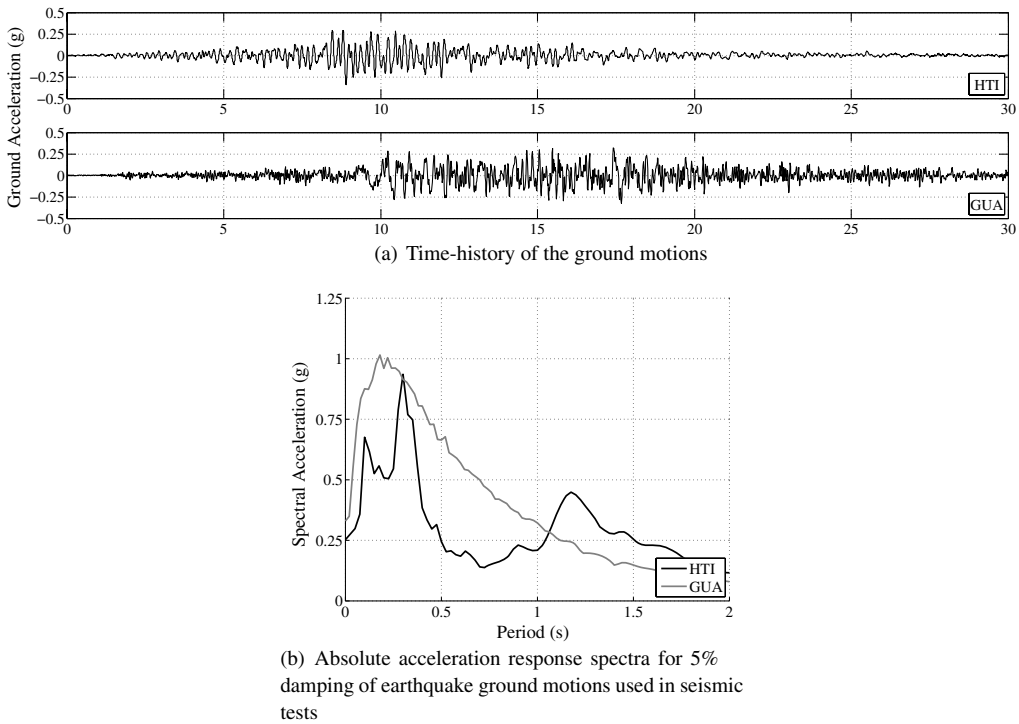
Figure 7. Time and frequency content of the Haiti (HTI) and Guadeloupe (GUA) ground motions.

The time and frequency content of the ground motion, as obtained by the method described above for the Guadeloupe far-field scenario ($PGA = 0.33g$), is indicated in Figure 7.

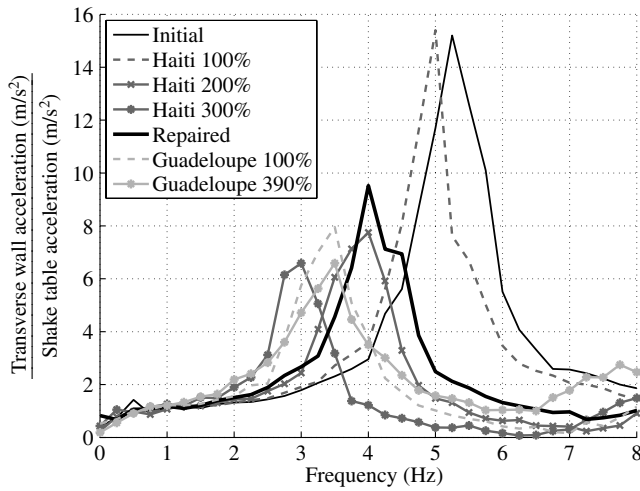
Figure 9. Frequency response function of the transverse wall acceleration to the shake table acceleration.

- the frequency response function (FRF, Figure 9) between the output acceleration at node 7 (ACC7) and the input table acceleration (ACC10) obtained during each low-level white noise input test (Figure 6). As a reminder, the FRF is a representation in the frequency domain of the ratio between an output and input acceleration signals;
- the deterioration of the normalized equivalent lateral stiffness (NELS) in the N–S direction after each seismic test (Figure 10a), in assuming a single-degree-of-freedom response of the test building. Since the initial fundamental period T_0 is known, as is the fundamental period T_i measured after each seismic test, the NELS k_i as a percentage of initial lateral stiffness k_0 can be calculated after each seismic test as

observed in Figure 9 for HTI 100% assimilated with structural rearrangement is no longer visible here. The nonlinearity and dissipated energy increase as stiffness decreases (Figure 18f) after each HTI 200% and HTI 300% signal, which reveals the structural damage (Section 4.3). Following the reparation and during GUA 100%, the overall

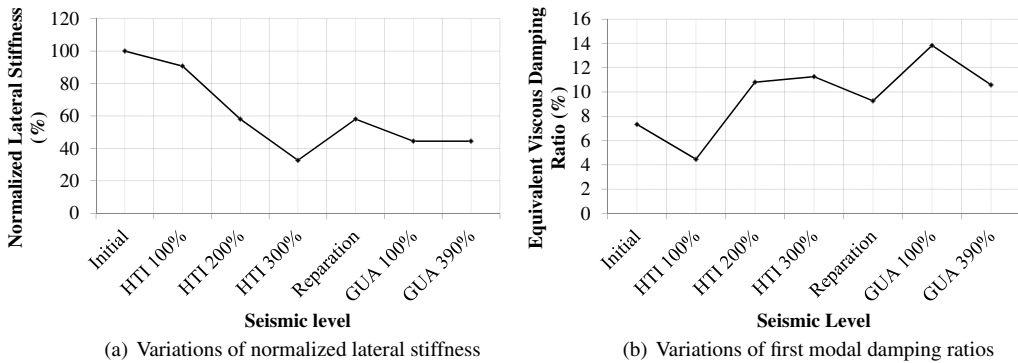
Figure 10. Variation of seismic indicators.

- GUA 100%: After this test, it is worthwhile to note that despite the relative harmfulness of the seismic signal (in comparison with the two previous ones and the next one), the energy dissipation shown in Figure 10b reached a maximum value due to damage to the repaired connections, which is correlated to a decrease in both the NELS and acceleration amplitude.

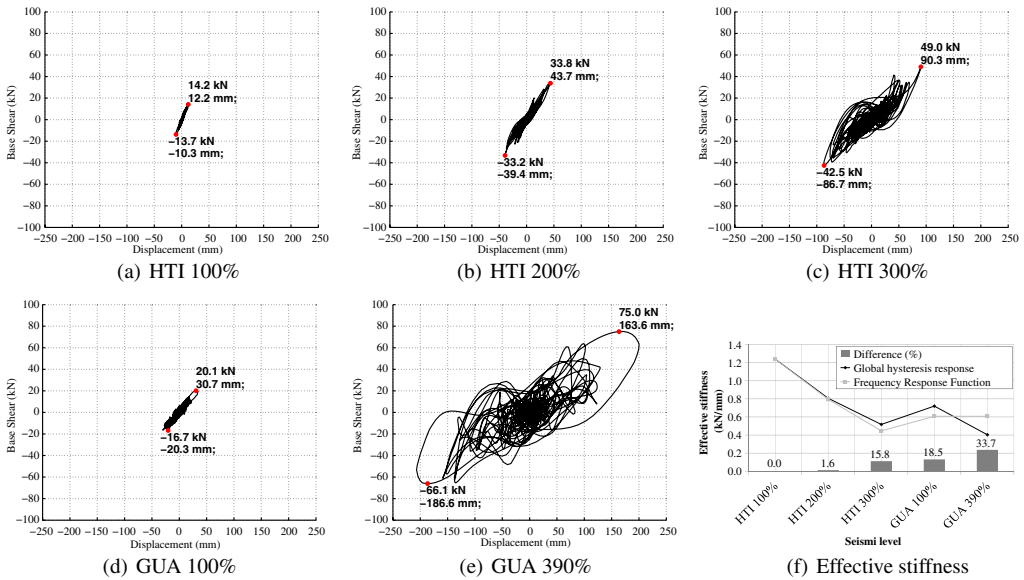
Figure 18. Global hysteretic responses of the transverse wall.

Figure 18f shows the evolution in the effective lateral stiffness of the transverse wall after each ground motion [called “global hysteresis response” (GHR) in the graph caption], along with a comparison to the normalized lateral stiffness obtained from results of the frequency response function (FRF). The effective stiffness values have been derived by computing the slope connecting the positive and negative peak base shear forces and the corresponding displacement from the graphs in Figure 18. To compare these results, the following assumption was made: The effective stiffness obtained for HTI 100% of GHR and FRF are equal.

From Figure 18f, it can be noted that the effective stiffness obtained with the results of GHR and FRF yield similar results except for GUA 390%, whose GHR seems to provide more plausible results since damage observed during this test was the most significant.

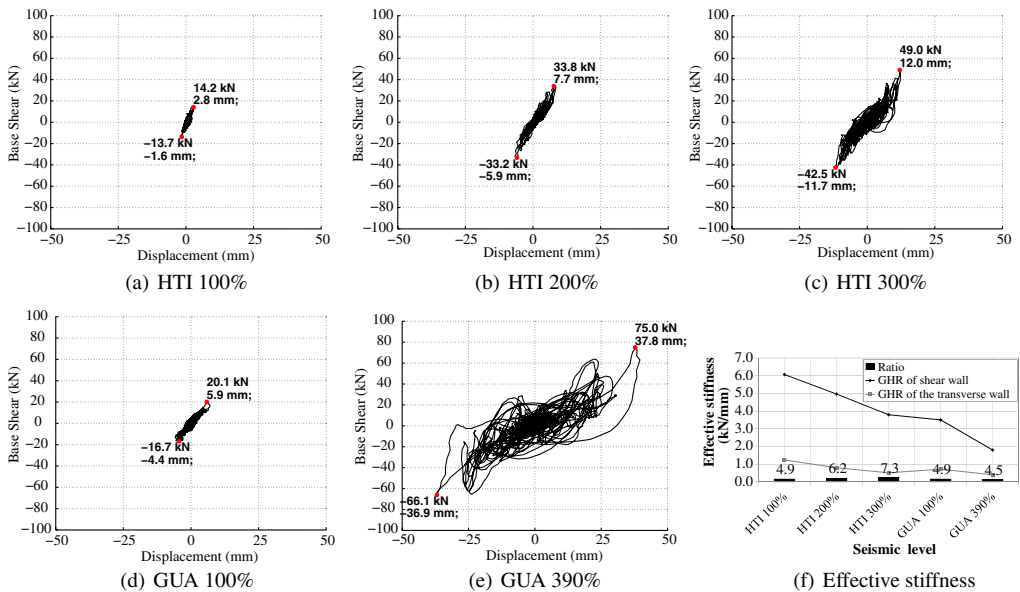
Figure 19. Global hysteretic responses of the shear wall.

Figure 19 also depicts the diagram of the base shear versus the top shear wall displacement. The same observations as in Figure 18 are applicable here: The connection between the behavior of the shear wall and the transverse wall can again be highlighted. Figure 19f shows the evolution in the effective lateral stiffness of the shear wall and transverse wall after each ground motion and moreover indicates the ratio between the effective stiffness obtained for the shear wall and that for the transverse wall. This figure underscores the similar evolution of both curves with the ratio between each pair of values varying between 4.5 and 7.3. It can also be inferred that the behavior of the shear wall benefits from less damage than the transverse wall; hence, the reparation process exerts less influence on its behavior.
