Cavitation Erosion Resistance Assessment and Comparison of Three Francis Turbine Runner Materials

Markku Ylönen, Pentti Saarenrinne, Juha Miettinen, Jean-Pierre Franc, Marc C. Fivel, Tuomo Nyysönen

Markku Ylönen, Pentti Saarenrinne, Juha Miettinen, Jean-Pierre Franc, Marc C. Fivel, et al.. Cavitation Erosion Resistance Assessment and Comparison of Three Francis Turbine Runner Materials. Materials Performance and Characterization, 2018, 7 (5), 10.1520/MPC20180015 . hal-01929313

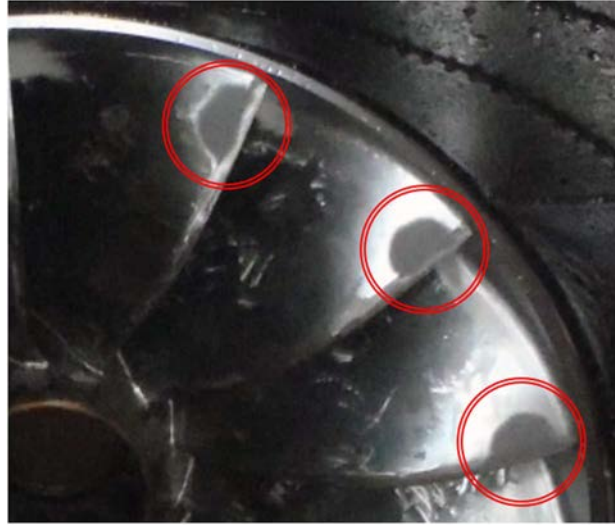
FIG. 1

The red circles indicate cavitation damage in a Francis turbine runner blade's trailing edges.

The main parts of a Francis turbine that suffer from cavitation erosion, along with their cavitation types, are: (1) the blade suction-side walls, inlet edge cavitation; (2) the runner blade trailing edges, travelling bubble cavitation; (3) the runner hub walls, inter-blade cavitating vortices; and (4) the runner blades, leading edge cavitation [2–4]. An example of cavitation damage in Francis turbine runner blades, concentrated on the blade's trailing edges, is presented in **Fig. 1**. Cavitation may also occur in the draft tube vortex rope of a Francis turbine, but there the cavitation bubbles rarely collapse near any boundary structures.

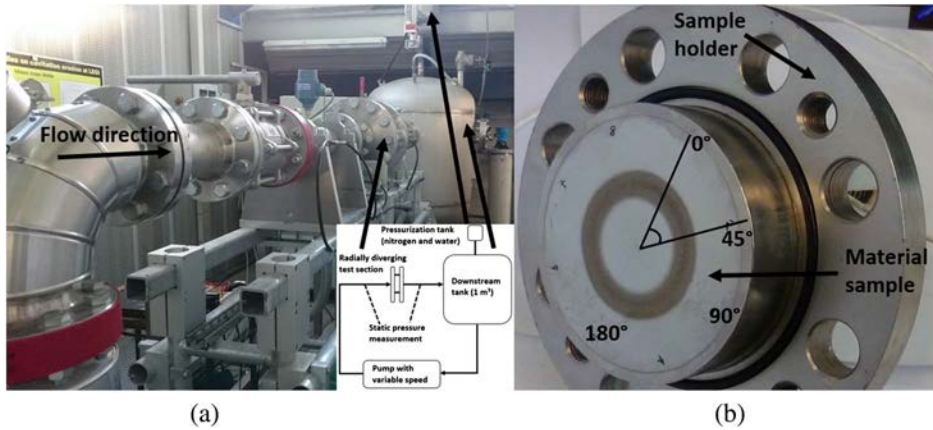
FIG. 2 The cavitation tunnel used in this study, with schematics and the specimen. The surface profiles were measured in the eight measurement zones or lines, one profile for each. The zones were named so that 0° corresponds to “north,” 45° to “northeast,” and so on.

The cavitation number in this study was 0.87, corresponding to an upstream pressure of about 4 MPa and a downstream pressure of about 1.86 MPa. The downstream section is pressurized by nitrogen gas, and a pump linked to a frequency transformer is used to control both the upstream pressure and the flow velocity in the tunnel. Downstream pressure may be set between ambient pressure and about 3 MPa, and the maximum upstream pressure is 4 MPa. Similar cavitation tunnels can be studied in more detail in [6,23,26]. **Fig. 2** presents the overview and schematic of the cavitation tunnel, along with the material specimen and specimen holder.

The test section consists of an inlet nozzle with a 16-mm diameter, followed by a radially diverging channel with a 2.5-mm thickness. The cross-sectional area of the channel drops by a factor of 1.6 at the beginning of the radially diverging part. This is where cavitation begins. The cavitation bubbles collapse somewhere between 19–32 mm radial distance from the center of the specimen, with the maximum erosion occurring at a distance of 22 mm from the center.

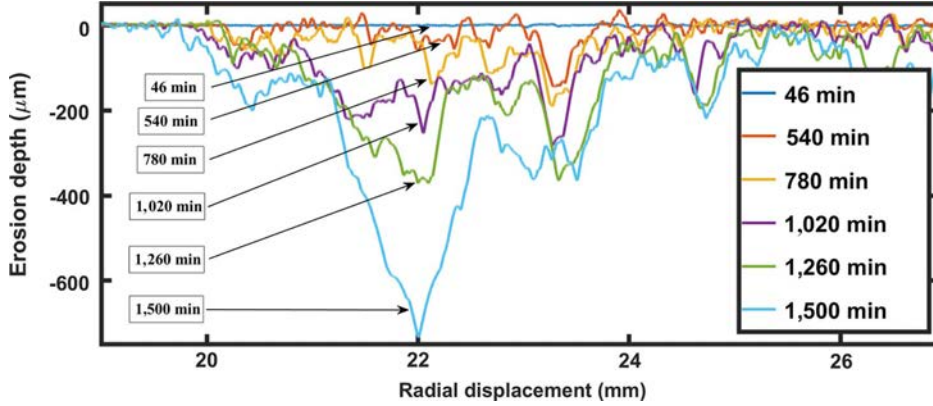
FIG. 3 Cavitation erosion evolution of low-alloy steel. For the sake of clarity, only chosen profiles corresponding to different exposure times are displayed.

Ten to twenty profiles were obtained for each azimuthal angle for each of the specimen disks, each corresponding to an instant of time in the erosion process. **Fig. 3** shows the erosion evolution as a function of time for the low-alloy steel specimen with an azimuthal

angle of 0° . The maximum penetration depth varies through the different azimuthal angles for the same specimen but is always located in the same radial location, as the erosion pattern is axisymmetric.

The first profile plotted in **Fig. 3** shows the transition area between the incubation and acceleration periods that occurs after 46 minutes of exposure to cavitation. The erosion on the specimen is visible to the naked eye, and in the measured profiles, it appears as surface roughness. The blue curve shows the erosion after 25 hours (1,500 minutes), which was the total exposure time of the low-alloy steel and corresponds to a penetration depth of about $750\ \mu\text{m}$ in the specimen surface for the azimuthal angle of 0° (about $450\ \mu\text{m}$ for angles 90° and 270°). The initial surfaces, presented in **Fig. 4**, were virtually flat compared with the advanced erosion stages.

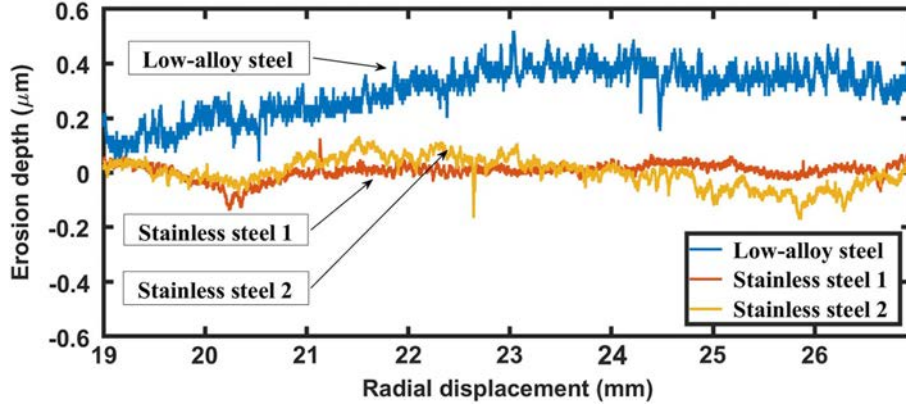
FIG. 4 Initial surface profiles for the low-alloy steel and Stainless steels 1 and 2.

The initial profiles in **Fig. 4** are only for one azimuthal angle, but the profiles for the other angles are of a similar order of magnitude. The initial profiles were separated from the subsequent ones, although this procedure has only a marginal effect, as the roughly half-micrometer fluctuations are negligible compared with the up-to-700 micrometer penetration depths. Values above zero in depth were observed for all the materials, especially in the incubation period. This is due to the piling up of the eroding metal because of the cavitation impacts. This is expected in materials with a high ratio between the Young's modulus and the yield stress, such as most metals [7].

The volume loss at a given time for a given specimen was calculated from the erosion profiles, as shown in **Fig. 4**. To calculate the total volume loss over the specimen, the depth value for each point was multiplied by the circumference. This meant that the volume loss

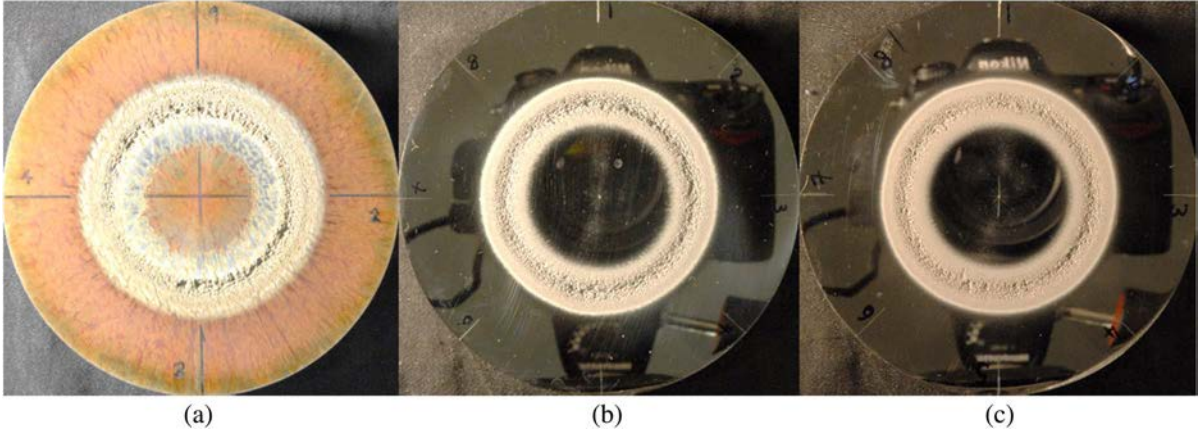
FIG. 5 Material specimens after full exposure time: (a) low-alloy steel, 25 hours, (b) Stainless steel 2, 70 hours, (c) Stainless steel 1, 65 hours. The low-alloy steel is oxidized because of contact with water during the test.

As cavitation is assumed to be axisymmetric in the test section, one would assume an axially uniform erosion rate in the disk. To mitigate possible anomalies in the axisymmetry of the erosion, the stainless steel specimens were turned 90 degrees in the specimen holder after each profile measurement. This procedure was introduced after the experiments with the low-alloy steel, as nonuniformities had been observed in these. Even with this procedure, the erosion depth was not equal in all the specimen azimuthal angles. **Fig. 5a–c** shows photographs of the tested specimen materials after their respective full exposure times.

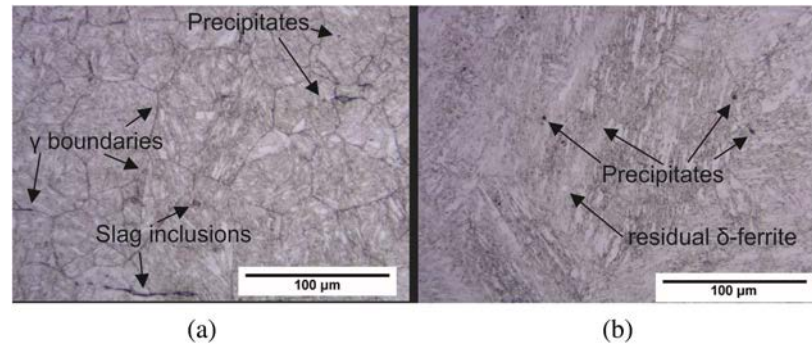
FIG. 6

Optical microscope images of Stainless steels (a) 1 and (b) 2.

To characterize the material microstructure, the stainless steel specimens were polished, etched, and then studied through optical microscopy. Two examples of the microscope images are presented in Fig. 6a–b. The microstructure study concentrated only on the two stainless steels, as the low-alloy steel was considered an outdated turbine material, and it was only used for erosion rate comparison.

According to the optical microscope analysis, Stainless steel 1 in Fig. 6a is fully martensitic, with small amounts of carbides and other precipitates, as well as larger slag inclusions. The precipitates (possibly carbides) are too small to properly resolve by optical microscopy. The microstructure of Stainless steel 2 in Fig. 6b is predominantly martensitic, with a small amount of residual δ -ferrite and carbides and other precipitates, which have a bimodal size distribution. The dark lines in Fig. 6a emerge from the prior austenite microstructure. They were not found in the other specimen, both because of the etching

The notable difference between the microstructures is the considerably finer prior austenite grain size of Stainless steel 1, measured as $37\text{ }\mu\text{m}$, with a standard deviation of $10\text{ }\mu\text{m}$, using the mean lineal intercept method as defined by ASTM E112, *Standard Test Methods for Determining Average Grain Size* [29]. The prior austenite boundaries of the specimen Stainless steel 2 could not be resolved. However, based on the visual observation of block and packet size and the configuration of the lath structure, the prior austenite grain size of Stainless steel 2 is much larger, by approximately an order of magnitude. The prior austenite grain size has been shown to correlate with martensite packet and block size [30], which in turn has a negative correlation with strength. It has been shown that impact resistance and plasticity are particularly sensitive towards prior austenite grain size [31,32], possibly explaining the better resistance of Stainless steel 1 towards cavitation impacts.

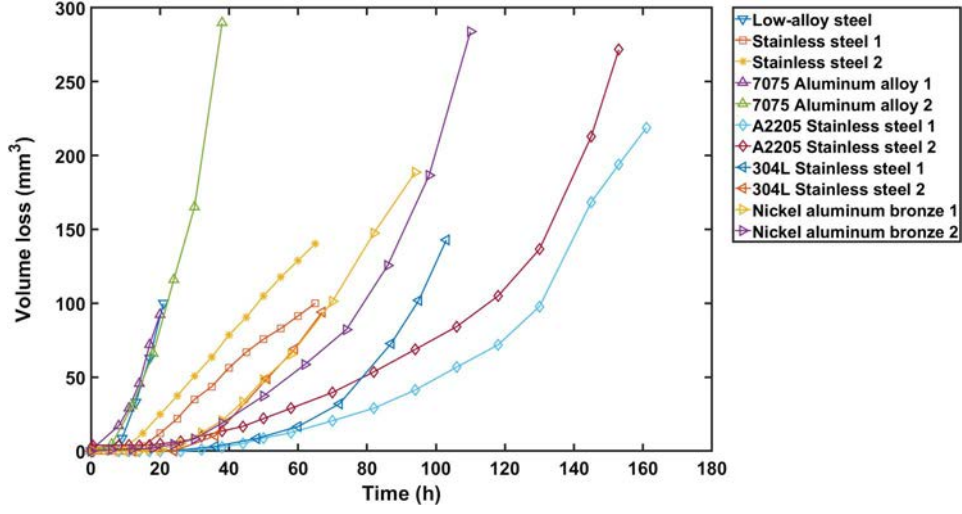
FIG. 7 Volume loss of eroded materials.

The volume loss of the eroded materials as a function of time is presented in Fig. 7. The three specimens tested in this study, i.e., the low-alloy steel and Stainless steels 1 and 2 are presented, as are two specimens each of the other materials tested by Franc et al. [24]. Their specimens were smaller than those used for this study, as they were fitted to a specimen holder that holds eight specimens at a time. Their small 16-mm-diameter disks were eroded simultaneously, but for ease of comparison, the erosion of Franc et al.'s small disks was calculated as if they covered the same area as our large disks.

The incubation time was not used in comparing the materials in this study, because the variance between similar materials was too great, so its effects were removed by linear curve fitting to the linear part of the volume loss curves in Fig. 7 and then defining the x -axis intersection of the linear fit. To define the average volume loss rate between 50 mm^3

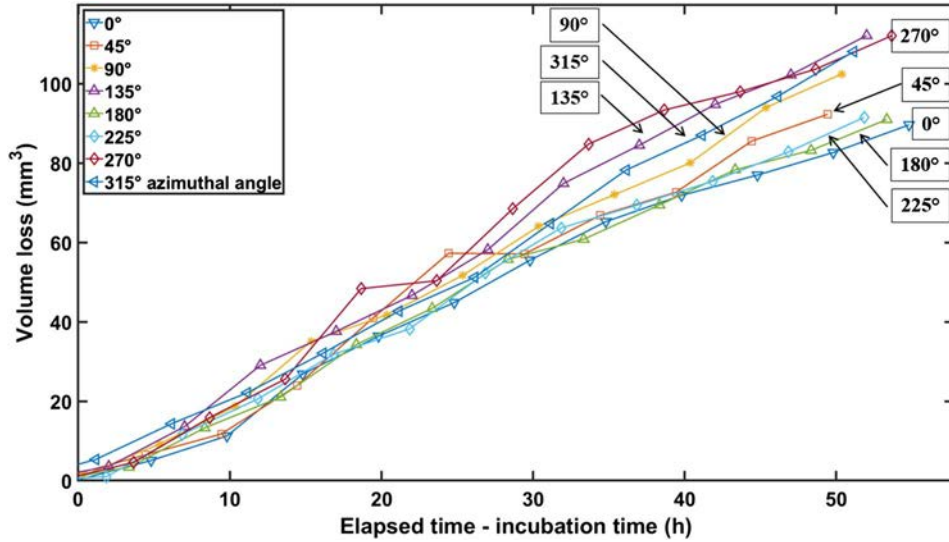
FIG. 9 Volume loss of Stainless steel 2 for all eight specimen azimuthal angles. The incubation time was calculated for each azimuthal angle separately and was then subtracted from the exposure time to negate its effect.

microstructure would lead to different erosion rates. These may that persist even if the erosion process goes on for a long time. The erosion rates do not seem to fall clearly around a single value as the erosion evolves. The strength of cavitation erosion in the cavitation tunnel is assumed to be axisymmetric, and even if this is not absolutely true, turning the specimen between each testing intervals should have negated any nonaxisymmetrical effect.

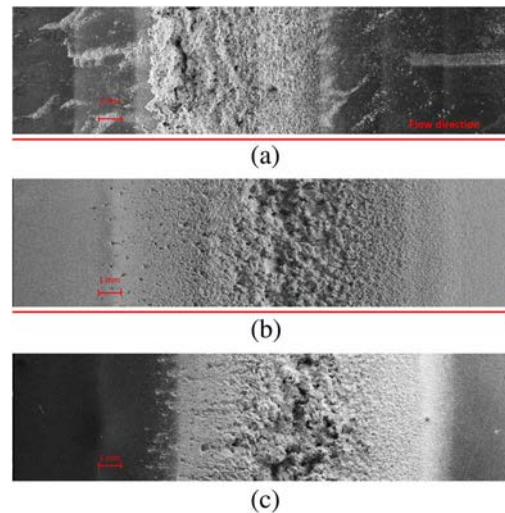
FIG. 10

Panoramic SEM images of (a) low-alloy steel, (b) Stainless steel 1 and (c) Stainless steel 2 with a $20\times$ magnification. Flow direction from the specimen center towards the edges is marked with the red arrows between the images.

The erosion in the low-alloy steel in **Fig. 10a** begins abruptly compared to the stainless steels in **Fig. 10b–c**. The erosion in the downstream region after the maximum erosion depth is about 6-mm long for all three materials, while in the upstream region, although it is approximately the same for the stainless steels, it is only about 2-mm long for the low-alloy steel (based on visual observations from these images). The pits and erosion in the upstream region of the stainless steels consist of individual pits and surface roughness, placing the stage of erosion in those regions as somewhere between the incubation and acceleration periods. The downstream regions of all the specimens are rougher than the upstream regions, putting these regions in the acceleration, or even the steady-state, period of erosion evolution.

The exposure time of the low-alloy steel was much lower than that of the stainless steels. As the upstream damage to the stainless steels consists of single pits and surface roughness, it is concluded that the rate of cavitation impacts is much lower upstream of the maximum depth than it is in other regions. Because of the low-alloy steel's lower exposure time, there might be less time for such individual pits to form in the upstream region.

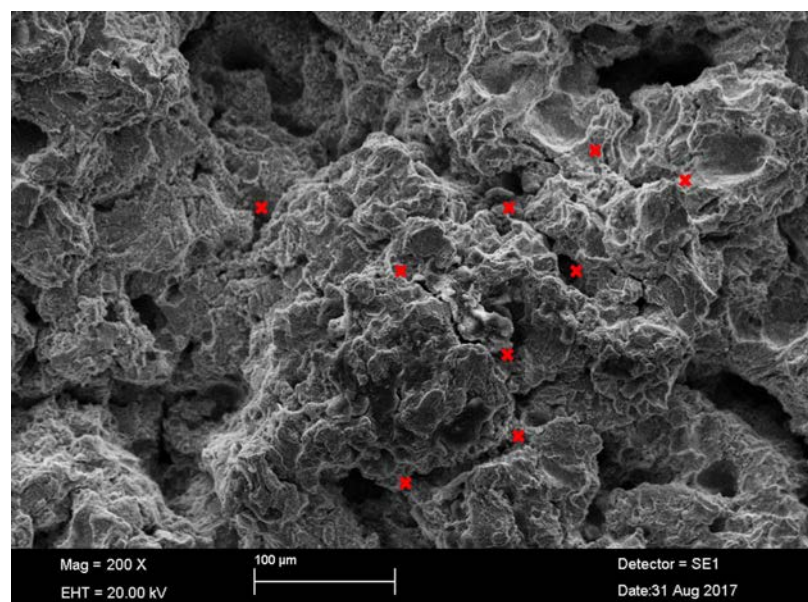
FIG. 11

Low-alloy steel SEM image erosion detail with 200 × magnification. Some of the cracks are marked by red crosses.

Figs. 10 and 11 show SEM images of the low-alloy steel at a greater magnification (200×). The evolving cracks can be seen everywhere, so it may be assumed that these cracks, and any subsequent ruptures, would be a major factor in the rate of material loss, as expected.

In **Fig. 11**, the eroded surface is uneven and the “valleys” of the erosion pits seem to be deep compared to the surrounding “mountains.” The actual depth of the pits could not be defined using the SEM. This image with 200 × magnification shows the overall structure of the highly eroded surface, but it does not tell us much about the erosion mechanisms. When a chunk of the material is removed by rupture, it leaves a smooth surface behind, as can be seen in **Fig. 12**. The smooth surface is then attacked by subsequent cavitation impacts, leaving small pits that eventually start to overlap.

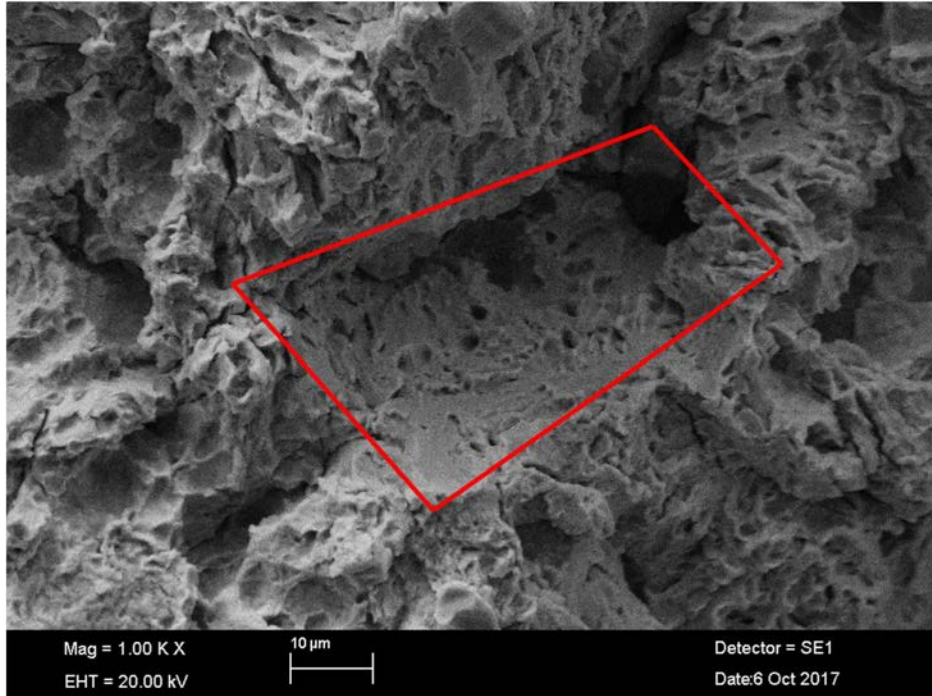
FIG. 12 Stainless steel 1 SEM image erosion detail with 1,000 x magnification. The red lines highlight a relatively smooth surface.

The 1,000 × magnification in **Fig. 12** offers more insight into the erosion mechanisms. The surface in the middle of the image is relatively smooth, with some small widely-spaced pits in it. The diameter of the small pits is in the range of one μm , which corresponds to small cavitation impacts. One possible cause for such a smooth surface could be that a relatively large chunk, microscopic in actual size, of material was removed quite recently. Once the large chunk had been removed, the new smooth surface was only exposed to cavitation for such a short time (the time remaining in the test period) that only the small individual pits are seen.

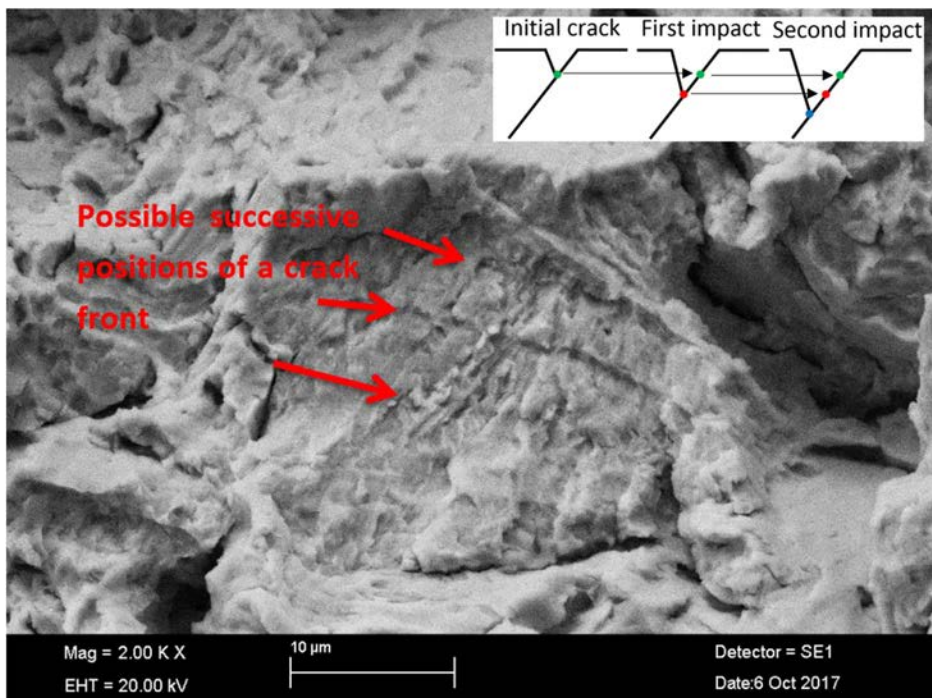
FIG. 13 Successive crack front positions for Stainless steel 1 with 2,000 x magnification. The schematic in the top-right corner describes the crack propagation and the development of the “beach marks.”

Fig. 13, at 2000 × magnification, shows the progression of a crack front.

A series of lines, identified by the red arrows, are visible in **Fig. 13**. As each new impact of sufficient amplitude hits the surface of the material in the vicinity of the crack, the crack front is supposed to jump from one line to the next. This crack propagation ends up with the removal of a micropiece of material that makes the plane of the propagated crack visible, as can be seen in **Fig. 12**. This pattern is commonly associated with low-cycle fatigue, which supports the idea that cavitation erosion at the intensity generated in the cavitation tunnel is most probably due to low-cycle fatigue.

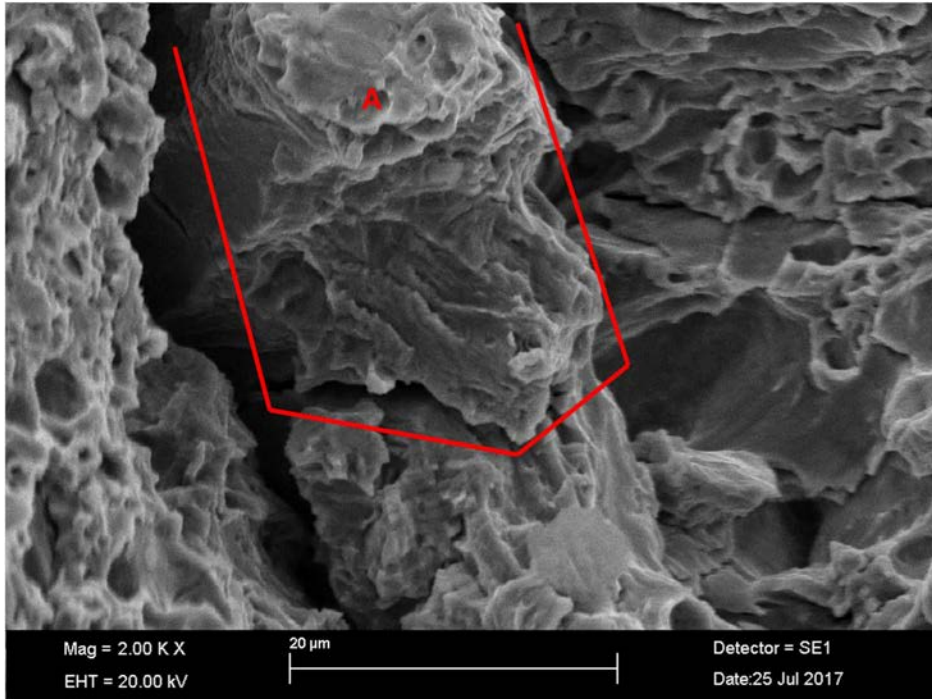
FIG. 14 A SEM image of Stainless steel 2 erosion with 2,000 x magnification. The red lines highlight the assumedly soon-to-be-removed material chunk marked by the red A-letter.

Fig. 14 shows a well-developed crack propagation process with a presumably soon-to-be-removed chunk of material.

The image with 2000 × magnification in **Fig. 14** offers some insight into the removal of individual chunks of material. The chunk in the middle of the image is surrounded by large cracks, and it is covered with plastic deformation resulting from cavitation impacts. If the erosion were to continue, the cavitation impacts hitting the chunk of loosened material would eventually cause it to break away.
