Assessing the buffering function of coastal systems in the face of tropical cyclones: insights from Tubuai Island, French Polynesia

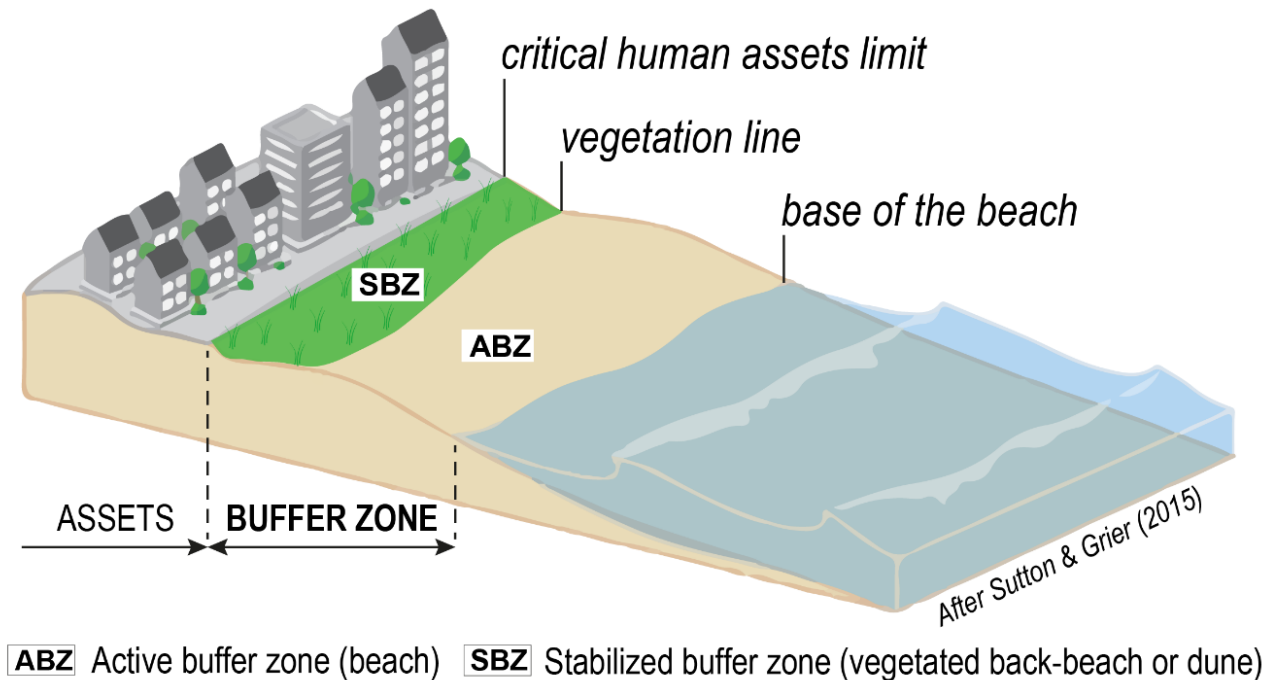
Buffer zone definition

“natural” area located between the **base of the beach** and the **first human assets** (roads, buildings, infrastructures)

Composed of an active part (beach) and a stabilized part (the vegetated back-beach), separated by the **vegetation line** or **coastal defences** (= stability line)

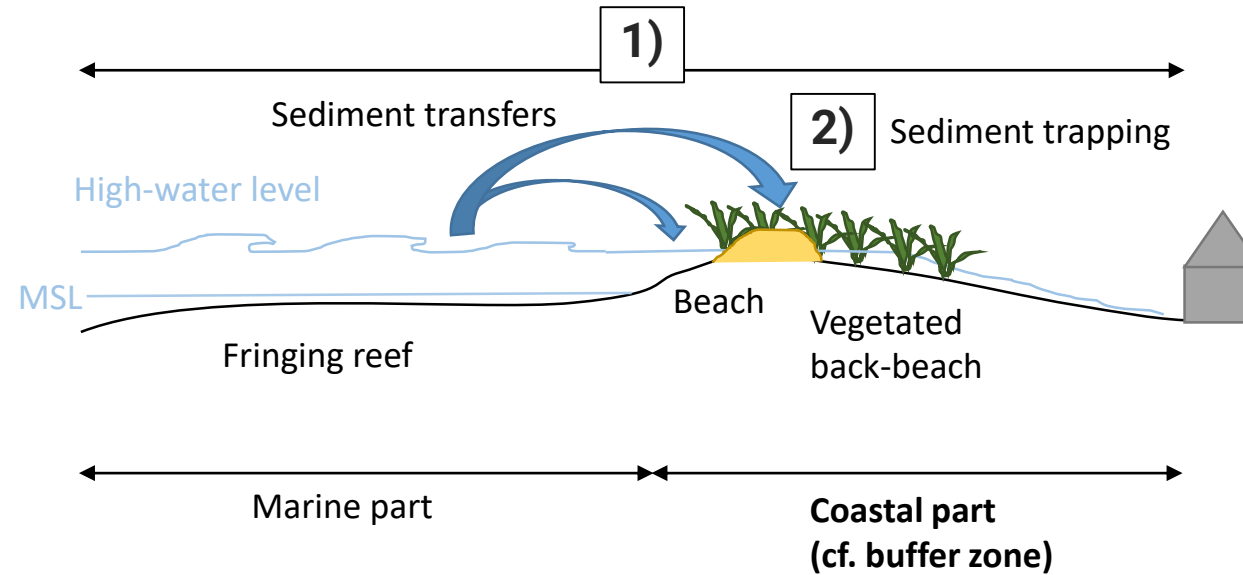
Buffering function: service offered by natural features (morphological features, vegetation) which results in the damage reduction in face of a hazard (e.g. tropical cyclones). This coastal protection service depends notably on:

3) « Natural barrier » against marine inundation:

- No inundation of human assets

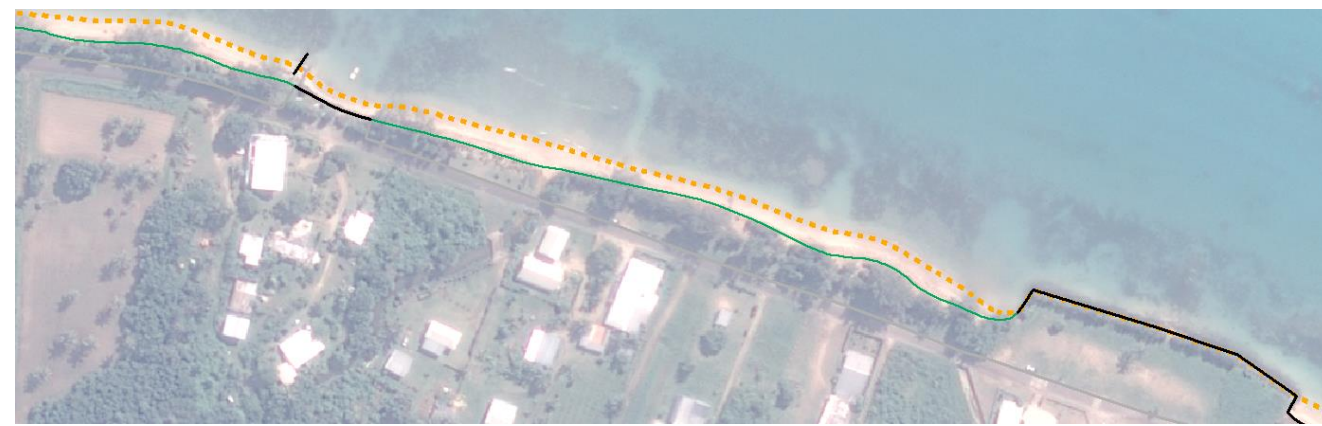
1. buffer zone limits digitization

2. Spatial framework of the GIS analysis

10m-interval transects cast perpendicular to the shore. 860 transects from west to east

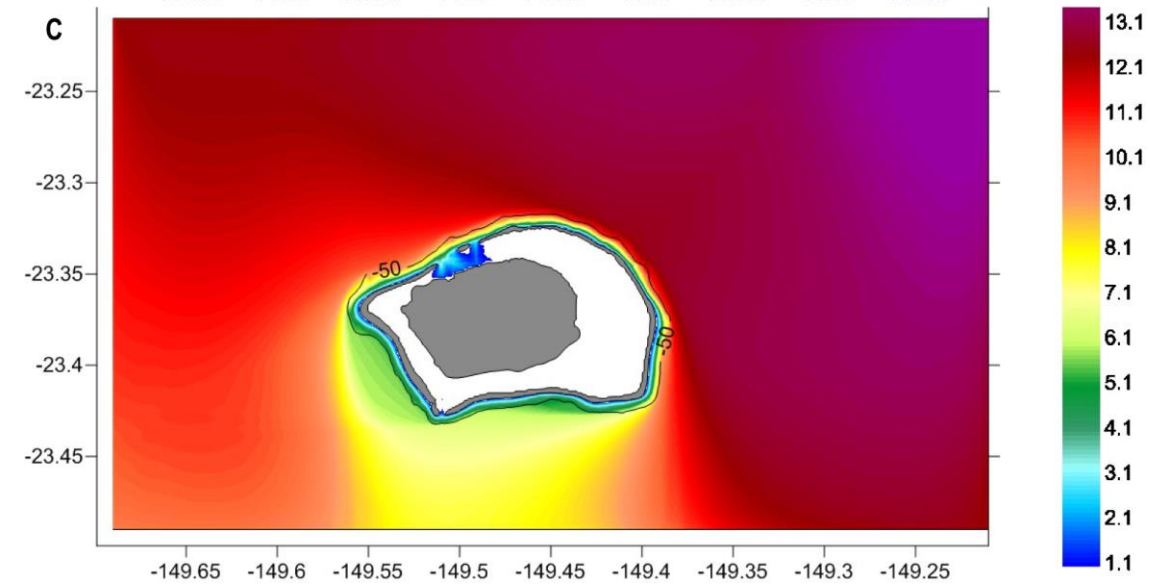
- February 4-5, 2010
- Hit the northern coast
- Category 4 (gusts of 198 km/h)
- Waves reaching 6-8 m / storm surge of around 2 m)
(Barriot et al., 2016)

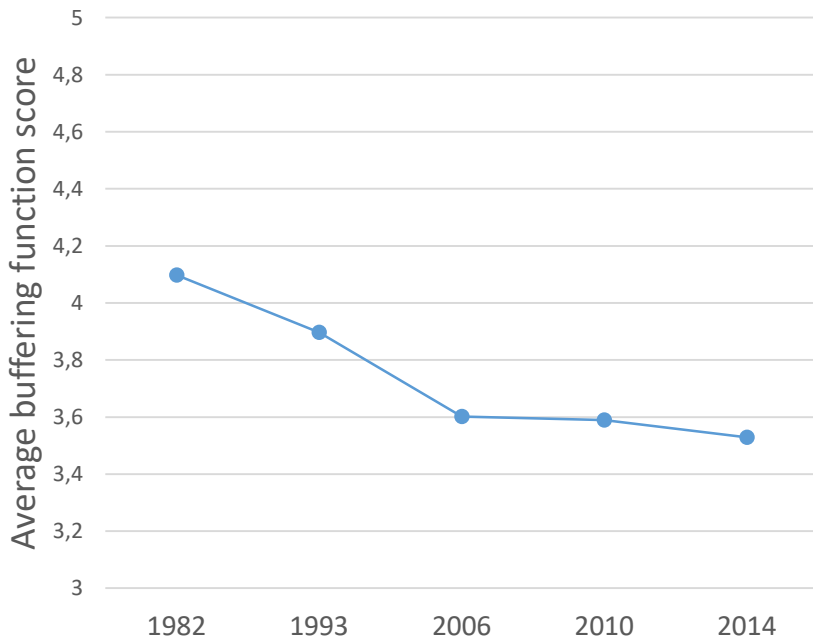
Decreasing in buffering function average score (-0,6 between 1982 and 2014)

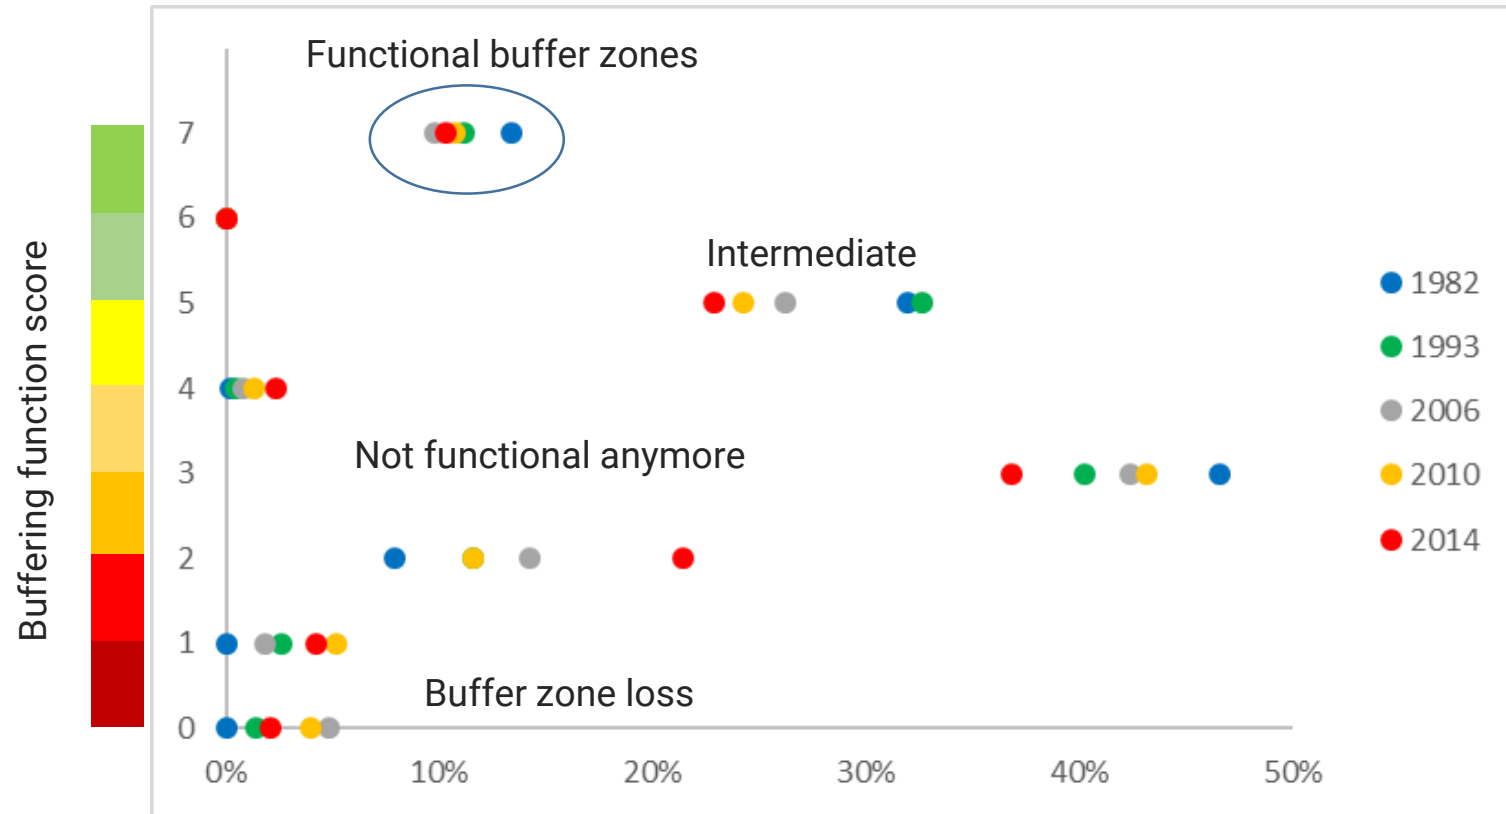
Diminution of high scores of buffering functions (5-7)
Augmentation of very low scores (0-2)

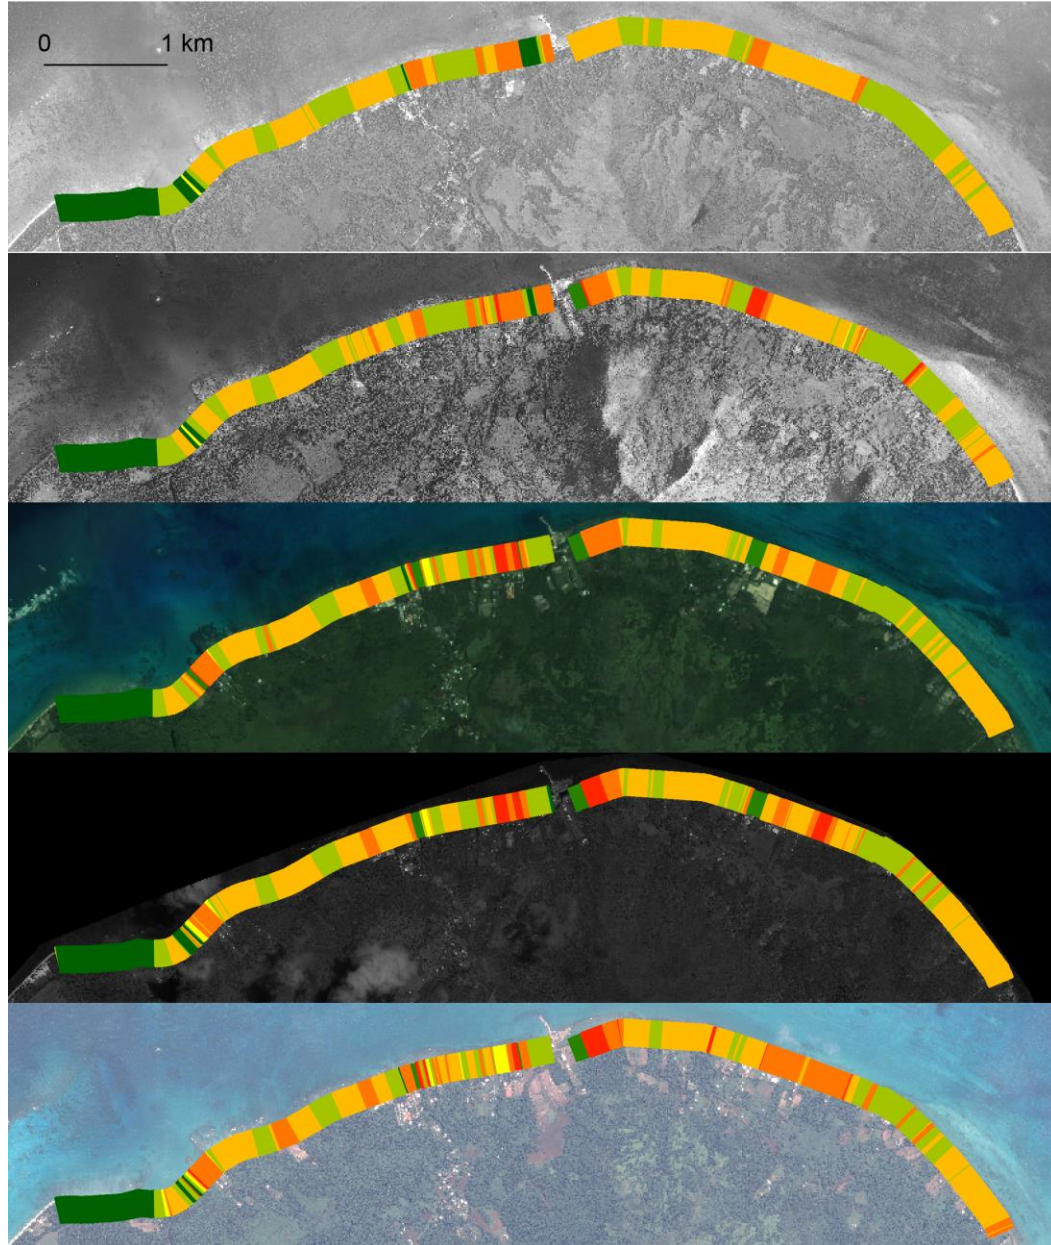
Buffering function score

High spatial variability?

Western part of cell 1: most preserved area

Except this: low functionality because of high human pressure

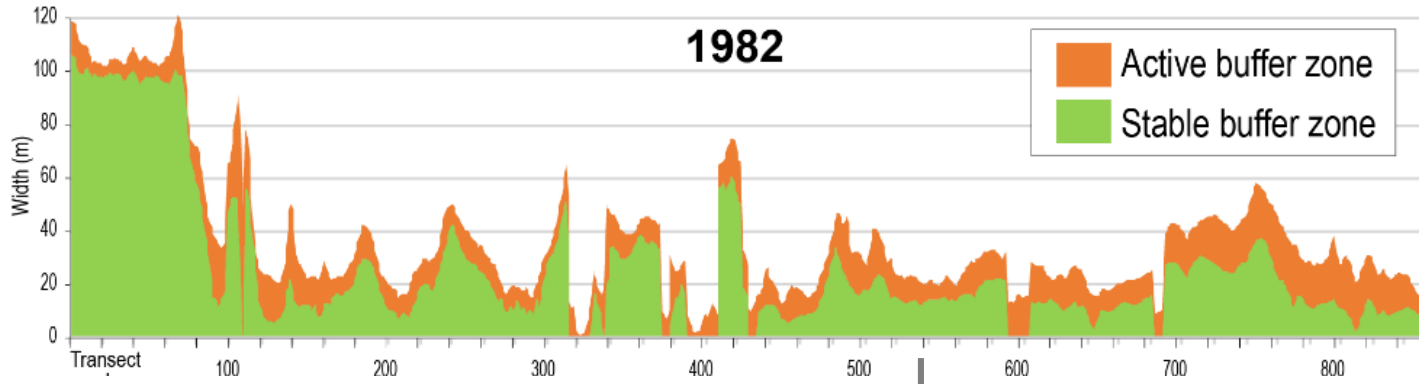
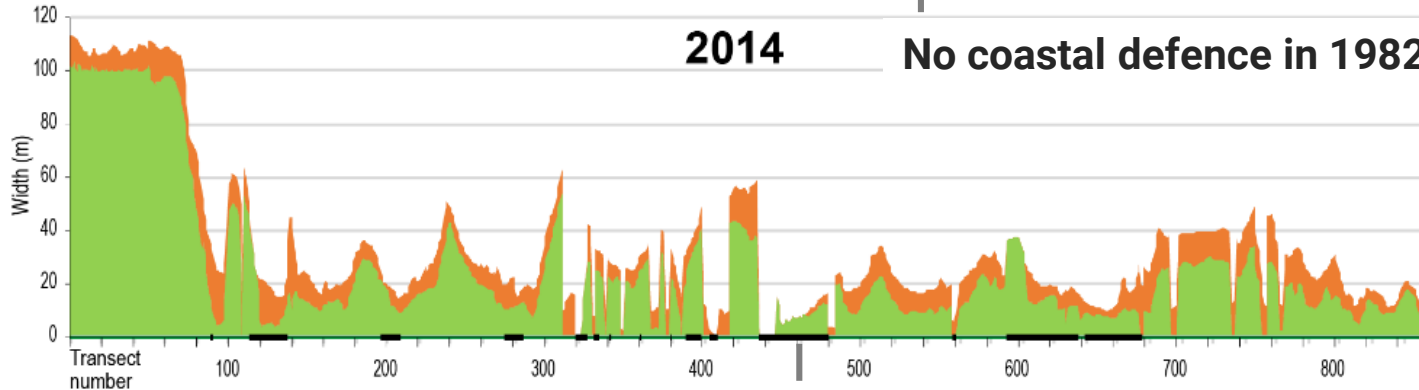
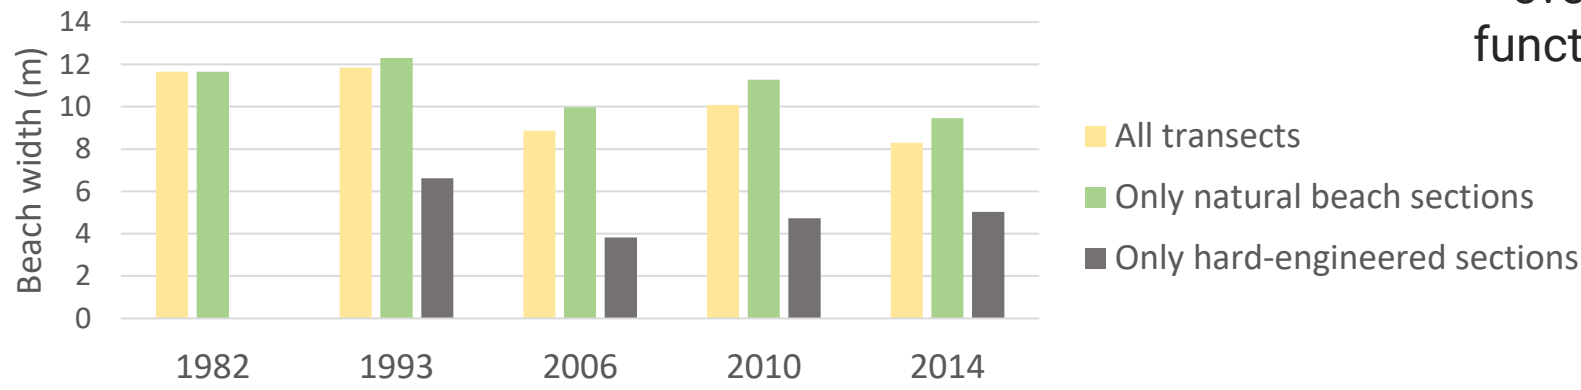
Coastal defence

Contraction (even if moderate)

Large **extension** of **shoreline armouring** (thick black line)

Disparition of entities (e.g. **beach loss**)

Fragmentation of the buffer zone

= even spatial variability, low buffering function, especially since 2006

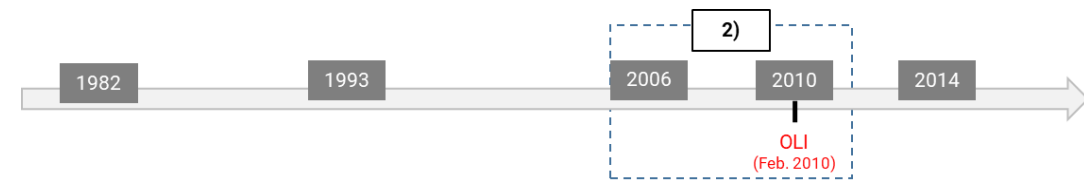
Results: Impacts of TC Oli (feb. 2010)

- Marine inundation: major impacts and damages (Etienne, 2012; Barriot, 2016)
- Coastal erosion: moderate impacts (Salmon & Duvat, submitted)

- Numerous damaged buildings and road sections
- Destruction of vegetation
- Washover deposits (30-50 cm thick on the road) (Etienne, 2012)

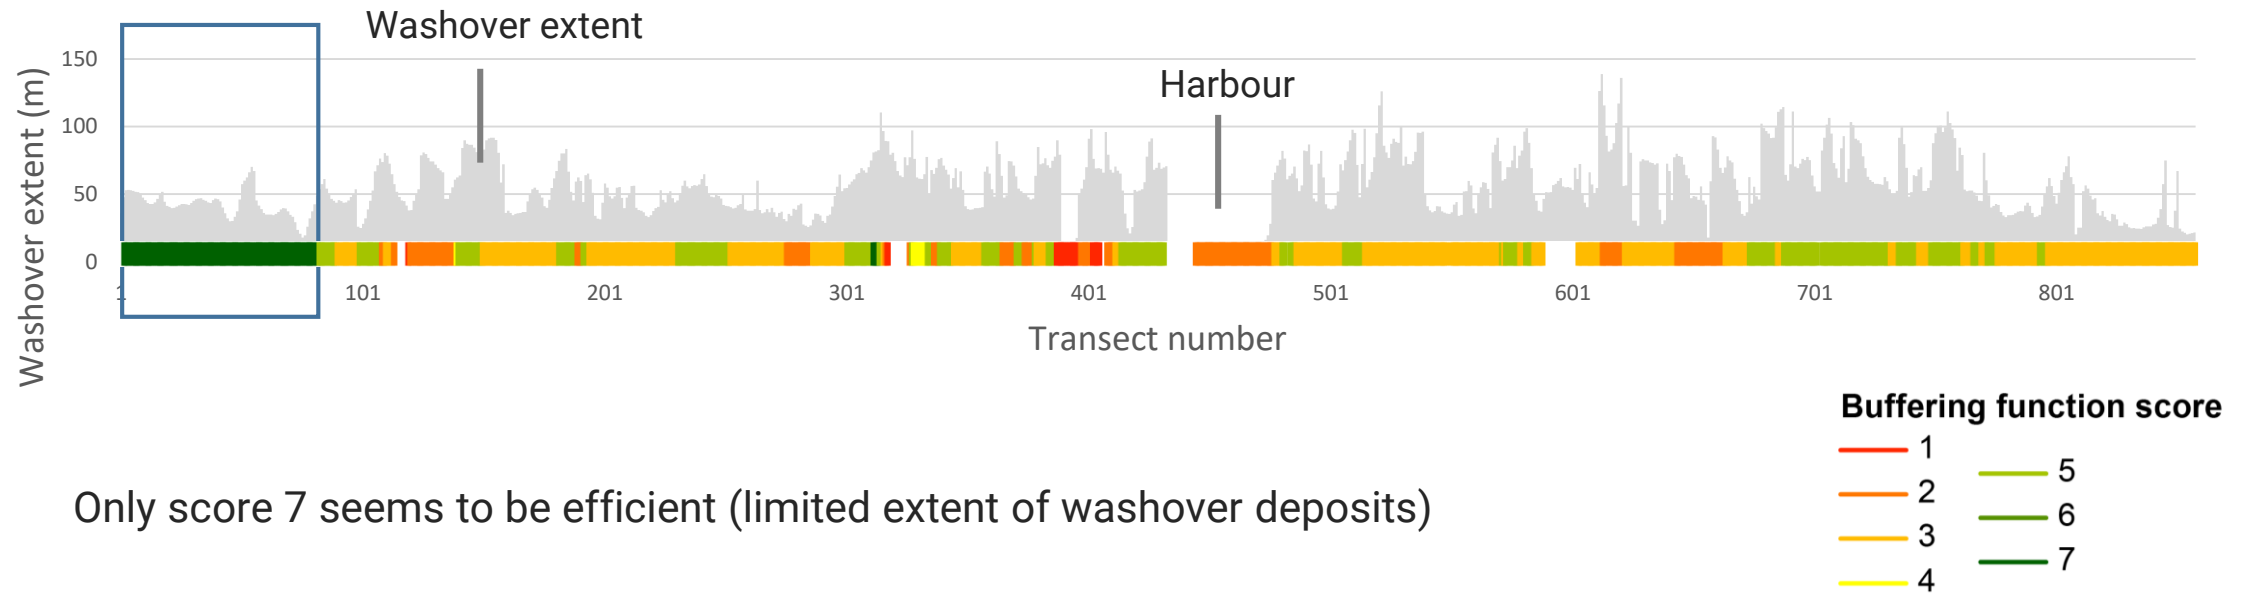
Crossing the index with the washover extent:

Only score 7 seems to be efficient (limited extent of washover deposits)

Score 5 did not show any protective role

For the rest, no visual correlations

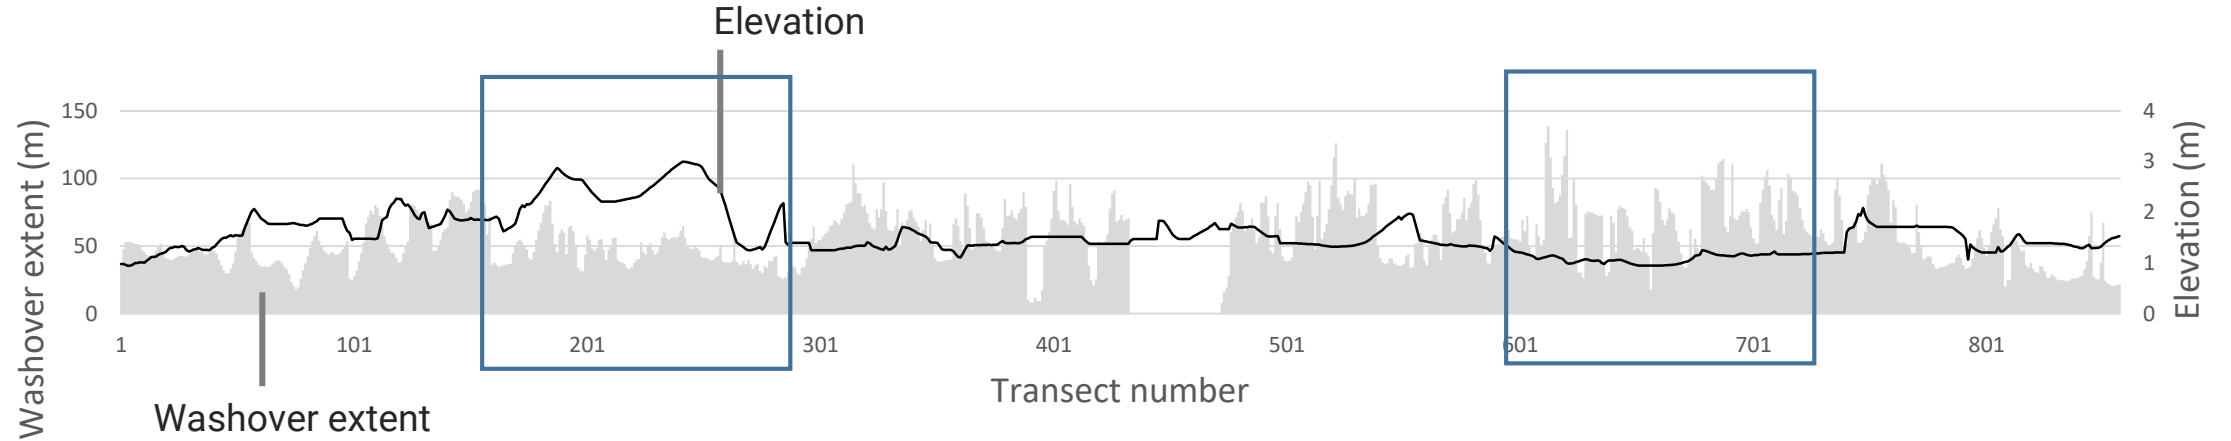
Washover deposits went further inland when elevation was low

> **Elevation is too low** (max = 3 m)

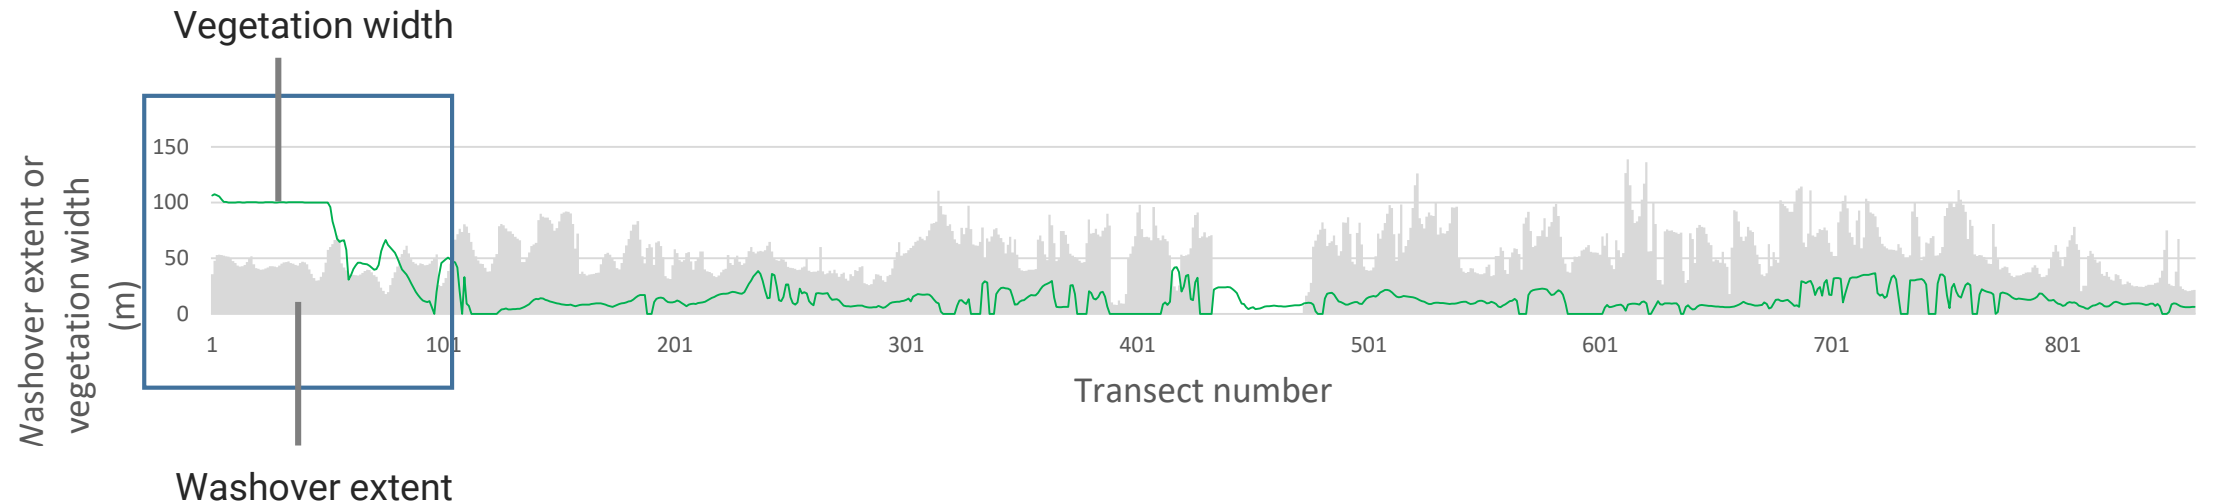
Washover deposits went further inland when vegetation width was low

> Buffer zone **width** and **vegetation characteristics** (introduced species, narrow and discontinuous belt) are not adapted

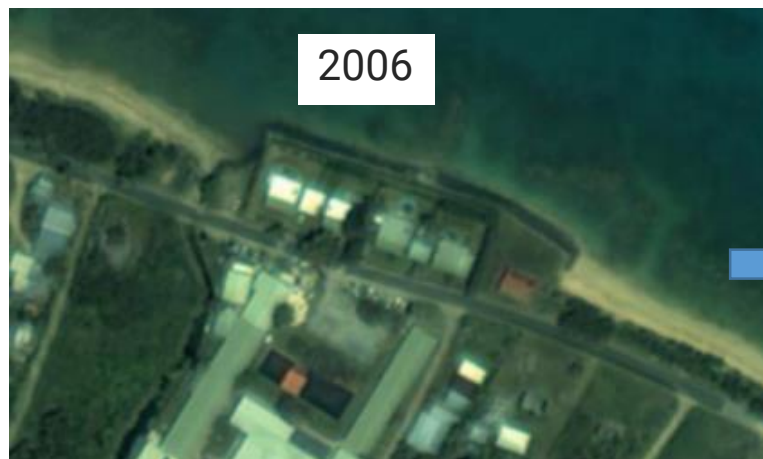
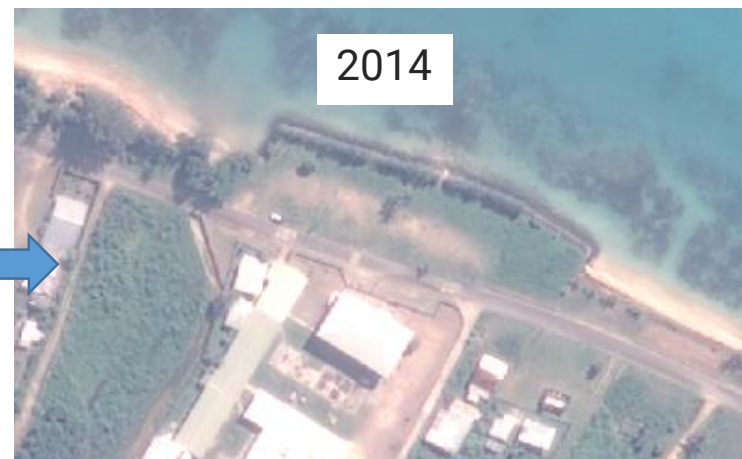
We observed some areas **where assets were relocated elsewhere inland** = buffer zone extension (both active and stabilized parts) due to building destruction

Tubuai has a **wide coastal plain** and **its density is low**
