## Fatigue safety verification of a steel railway bridge using short term monitoring data

Bartlomiej Sawicki, Eugen Brühwiler, Mariia Nesterova

**ABSTRACT:** The case study of the fatigue safety examination of the 120 years old steel riveted bridge carrying a single railway track on two main girders is presented. The overall assessment according to the Swiss Standard SIA 269 for existing structures indicated sufficient resistance at Ultimate Limit State but not at Fatigue Limit State, and the replacement of girders was recommended. To challenge this, the detailed examination was performed using data obtained from short term monitoring by the system installed on the main girders of one span over a period of four weeks. Fatigue stress histograms were constructed, and it was shown that measured stress ranges are smaller than the fatigue endurance limit, indicating a theoretically infinite fatigue life. No structural intervention is thus necessary. This case study shows that a simple short term monitoring is very useful for the fatigue examination of bridges allowing for reducing or avoiding (costly) interventions on structures.

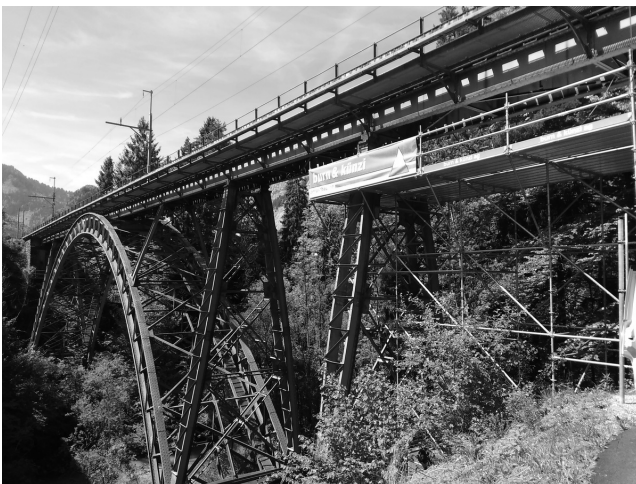
Figure 1 The railway bridge with the scaffolding for installation of monitoring.

A riveted steel bridge located in Switzerland was built in 1897 and is composed of an arch of 48m span and approach viaducts. Columns support girders approximately every 10m over a total bridge length of 79.1m. The girders carry a single normal gauge railway open track (sleepers are directly fixed on the steel structure) for bi-directional passenger trains (Fig. 1).

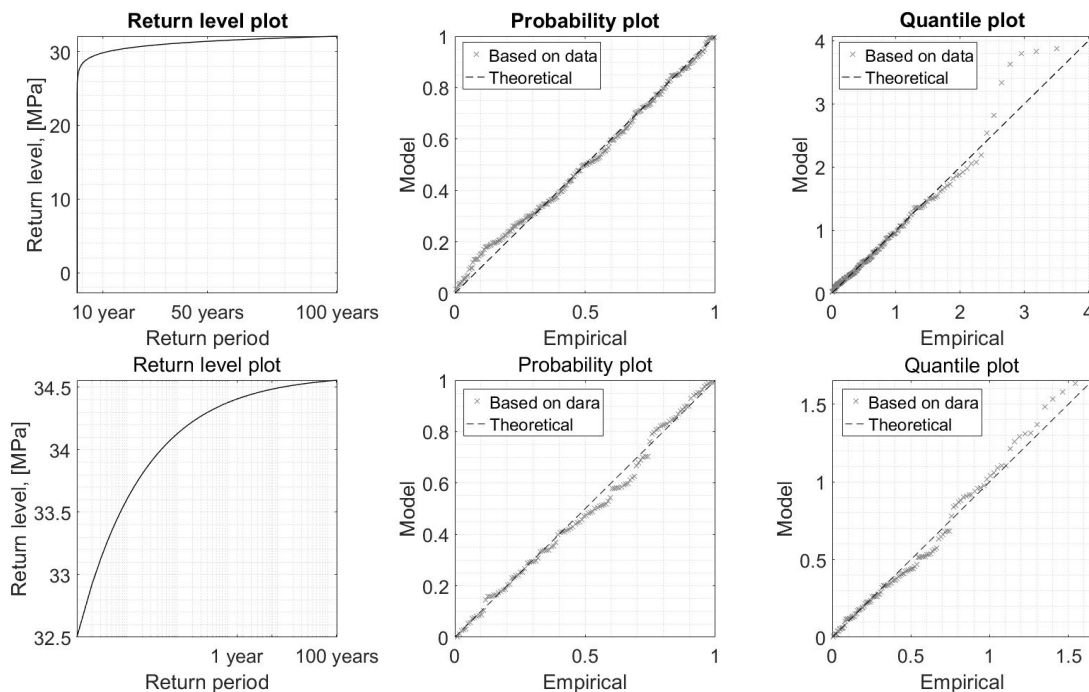
Figure 6 Return levels plots and goodness of fit for two sets of trains (27.5 MPa threshold).

It was found that the return levels for the return period were close to the measured values (Fig. 6). This was expected, as the railway traffic is highly consistent and repetitive. Also, there was no isolated extreme event as can often be observed for road bridges (Treacy, 2014). This confirms also that the monitoring campaign was sufficiently long
