# Influence of Pt Addition and Manufacturing Process on the Failure Mechanisms of NiCoCrAlYTa-Base Thermal Barrier Coating Systems under Thermal Cycling Conditions

**Abstract:** The cyclic oxidation of NiCoCrAlYTa-base thermal barrier coating systems was investigated at 1100 °C. The influence of the NiCoCrAlYTa deposition process, the coating modification by a Pt-overlayer, and the surface preparation steps were studied. Thermal cycling results showed that the addition of a Pt-overlayer, a dense and oxide-free bond-coating microstructure, together with a smooth NiCoCrAlYTa surface prior to Pt deposition and a suitable surface preparation before thermal barrier deposition all increase the lifetime. Degradation mechanisms are proposed to explain how coating defects develop during thermal cycling and how the fabrication process influences both failure and lifetime.

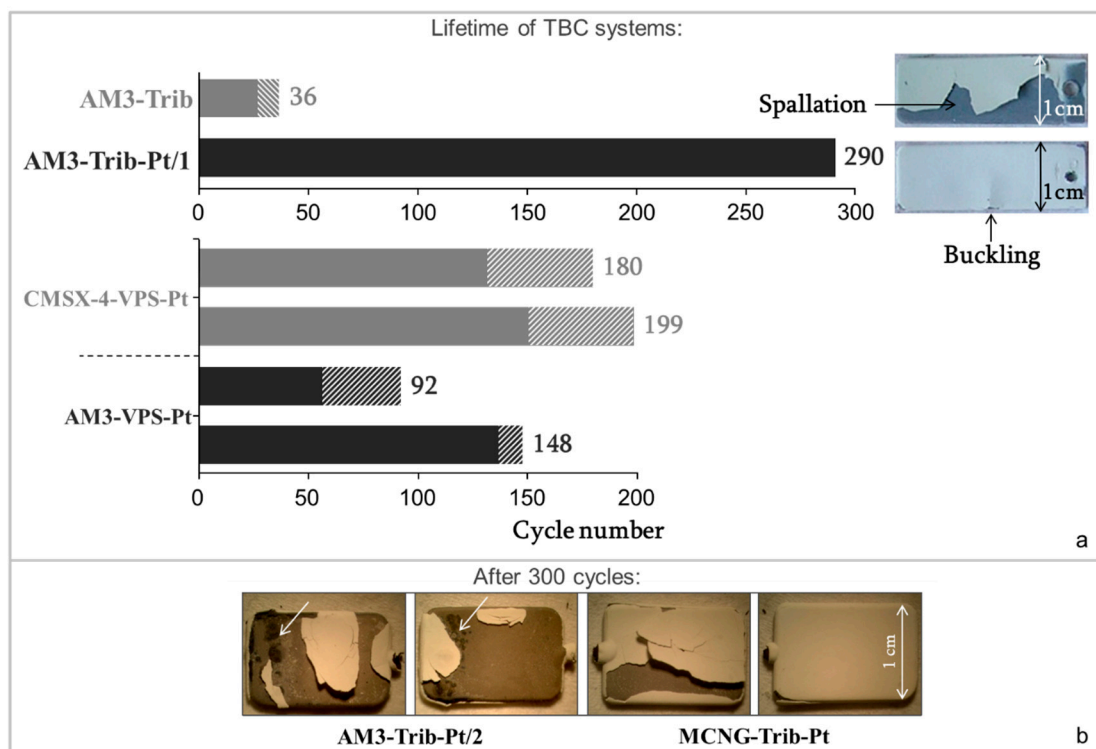
**Figure 2.** (a) Lifetime at 25% of spallation or buckling for AM3-Trib, AM3-Trib-Pt/1, AM3-VPS-Pt and CMSX-4-VPS-Pt TBC systems, and pictures of AM3-Trib and AM3-Trib-Pt/1 TBC systems after failure. The hatched areas represent the lifetime uncertainty; (b) Pictures of both sides of AM3-Trib-Pt/2 and MCNG-Trib-Pt/2 TBC systems after 300 cycles. The arrows indicate areas of catastrophic degradation. Thermal cycles of 1 h at 1100 °C, with a high-flow air cooling.

After 300 cycles at 1100 °C, AM3-Trib-Pt/2 and MCNG-Trib-Pt/2 TBC systems exhibited spallation, Figure 2. The spalled area proportion was much larger when AM3 was the superalloy. For both systems, SEM observations on spalled areas revealed oxidized bond-coating surface with TGO flakes, Figure 4. These TGO flakes exhibited thermal barrier remains that did not look like corn kernels but rather like the broken base of YSZ columns. Oxidized wells were also visible on the bond-coating surface of the MCNG-Trib-Pt/2 TBC system, Figure 4b,c. However, cross-section observations indicated that the TGO layer was still adherent to the thermal barrier after spallation, Figure 5a,b. After 300 cycles of 1 h at 1100 °C, the bond-coating microstructure of the AM3-Trib-Pt/2 TBC system was mainly composed of the  $\gamma$ -Ni phase, with  $\gamma'$ -Ni<sub>3</sub>Al phase regions present below the surface and at the BC/superalloy interface, Figure 5c,d. The composition, in at %, of the  $\gamma$ -Ni and  $\gamma'$ -Ni<sub>3</sub>Al phases close to the surface were 44.4Ni-18.8Co-20.6Cr-9.2Al-4.2Pt-0.2Ta-1.0Ti-0.8W-0.9Mo and 52.4Ni-10.3Co-5.9Cr-16.2Al-7.4Pt-2.2Ta-3.2Ti-0.9W-0.7Mo-0.8Y respectively, based on EDS analyses. A few  $\gamma'$ -Ni<sub>3</sub>Al regions were also observed within the internal coating zone with no TaC carbides, which was not the case for the AM3-Trib-Pt/1 TBC system after 290 cycles. For the MCNG-Trib-Pt/2 TBC system, the bond-coating was single-phased  $\gamma$ -Ni, with a composition in at % equal to 49.7Ni-17.3Co-16.5Cr-9.9Al-3.4Pt-0.8Ta-0.4Ti-0.9W-0.4Mo-0.3Hf-0.3Y close to the surface, based on EDS analyses.  $\gamma'$ -Ni<sub>3</sub>Al regions were only visible at the BC/superalloy interface. Most carbides had disappeared and the remaining ones were localized along the interface with the superalloy.

After only 300 cycles, an unusual degradation was observed on the bond-coating surface of the AM3-Trib-Pt/2 TBC system, as pointed out by the arrows on Figure 2b,c. Next, SEM observations of the bond-coating surface and cross-section were done on this specific area, Figure 6. On the surface, particles, either Pt-rich or Ta-rich (containing also some Ti for the latter), were dispersed in (Ni, Co, Cr, Al)-rich oxides. An XRD analysis done on this specific area confirmed the presence of other oxides than alumina (like NiO, NiCr<sub>2</sub>O<sub>4</sub>, and TiTaO<sub>4</sub>) and revealed that the Pt-rich particles were pure Pt, Figure 7. Cross-section observations showed that this unusual degradation concerned the entire circumference of one sample end, Figure 6c. (Ni, Co, Cr, Al)-rich oxides containing Pt and Ta-rich particles did not spread over the entire surface, Figure 6d, while an Al<sub>2</sub>O<sub>3</sub> layer dividing the bond-coating into two zones, an outer zone and an inner one, was present along the entire sample circumference, Figure 6c. No Al was detected by EDS in the region situated between the external oxide scale and the inner Al<sub>2</sub>O<sub>3</sub> layer. Such catastrophic degradation was not observed for the MCNG-Trib-Pt/2 TBC system despite oxide penetrating within the bond-coating in a few areas, Figure 8.

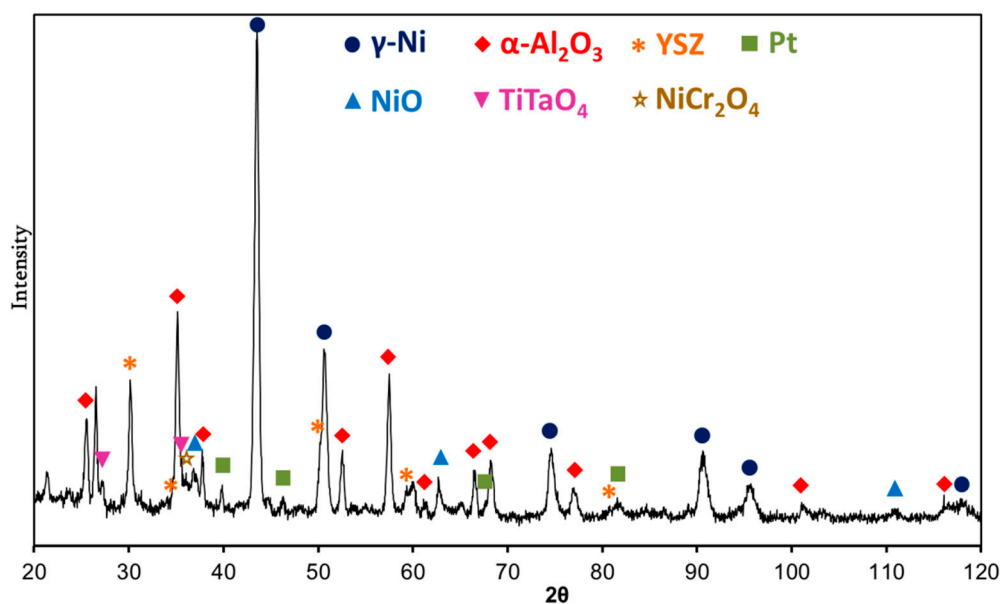
**Figure 7.** X-ray diffraction (XRD) diagram obtained from the bond-coating surface of the AM3-Trib-Pt/2 TBC system, in the area of catastrophic degradation.

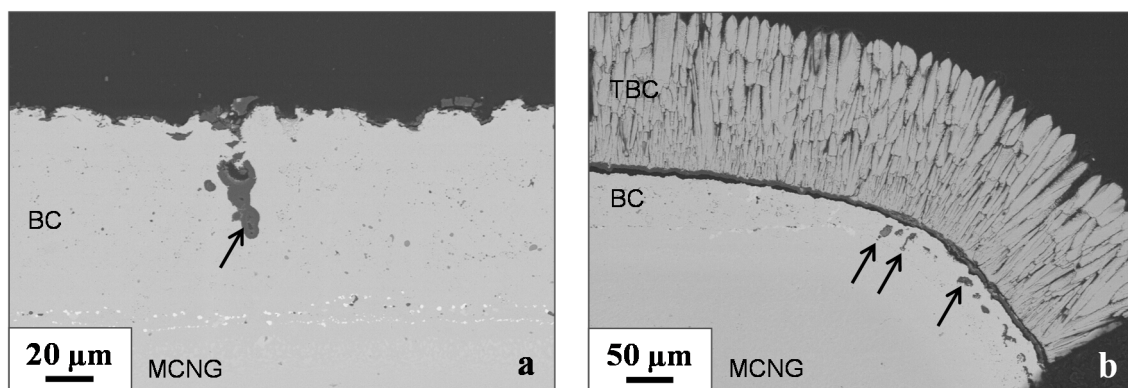
**Figure 8.** Cross-sections of the MCNG-Trib-Pt/2 TBC system after 300 cycles. The arrows identify zones of oxide penetration within the bond-coating, (a) on one sample face, (b) on one sample corner. Thermal cycles of 1 h at 1100 °C, with a high-flow air cooling. SEM images in BSE mode.

Even if no catastrophic degradation was observed for the MCNG-Trib-Pt/2 TBC system, oxidation penetration was encountered locally. This appeared similar to the onset of the catastrophic degradation that started on the edge for the AM3-Trib-Pt/2 TBC system. The higher surface/volume ratio at edges and corners explains the faster consumption of the Al reservoir contained within the material. Thermo-mechanical stresses are also higher and the quality of surface preparation is lower in these regions. All these reasons explain why degradation is greater at the sample edges. An increase in degradation in areas with a low curvature radius has previously been observed [73–75].

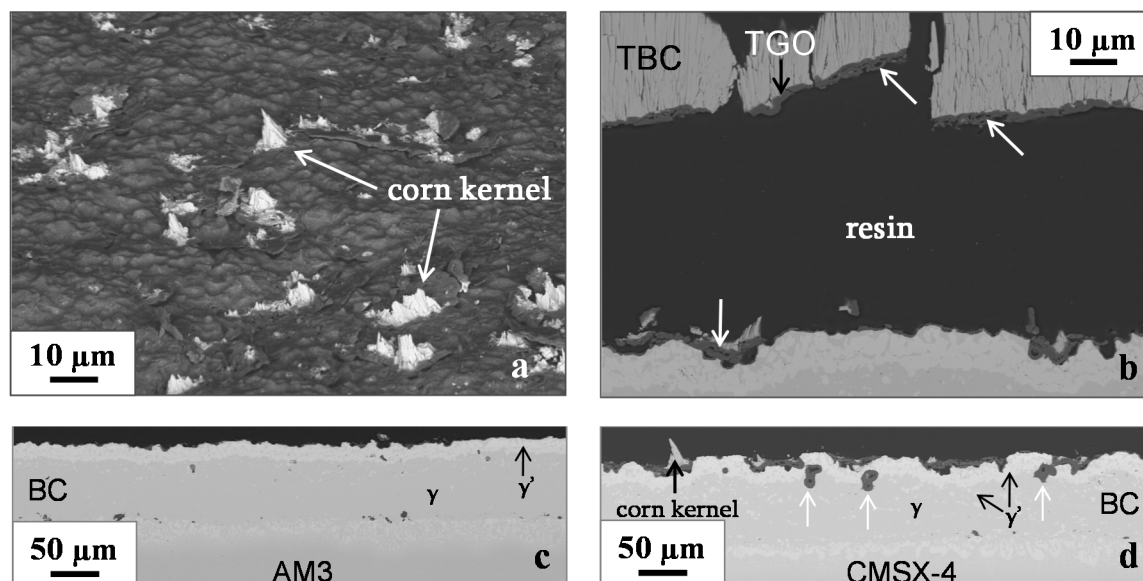
**Figure 9.** (a) Tilted VPS-Pt coating surface after spallation; (b,c) Cross-sections of the AM3-VPS-Pt TBC system after 92 cycles; (d) Cross-section of the CMSX-4-VPS-Pt TBC system after 199 cycles. The white arrows identify (a) the cavities within the TGO and (c) the oxide that locally penetrated deep within the bond-coating. Thermal cycles of 1 h at 1100 °C, with a high-flow air cooling. SEM images in BSE mode.

After thermal cycling, bond-coating surfaces and cross-sections were observed by SEM, Figure 9. The features are shown for the AM3-VPS-Pt TBC system that lasted 92 cycles but they were identical whatever the superalloy. First, many corn kernels were visible on the bond-coating surface after spallation, Figure 9a,b,d. Second, the oxide scale was an almost exclusive  $\text{Al}_2\text{O}_3$  layer but contained Ti, according to EDS analyses, and it exhibited cavities, Figure 9b. The bond-coating surface was deformed, Figure 9b–d, and some oxide penetrations within the bond-coating were visible, as for the CMSX-4-VPS-Pt TBC system that lasted 199 cycles, Figure 9d. The bond-coating was no longer composed of the martensitic phase, Figure 9c,d. A thick discontinuous  $\gamma'$ - $\text{Ni}_3\text{Al}$  layer, Ti- and Ta-rich, was present close to the surface and in the interdiffusion zone. The composition of this  $\gamma'$ - $\text{Ni}_3\text{Al}$  layer was, in at %, equal to 49.2Ni-11.3Co-6.1Cr-17.9Al-8.1Pt-3.5Ta-1.8Ti-0.9W-0.5Mo-0.7Y and 49.7Ni-11.7Co-5.4Cr-16.4Al-8.4Pt-4.2Ta-1.2Ti-1.2W-0.1Mo-0.2Re-0.3Hf-1.2Y for AM3-base and

CMSX-4-base systems respectively, based on EDS analyses. The inner part of the coating was composed of  $\gamma$ -Ni. A few isolated  $\gamma'$ -Ni<sub>3</sub>Al grains were also visible within the inner part, below the discontinuous  $\gamma'$ -Ni<sub>3</sub>Al layer, as few isolated  $\gamma$ -Ni grains were present above the thick  $\gamma'$ -Ni<sub>3</sub>Al layer.

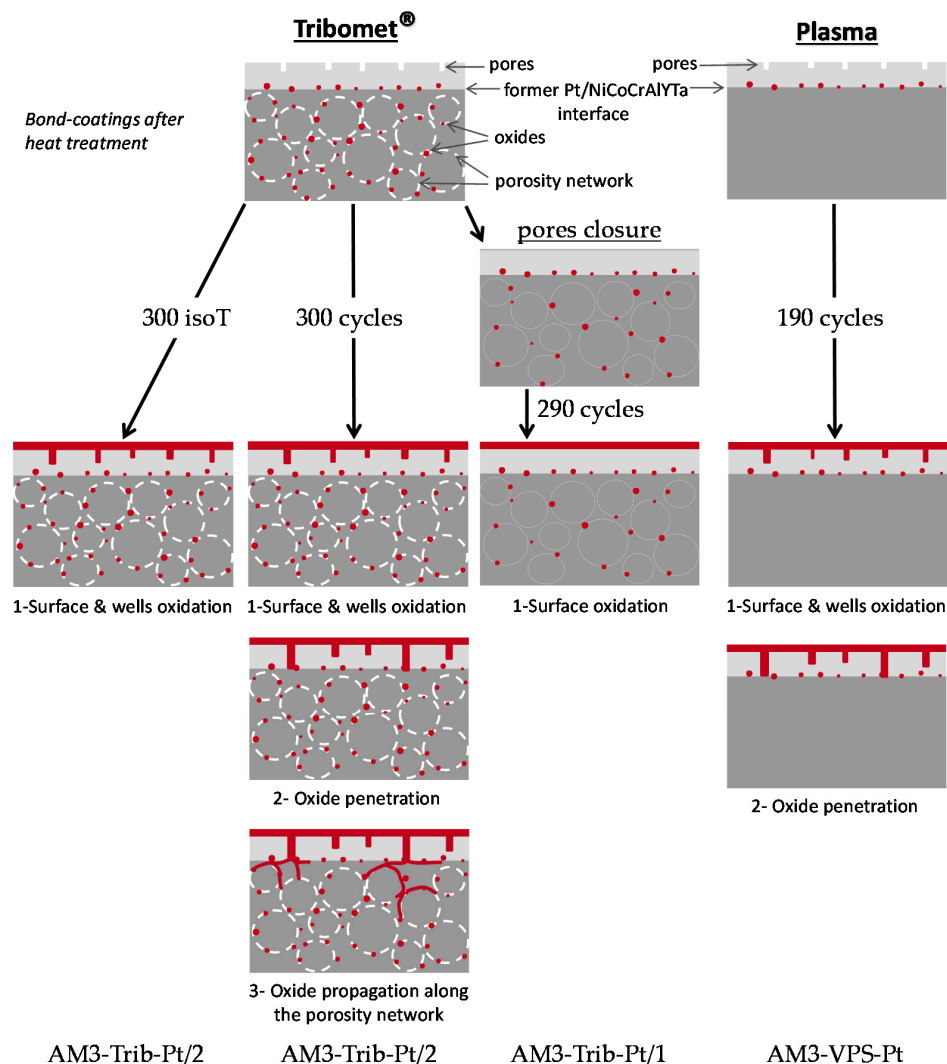
**Figure 10.** Proposed degradation mechanisms for TBC systems composed of a Pt-modified NiCoCrAlYTa bond-coating.

Catastrophic degradation occurred for the AM3-Trib-Pt/2 TBC system after 300 cycles at 1100 °C while this was not encountered for the AM3-Trib-Pt/1 TBC system that lasted 290 cycles at the same temperature. As explained previously, these TBC systems were not fabricated at the same time. The AM3-Trib-Pt/1 TBC system had a hole and a bond-coating over-thickness, while the AM3-Trib-Pt/2 TBC system had a welded stem. The thermal barrier thickness also differed between these batches. Due to these differences, the TBC system lifetimes must be compared with caution. Although the inner part of the Trib-Pt/1 bond-coating contained oxides, the oxide quantity was much lower than the one of the Trib-Pt/2 bond-coating. This prevented catastrophic degradation for the AM3-Trib-Pt/1 TBC system. Such an issue has already been mentioned by Subanovic et al. [76]. In their study, they showed that when the oxygen partial pressure within the VPS chamber was high enough, oxides rich in reactive elements were present through VPS NiCoCrAl(Y/Hf) coatings that exhibited poor oxidation behavior. Two other differences between these systems have to be mentioned: the surface preparation before Pt electroplating and before thermal barrier deposition. While for the AM3-Trib-Pt/1 TBC systems the bond-coating surface preparation was made at Praxair ST (the Tribomet® NiCoCrAlYTa coating manufacturer, Oldmixon, UK), the bond-coating surface of the AM3-Trib-Pt/2 TBC system was grit-blasted at Safran Aircraft Engines (Châtelleraut, France), according to parameters optimized for Pt-modified nickel aluminide coatings. It is then possible that the grit blasting carried out at Safran Aircraft Engines was insufficient to close the wells present at the Trib-Pt/2 surface. On the contrary, a surface preparation suitable for Trib coatings closed this open porosity and therefore prevented catastrophic degradation, Figure 10.
