Timber seismic bands: correlating their characteristics with local seismic activities and understanding their effects under seismic loads

Eugénie Crété, Santosh Yadav, Milo Hofmann, F. Vieux-Champagne, Yannick Sieffert, et al.. Timber seismic bands: correlating their characteristics with local seismic activities and understanding their effects under seismic loads. Inter-ISC'18, Jul 2018, kastamonu, Turkey. hal-02004219

TIMBER SEISMIC BANDS: CORRELATING THEIR CHARACTERISTICS WITH LOCAL SEISMIC ACTIVITIES AND UNDERSTANDING THEIR EFFECTS UNDER SEISMIC LOADS

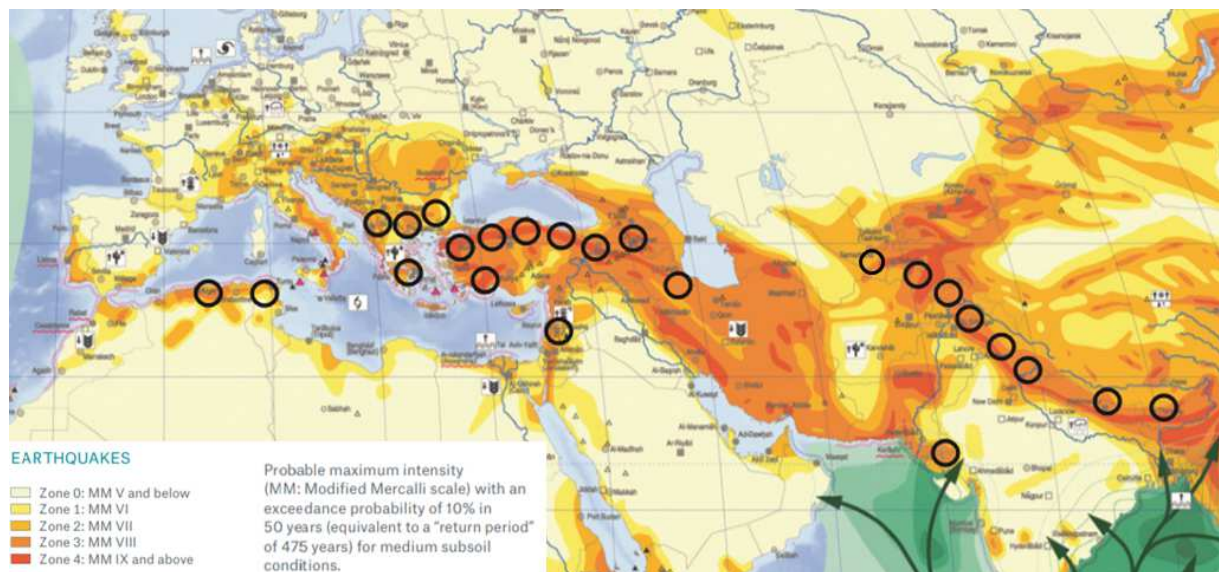
Figure 1: Map of the ladder-like timber bands technique geographic distribution and its correlation with seismic probable maximum intensities. This map results from the research carried out by M. Hofmann [6], background map by Munich Re Group.

Continuous and numerous exchanges between populations throughout the Alpine-Himalayan belt resulted in a wide geographical dissemination of aseismic technics and practices (Figure 1). More specifically, the most famous masons and craftsmen corporations were asked to build major constructions in broad areas whose delimitations were highly connected to the prevailing political domination, from the Byzantine Empire to the Ayyubid domination, the Mongol Empire, and finally the Ottoman Empire. In some cases, local corporations were then influenced by the work of these famous corporations, thus contributing to a dissemination of aseismic features at all society levels; this dissemination was even sometimes directly supported by political authorities through legal tools or the organization of trainings [6]. But these exchanges did not prevent local variations of these technics.

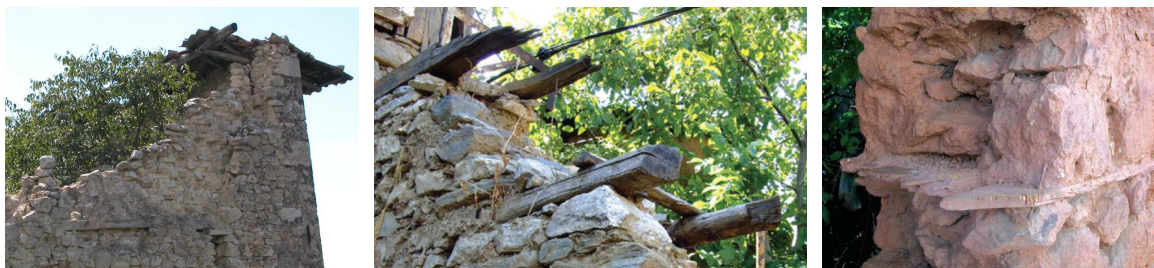
Figure 2: a) massive timber logs embedded in a partially collapsed masonry wall at Poggio Picenze (Italy); b) ladder-like timber bands inserted at regular spacing in Cumalikizik (Turkey) and c) planks insertion in a masonry wall in Kastamonu (Turkey) (Credit: Hofmann)

This study does not refer to structural systems mixing horizontal and vertical timber elements, as the authors assume that this mixing often entails major changes in the seismic behaviour of the structure. It thus focuses on horizontal timber insertions, and three main technics were documented in masonry load-bearing walls:

- a. A massive timber log embedded into the wall and connected to metallic anchors in façade;
- b. Ladder-like timber bands inserted at regular spacing;
- c. Several planks or logs placed next to each other on the whole wall section.

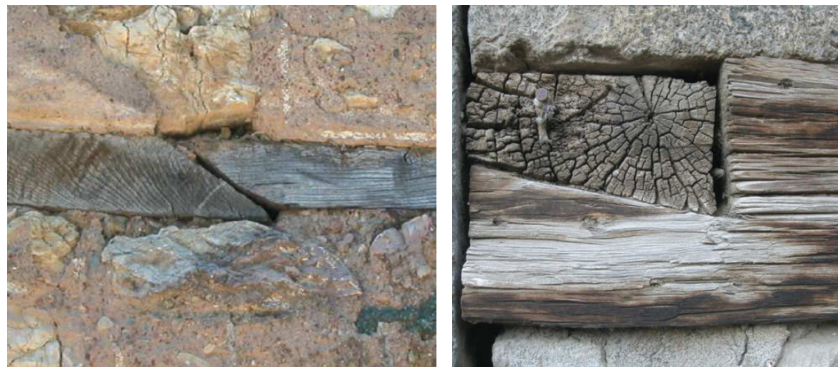
Figure 3: a) a chamfered joint in Vevçani (Macedonia) and b) a dovetail joint in Erzurum (Turkey) (Credit: Hofmann)

Moreover, connections between elements are very interesting to compare. Planks are usually connected by overlapping and basic nailing, while in case of ladder-like insertions, connections are more sophisticated: halved or chamfered joints, and in case of recent high seismic activity, dovetail joints were more likely to be observed.

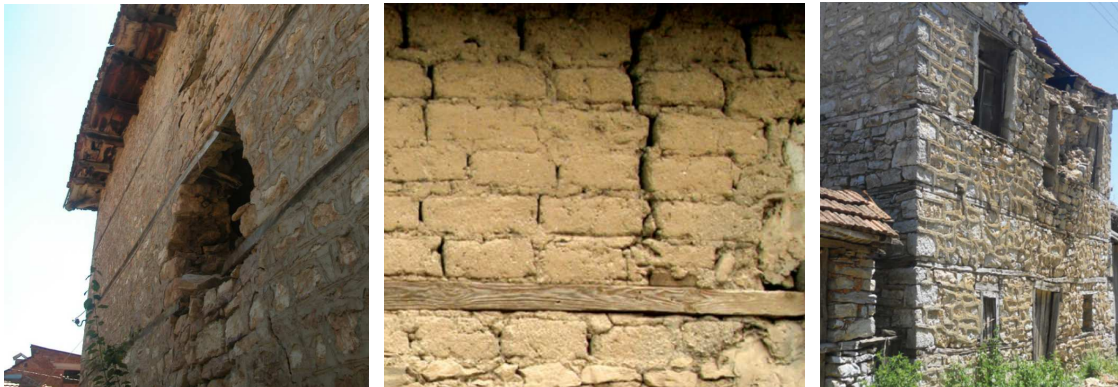
Figure 4: a) ladder-like insertions acting as lintels when partial collapse of a masonry wall occurred; b) preventing cracks propagation and c) restricting bending deflection (Credit: Hofmann)

Both ladder-like and planks insertions (referred respectively as techniques b and c in previous section) have several common effects providing a better behaviour to structures submitted to earthquake solicitations. They act as lintel in case of partial failure of the masonry (Figure 4a). Thanks to timber ability to resist traction, they prevent vertical and diagonal cracks from spreading (Figure 4b). Moreover, they confine the masonry elements, thus giving the wall extra resistance to out-of-plane solicitations (Figure 4c), while it is thought that they allow for movement between the wall portions and thus maintain a relative flexibility of the structure, which is of major importance to reduce the building vulnerability. Moreover, this confinement changes the structural behaviour of the wall, dividing it into several smaller portions embedded at both ends and thus changing its slenderness and resonance frequency. This confinement also increases the static compression resistance of walls [6].

Ladder-like insertions are even more efficient as confining devices of masonry elements – providing the wood and connections are resistant enough to traction – thus increasing compression resistance [6] and restricting bending deflection (Figure 4c). However, this confinement of walls subdivisions does not prevent movements between them and thus dissipation of energy, and may be an interesting balance between a relative stiffness of walls subdivisions and a relative flexibility of the whole building. Moreover, it was noticed that two-leaf walls without proper bound stones or corner stones are more likely to be found with ladder-like insertions: this observation supports the hypothesis that ladder-like insertions improves the connection between the different vertical leaves of a masonry wall – but authors would nevertheless recommend the use of bound stones to connect properly the masonry layers. As explained in next section, ladder-like insertions improve the wall resistance to shear solicitations. Moreover, the timber elements composing these insertions usually are well connected enough to act as a belt preventing corner separation and spreading the solicitations to the building as a whole, while maintaining a relative flexibility. Finally, contrary to planks insertions, ladder-like insertions do not create water stagnation zones in the walls– accelerating wood decay and rotting – and may thus be more adapted in areas where the timber mechanical properties are affected by frequent seismic solicitations.

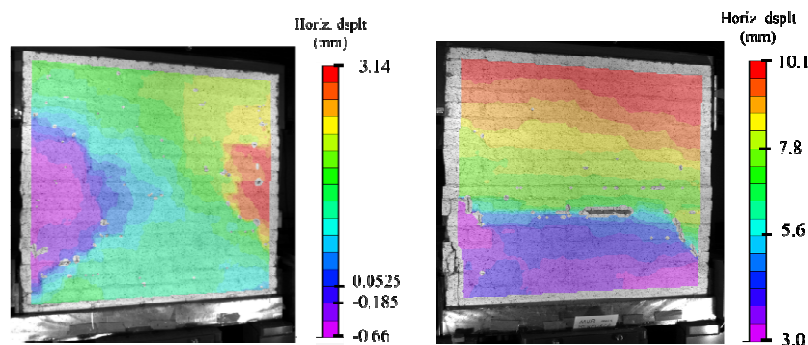
Figure 5: Horizontal displacement field obtained with DIC: from left to right; (a) UM, (b) RM.

Figure 5 shows the horizontal displacement field in the reinforced and unreinforced masonry walls before failure. In the case of the unreinforced masonry adobe wall (UM) (Figure 5a), contours show a typical diagonal crack pattern. The contours of the reinforced shear wall (RM) (Figure 5b) show the apparition of a friction plane along the bed joints. Two types of failure can be observed here. The unreinforced wall experienced shear failure as shown by the presence of diagonal cracks in the joints and through some adobe units. During the first cycles of the quasi-static test, the horizontally reinforced wall showed a behavior similar to the first wall: diagonal cracks appeared at the corners of the wall. However, when the lateral force magnitude increased, a horizontal failure plane developed two beds of bricks below the timber insertion, and sliding occurred along this plane. Additionally, very few cracks appeared above the reinforcement.

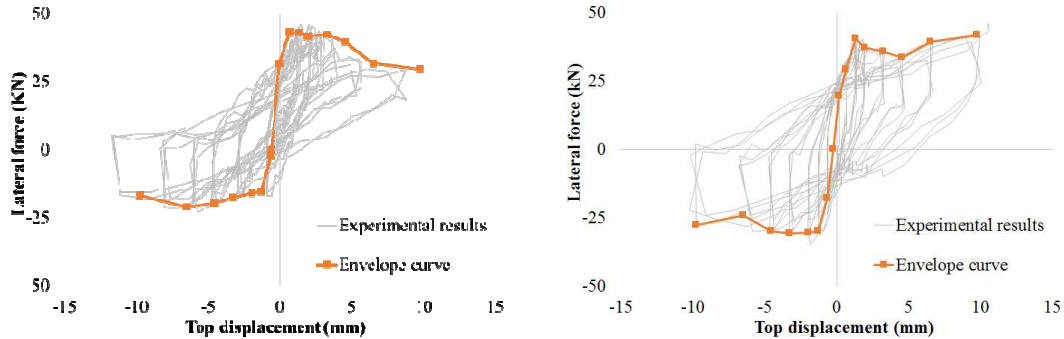
Figure 6: Hysteresis curves lateral force VS displacement for quasi static cyclic tests on: from left to right; (a) UM (b) RM

The hysteresis curves lateral force VS displacement, corresponding to the quasi-static cyclic tests on UM and RM, are presented on Figure 6. The envelope corresponds to the points of maximal force and maximal displacement for each series of three cycles of same magnitude.

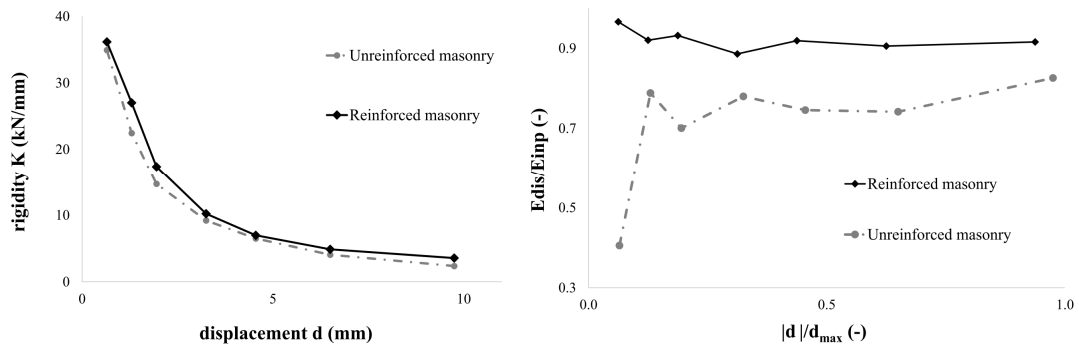
Figure 7: From left to right; (a) Stiffness degradation, (b) Energy dissipation.

The stiffness degradation of the walls was evaluated by computing the slope between two points of maximal force and displacement of two loading series, which corresponds to the slope between two points of the hysteresis curves. The stiffness degradation curves (Figure 7a) illustrate similar responses for the two walls. Most of the degradation happens during the three first loading cycles, and then the stiffness stabilizes. It can be noticed that the stiffness of the reinforced shear wall degraded more progressively, which fosters the hypothesis of a more ductile behavior of reinforced masonry pointed out by the hysteresis curves.

The hysteresis curves also reveal some information about dissipated energy in the system. The dissipated energy E_{dis} is defined as the area inside a cycle of hysteresis. The input energy E_{inp} is defined as the area under the curve, down to the x-axis. Figure 7b presents the variation of the ratio E_{dis} / E_{inp} depending on the displacement, normalized with the value of maximum displacement during the test d_{max} . The plot shows more significant energy dissipation in the case of the timber reinforced masonry wall (90%) compared to the unreinforced wall (80%). This could be explained by the friction phenomenon which is probably more important for the crack pattern depicted in Figure 5b. This dissipation of energy due to the ladder-like timber insertions is the subject of the second experimental campaign that is further explained in next section.

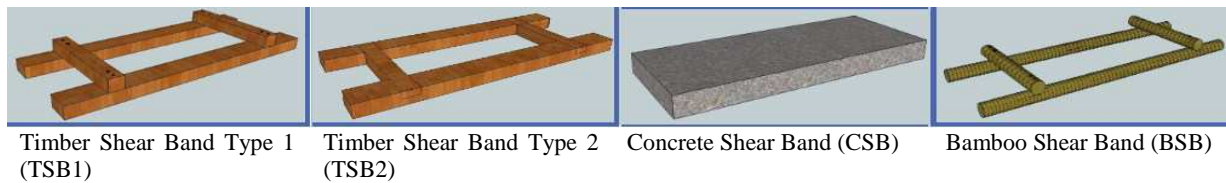
Figure 8: Different types of shear bands as recommended in DUDBC guidelines for reconstruction

Four types of shear band were prepared following the Department of Urban Development and Building Construction (DUDBC) guidelines [12], using timber, concrete and bamboo (Figure 8).

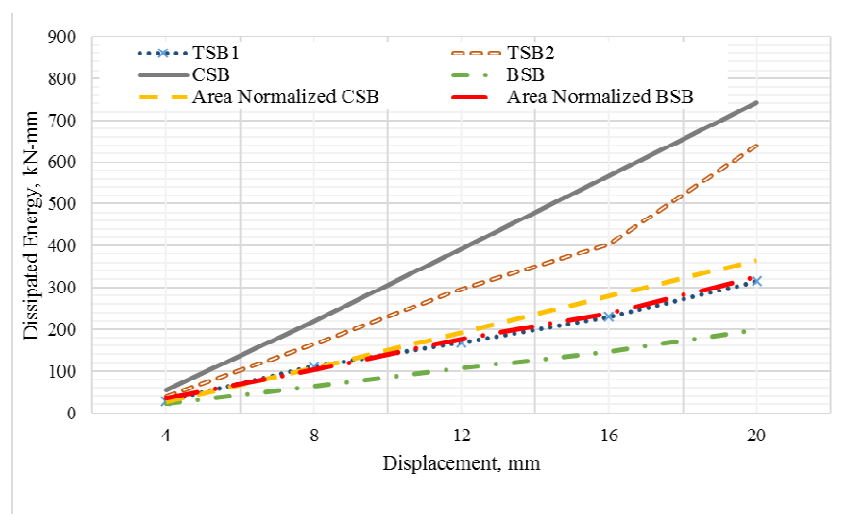
Figure 9: Comparison of energy dissipations by various types of shear band

The obtained data from the experiment was the displacement and the corresponding force needed to reach that displacement. A hysteresis curve is obtained by plotting the data. The area under the hysteresis curve provides the value of the energy dissipated during each cycle. The dissipated energy was measured using OriginPro 2017 software (<http://www.originlab.com/2017>), taking the average between the results obtained from the similar shear bands. Comparison of energy dissipation by various type of shear band is shown in Figure 9.

From the comparison, we can notice that more energy is dissipated with CSB compared to other materials and least energy is dissipated by BSB. The amount of energy dissipated also differs depending on the connections between timber elements. TSB2 could dissipate more energy than TSB1. In order to observe the significance of the contact surface area, the results for the CSB and BSB were normalized taking the contact surface area of TSB1 and 2 as the reference. The energy dissipated by the normalized CSB and normalized BSB are similar to that of TSB1. The energy dissipation patterns obtained tend to follow linear form for each of the shear band materials.
