Eugénie Crété, Santosh Yadav, Milo Hofmann, F. Vieux-Champagne, Yannick Sieffert, et al.. Timber seismic bands: correlating their characteristics with local seismic activities and understanding their effects under seismic loads. Inter-ISC'18, Jul 2018, kastamonu, Turkey. hal-02004219

TIMBER SEISMIC BANDS: CORRELATING THEIR CHARACTERISTICS WITH LOCAL SEISMIC ACTIVITIES AND UNDERSTANDING THEIR EFFECTS UNDER SEISMIC LOADS

Keywords: Masonry building; Timber insertions; Seismic shear band; Energy dissipation

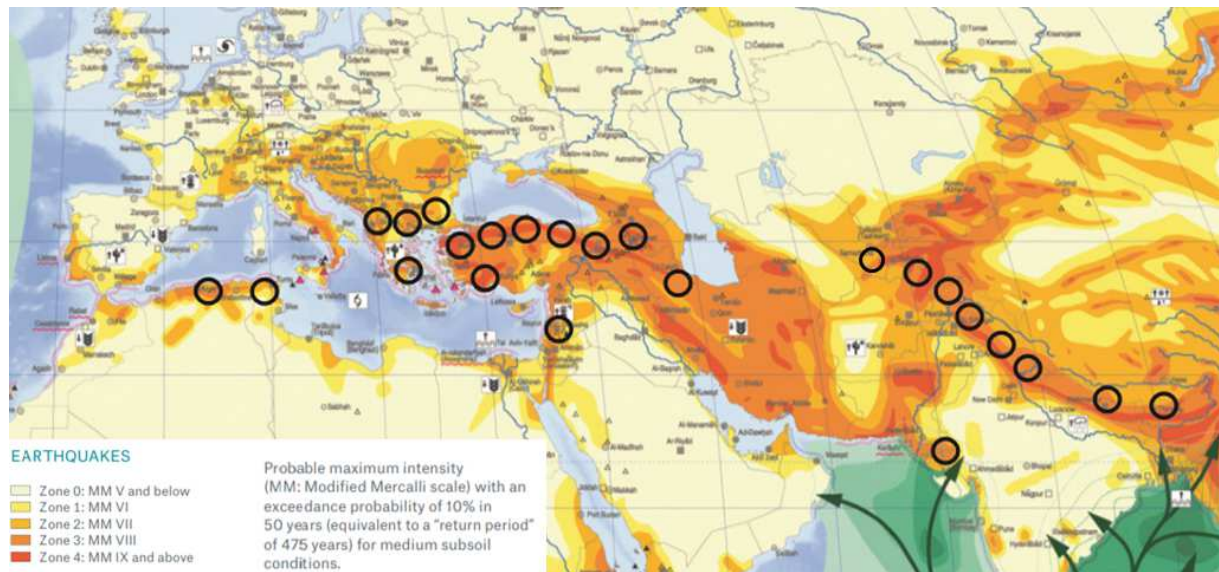
Figure 1: Map of the ladder-like timber bands technique geographic distribution and its correlation with seismic probable maximum intensities. This map results from the research carried out by M. Hofmann [6], background map by Munich Re Group.

Continuous and numerous exchanges between populations throughout the Alpine-Himalayan belt resulted in a wide geographical dissemination of aseismic technics and practices (Figure 1). More specifically, the most famous masons and craftsmen corporations were asked to build major constructions in broad areas whose delimitations were highly connected to the prevailing political domination, from the Byzantine Empire to the Ayyubid domination, the Mongol Empire, and finally the Ottoman Empire. In some cases, local corporations were then influenced by the work of these famous corporations, thus contributing to a dissemination of aseismic features at all society levels; this dissemination was even sometimes directly supported by political authorities through legal tools or the organization of trainings [6]. But these exchanges did not prevent local variations of these technics.

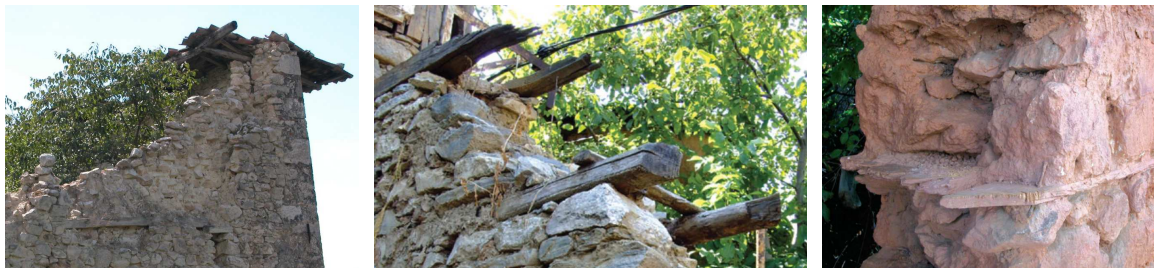
Figure 2: a) massive timber logs embedded in a partially collapsed masonry wall at Poggio Pienze (Italy); b) ladder-like timber bands inserted at regular spacing in Cumalikizik (Turkey) and c) planks insertion in a masonry wall in Kastamonu (Turkey) (Credit: Hofmann)

This study does not refer to structural systems mixing horizontal and vertical timber elements, as the authors assume that this mixing often entails major changes in the seismic behaviour of the structure. It thus focuses on horizontal timber insertions, and three main technics were documented in masonry load-bearing walls:

- A massive timber log embedded into the wall and connected to metallic anchors in façade;
- Ladder-like timber bands inserted at regular spacing;
- Several planks or logs placed next to each other on the whole wall section.

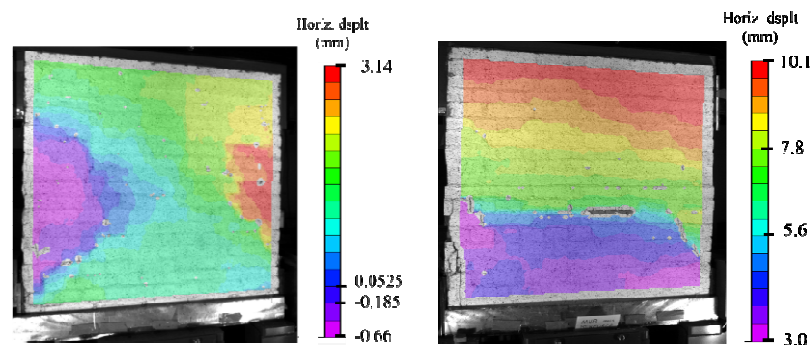
Figure 5: Horizontal displacement field obtained with DIC: from left to right; (a) UM, (b) RM.

Figure 5 shows the horizontal displacement field in the reinforced and unreinforced masonry walls before failure. In the case of the unreinforced masonry adobe wall (UM) (Figure 5a), contours show a typical diagonal crack pattern. The contours of the reinforced shear wall (RM) (Figure 5b) show the apparition of a friction plane along the bed joints. Two types of failure can be observed here. The unreinforced wall experienced shear failure as shown by the presence of diagonal cracks in the joints and through some adobe units. During the first cycles of the quasi-static test, the horizontally reinforced wall showed a behavior similar to the first wall: diagonal cracks appeared at the corners of the wall. However, when the lateral force magnitude increased, a horizontal failure plane developed two beds of bricks below the timber insertion, and sliding occurred along this plane. Additionally, very few cracks appeared above the reinforcement.

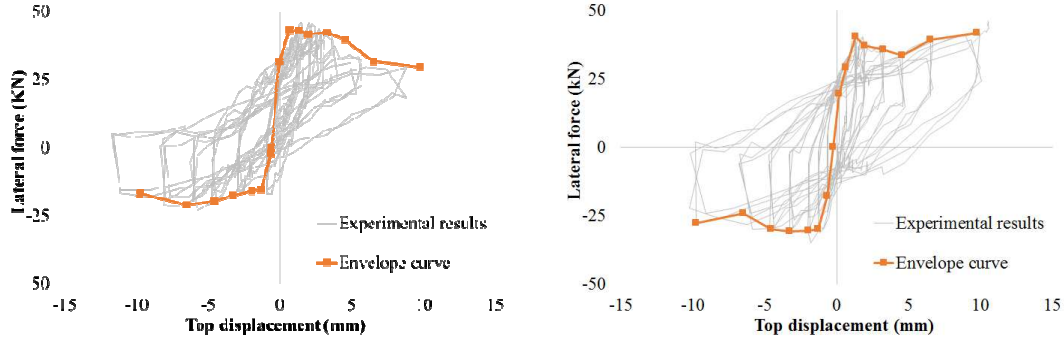
Figure 6: Hysteresis curves lateral force VS displacement for quasi static cyclic tests on: from left to right; (a) UM (b) RM

The hysteresis curves lateral force VS displacement, corresponding to the quasi-static cyclic tests on UM and RM, are presented on Figure 6. The envelope corresponds to the points of maximal force and maximal displacement for each series of three cycles of same magnitude.

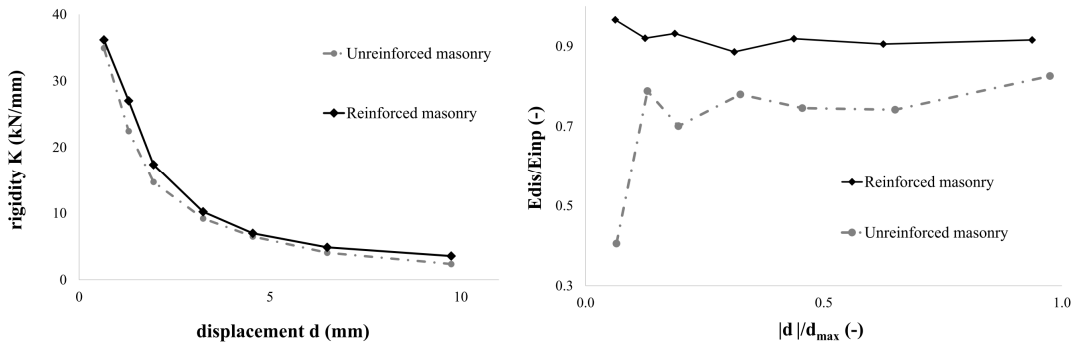
Figure 7: From left to right; (a) Stiffness degradation, (b) Energy dissipation.

The stiffness degradation of the walls was evaluated by computing the slope between two points of maximal force and displacement of two loading series, which corresponds to the slope between two points of the hysteresis curves. The stiffness degradation curves (Figure 7a) illustrate similar responses for the two walls. Most of the degradation happens during the three first loading cycles, and then the stiffness stabilizes. It can be noticed that the stiffness of the reinforced shear wall degraded more progressively, which fosters the hypothesis of a more ductile behavior of reinforced masonry pointed out by the hysteresis curves.

The hysteresis curves also reveal some information about dissipated energy in the system. The dissipated energy E_{dis} is defined as the area inside a cycle of hysteresis. The input energy E_{inp} is defined as the area under the curve, down to the x-axis. Figure 7b presents the variation of the ratio E_{dis} / E_{inp} depending on the displacement, normalized with the value of maximum displacement during the test d_{max} . The plot shows more significant energy dissipation in the case of the timber reinforced masonry wall (90%) compared to the unreinforced wall (80%). This could be explained by the friction phenomenon which is probably more important for the crack pattern depicted in Figure 5b. This dissipation of energy due to the ladder-like timber insertions is the subject of the second experimental campaign that is further explained in next section.

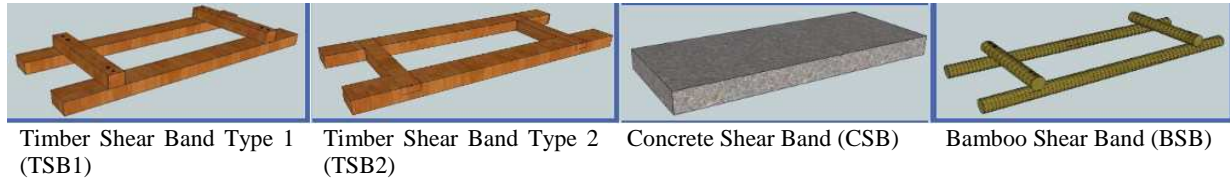
Figure 8: Different types of shear bands as recommended in DUDBC guidelines for reconstruction

Four types of shear band were prepared following the Department of Urban Development and Building Construction (DUDBC) guidelines [12], using timber, concrete and bamboo (Figure 8).

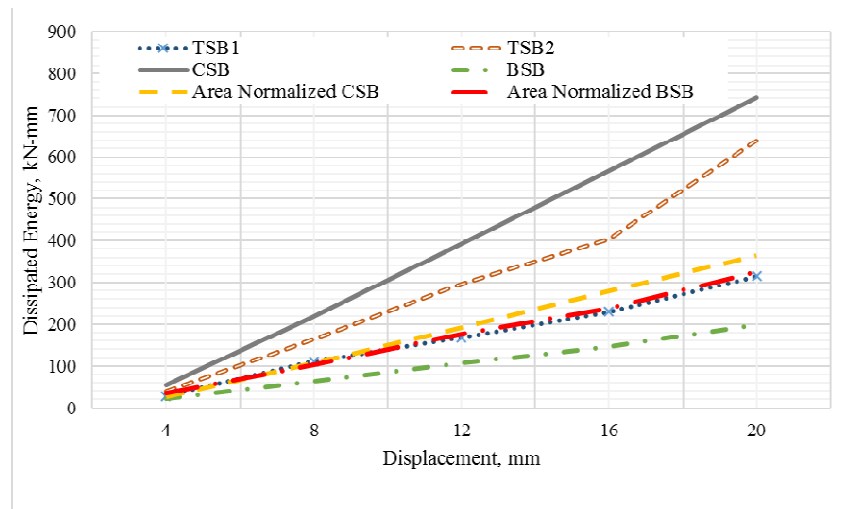
Figure 9: Comparison of energy dissipations by various types of shear band

The obtained data from the experiment was the displacement and the corresponding force needed to reach that displacement. A hysteresis curve is obtained by plotting the data. The area under the hysteresis curve provides the value of the energy dissipated during each cycle. The dissipated energy was measured using OriginPro 2017 software (<http://www.originlab.com/2017>), taking the average between the results obtained from the similar shear bands. Comparison of energy dissipation by various type of shear band is shown in Figure 9.

From the comparison, we can notice that more energy is dissipated with CSB compared to other materials and least energy is dissipated by BSB. The amount of energy dissipated also differs depending on the connections between timber elements. TSB2 could dissipate more energy than TSB1. In order to observe the significance of the contact surface area, the results for the CSB and BSB were normalized taking the contact surface area of TSB1 and 2 as the reference. The energy dissipated by the normalized CSB and normalized BSB are similar to that of TSB1. The energy dissipation patterns obtained tend to follow linear form for each of the shear band materials.
