# Distributed Fiber Optics Sensing and Coda Wave Interferometry Techniques for Damage Monitoring in Concrete Structures

**Abstract:** The assessment of Coda Wave Interferometry (CWI) and Distributed Fiber Optics Sensing (DFOS) techniques for the detection of damages in a laboratory size reinforced concrete beam is presented in this paper. The sensitivity of these two novel techniques to micro cracks is discussed and compared to standard traditional sensors. Moreover, the capacity of a DFOS technique to localize cracks and quantify crack openings is also assessed. The results show that the implementation of CWI and DFOS techniques allow the detection of early subtle changes in reinforced concrete structures until crack formation. With their ability to quantify the crack opening, following early detection and localization, DFOS techniques can achieve more effective monitoring of reinforced concrete structures. Contrary to discrete sensors, CWI and DFOS techniques cover larger areas and thus provide more efficient infrastructures asset management and maintenance operations throughout the lifetime of the structure.

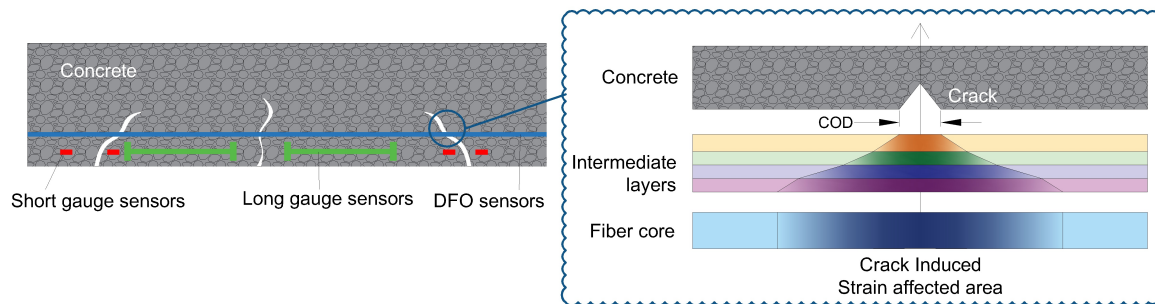
**Figure 1.** Crack detection using Distributed Fiber Optics Sensing (DFOS) techniques.

As mentioned in the previous paragraph, DFOS techniques provide spatially distributed strain measurements. Thus, as shown in Figure 1, direct damage detection and localization can be achieved

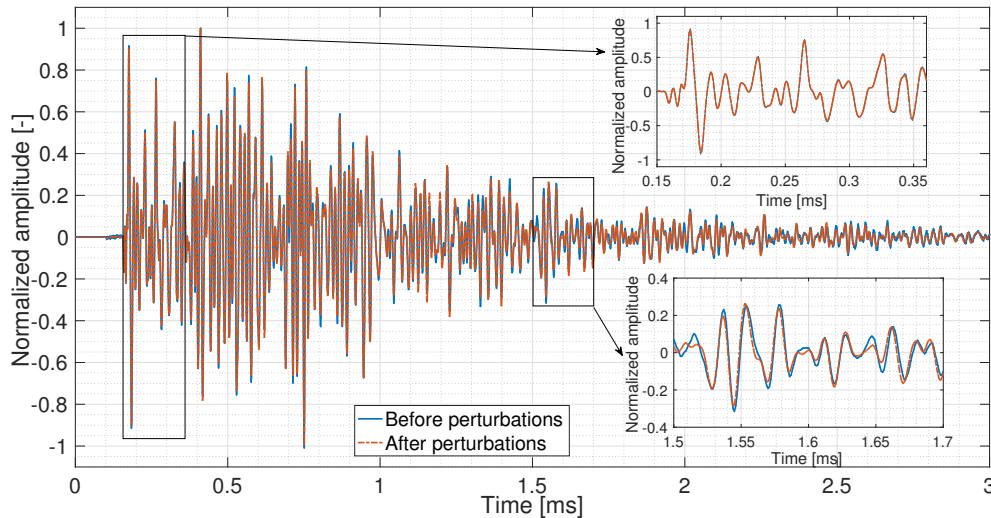
Figure 2. Signals recorded before and after perturbation in the medium [31].

The principle of CWI is to compare the coda waves recorded in two different states to monitor weak velocity variations and waveform modifications. As shown in Figure 2, two signals are

recorded before and after a perturbation. The first arrivals of the signals are almost the same (i.e., [0.16 ms, 0.35 ms]), while the coda wave (i.e., [1.5 ms, 1.7 ms]) shows a significant difference. For this reason, CWI is more sensitive to weak perturbation in the medium.

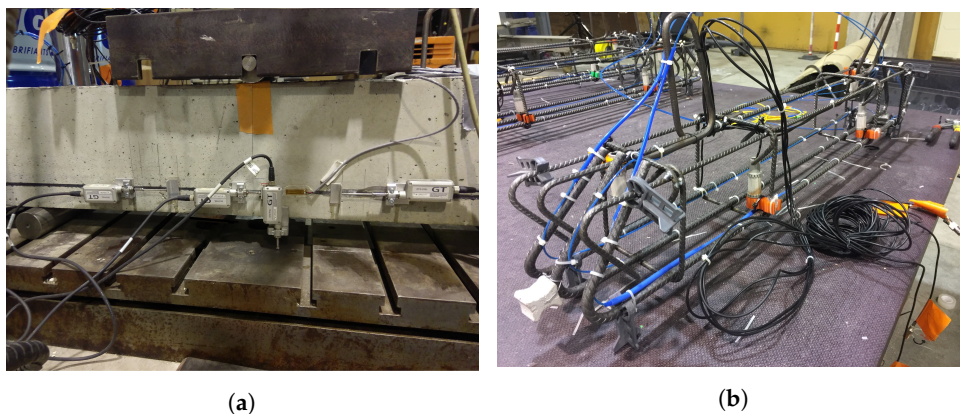
**Figure 3.** (a) front view of the loading arrangement and the beam instrumented with sensors before testing; (b) Ultra Sonics (US) and Distributed Fiber optics (DFO) sensors attached to the rebars before casting of concrete.

A  $20 \times 20 \times 100$  cm reinforced concrete beam was tested under continuous three-point loading with a loading speed of 1 kN/min (Figure 3a). As shown in Figure 4a, the beam was reinforced with three  $\phi 10$  longitudinal reinforcement bars (rebars) in the tension area and three  $\phi 6$  rebars in the compression area, attached together by four  $\phi 6$  stirrups. The beam was instrumented with SG (green color), LVDT (grey color), Ultra Sonic US (red color) and DFO (blue color) sensors. Before casting of concrete, four US sensors were attached to the stirrups while one optical cable was fixed over the length of four rebars (Figure 3b). After casting, the same optical cable was bonded to the surface of the beam by making a groove in the concrete at the same level of rebars and gluing the optical cable using a two components epoxy adhesive.

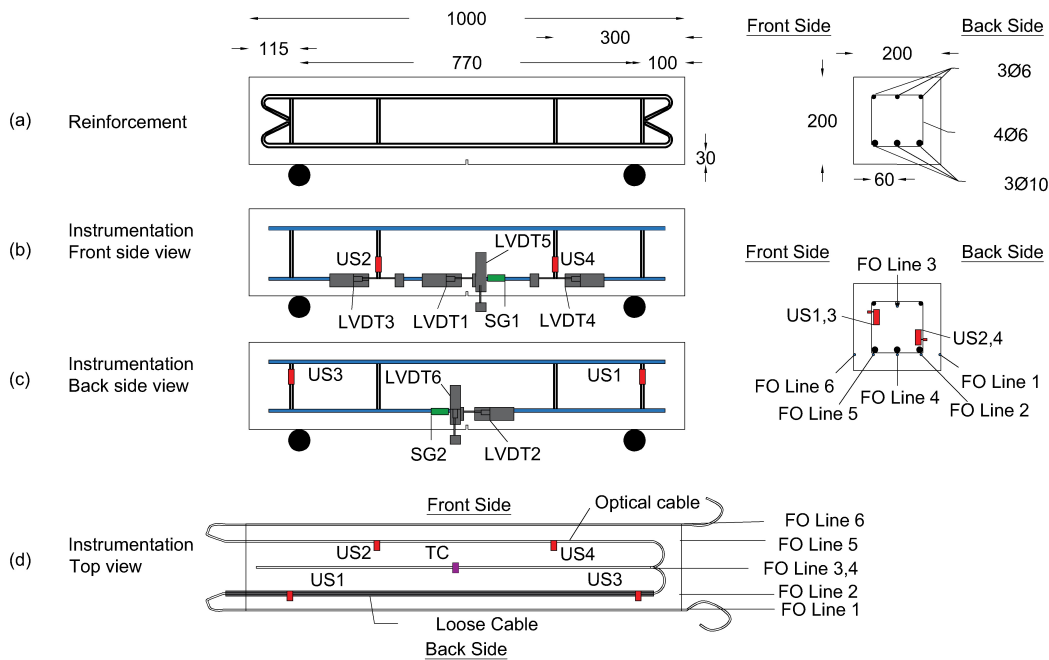
**Figure 4.** (a) dimensions of the beam and different rebars positions; (b) front view of sensors positions; (c) back view of sensors positions; (d) top view of sensors positions.

Figure 4 shows the top view of the optical cable trajectory while respectively:

- Glued on the front surface (Line 1).
- Attached to the front bottom rebar (Line 2). This line was surrounded by a tube to create a loose part for temperature compensation.
- Attached to the mid top rebar (Line 3).
- Attached to the mid bottom rebar (Line 4).
- Attached to the back bottom rebar (Line 5).
- Glued on the back surface (Line 6).

In addition, two LVDT sensors (one from each side) were measuring deflection at the center of the beam, while four other sensors were fixed at the level of rebars for displacement monitoring at specific locations as shown in Figure 4b,c. Moreover, two SG sensors (one from each side) were fixed 6 cm away from the central part of the beam. A thermocouple (purple color), fixed in the central part of the beam, followed low temperature variations (in the order of  $\pm 0.1$  °C) during the test in accordance with those measured all over Line 2 (Figure 4d).

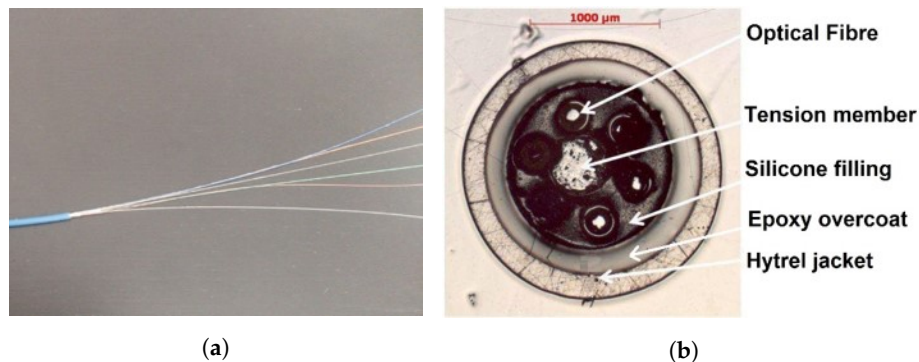
**Figure 5.** (a) Photo of the optical cable. (b) Micrography of different constitutive layers of the optical cable [22].

ODISI-B interrogator (manufactured by Luna, Blacksburg, VA, United States) was chosen for this experiment. Based on Optical Backscattering Reflectometry (OBR) technique, this interrogator can reach a spatial resolution of 5.2 mm with a maximum strain repeatability of  $\pm 10 \mu\text{m}/\text{m}$  and a strain accuracy of  $\pm 25 \mu\text{m}/\text{m}$ . Figure 5 shows the AFL optical cable (from Sensornet, Hertfordshire, United Kingdom) used as a sensor. As shown in Figure 5b, the cable holds six fibers wrapped around a central rod and embedded in a soft polymer matrix. One of the optical fibers was connected to the interrogator and used for performing the measurements.

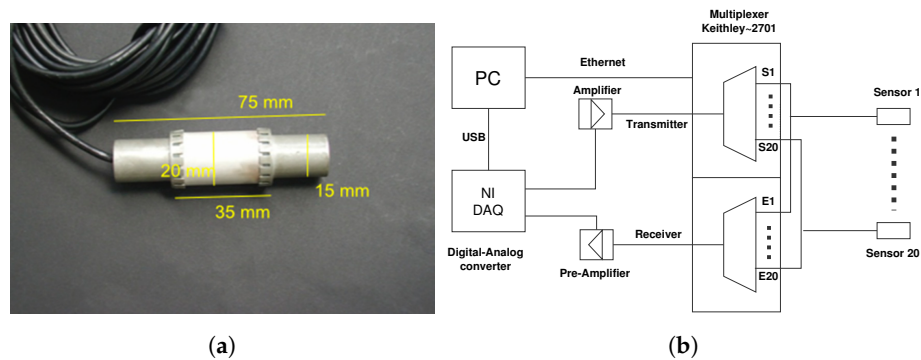
Figure 6. (a) dimensions of “SO807” [34]; (b) diagram of the data acquisition system.

A new embedded ultrasonic transducer “SO807” was used for this experiment. It was designed by Acoustic Control Systems ACS (Sarrebuck, Germany) in cooperation with and exclusively for BAM [34]. The main part of SO807 is a hollow piezo ceramic cylinder (Figure 6a) that can be both transmitter and receiver, and can be installed easily during the construction. The central frequency of this transducer is around 62 kHz. Contrary to classic ultrasonic sensors glued on the structure surface, SO807 is embedded inside the concrete material and thus records fewer surface waves

and is less influenced by near-surface changes (e.g., temperature influence). As shown in Figure 6b, a Keithley 2701 multiplexer (manufactured by Linktronix, Thalwil, Switzerland) was used to switch between different combinations S-E (transmitter-receiver) during the test. This data acquisition system allows autonomous continuous monitoring of the structure with a sampling frequency of 1 MHz.

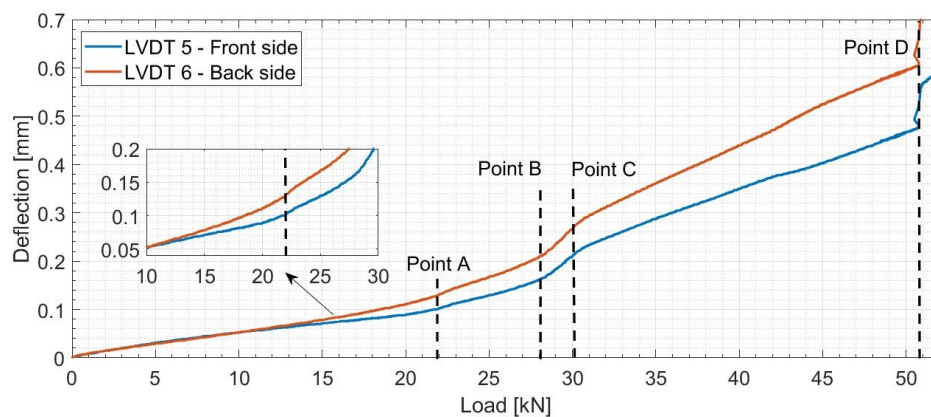
Figure 7. Variation of the vertical deflection in the central part of the beam measured by Linear Variable Differential Transformers (LVDT) sensors.

Back and front side vertical deflection values measured by LVDT sensors are plotted in Figure 7, in which the four marked points mark out each change in the curve shape and therefore a change in the behavior of the reinforced concrete beam.

Point A (load = 22 kN) marks the end of a linear elastic phase and the start of nonlinear behavior of the beam. This nonlinear behavior is due to the initiation of small micro cracks in the central part of the beam where the highest value of bending moment is located. Between Point B and Point C, the beam goes through a remarkable increase in deflection rate. Hence, this state marks a rapid reduction in the stiffness of the beam and therefore high deterioration problems. The jump in deflection observed when the load reached 51 kN (Point D) is believed to be due to the formation of a macro crack. Furthermore, distributed load and geometric imperfections of the beam could explain the difference in front and back side deflection values. This difference becomes more evident after the beam enters its nonlinear state.

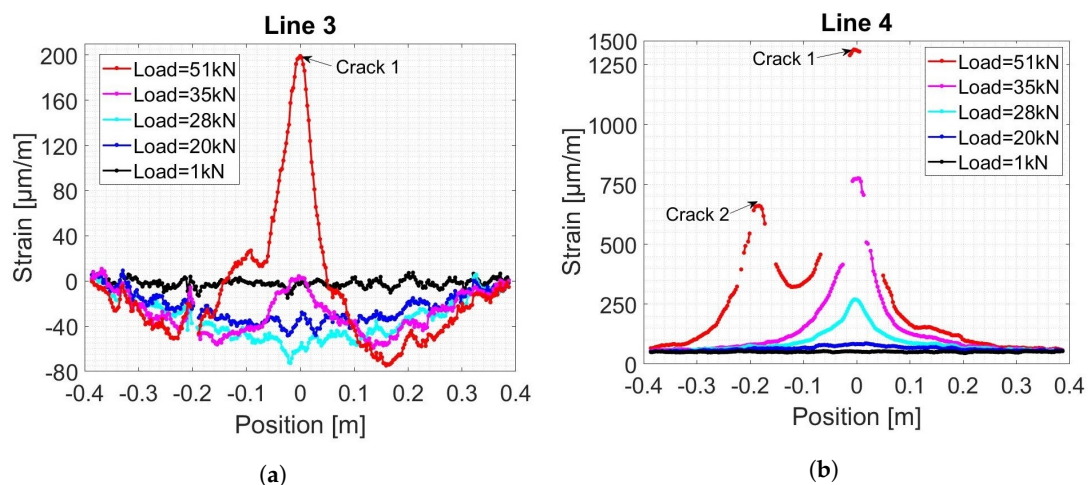
**Figure 8.** Spatial strain distribution in concrete measured by the DFOS system near the top (a) and bottom (b) rebars.

over the length of FO Line 3 (near the top rebars) and Line 4 (near the bottom rebars) at five different load levels is plotted in Figure 8. Fixed at the level of the bottom rebars, Line 4 detects a micro crack when the load level increases from 20 kN to 28 kN. The strain profile evolves exponentially, indicating that a first crack, located near the central part of the beam, reaches the level of the bottom rebars. For regular concrete, the strain in the tension part does not exceed  $100 \mu\text{m}/\text{m}$ . With the increase in the crack opening, strain reigning in concrete material becomes therefore negligible when compared to the CIS that extends spatially to more than 40 cm of the length of the cable. On the other hand, FO Line 3 fixed at the top rebars shows the negative triangular strain distribution in the compression part of the beam. Strain profile at 35 kN load level shows higher values in its central part. The exponential shape indicates that the same crack propagates over the height of the beam until reaching top rebars. When the load reaches 51 kN, strain distribution in Line 4 shows another exponential increase indicating that a second micro crack appears around 20 cm from the center of the beam. While COD value increases, and due to rapid strain transitions near the crack location, a high number of dropouts are filtered by ODISI-B interrogator software (Version 5.2.2).

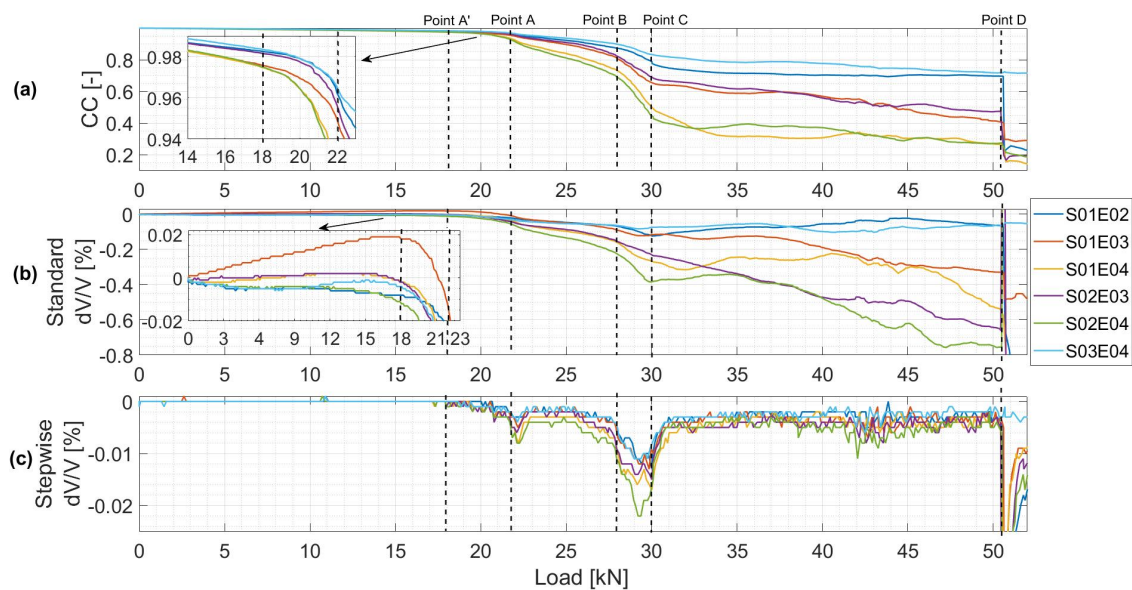
**Figure 9.** (a) CC plots for each  $S_{xx}E_{yy}$  combination. (b)  $dV/V$  plots for each  $S_{xx}E_{yy}$  combination. (c) Stepwise  $dV/V$  plots for each  $S_{xx}E_{yy}$  combination.

The CC and  $dV/V$  values, calculated by standard and stepwise CWI for all different combinations of sensors  $S_{xx}E_{yy}$  (transmitter  $xx$  and receiver  $yy$ ), are plotted in Figure 9. A reference signal was chosen for standard CWI calculations before any load was applied. The CC values for all different combinations decrease as the load increases continuously during the test (Figure 9a). CC and deflection plots took a similar trend as they are related to the stiffness of the reinforced concrete beam. As micro cracks propagate over the height of the beam, the similarity between the ultrasonic signals reduces and is accompanied by a rapid decrease in CC values. Similarly, standard  $dV/V$  values decrease during the test depending on stress changes and positions of the sensors (Figure 9b). During the linear elastic state, these values vary between 0.02% and  $-0.01\%$  for S01E03 and S02E04 combinations where the two sensors were positioned, respectively, in the upper and bottom part of the beam. While  $dV/V$  decreases for combination S02E04, S01E03  $dV/V$  increases linearly with the increase in compression stresses in the upper part of the beam. Indeed, the stress–velocity variation coefficient changes between different combinations depending on the location and the distance between the two transducers [34]. Local velocity changes compared with the previous signal are observed clearly from stepwise  $dV/V$  (Figure 9c). The changes in stepwise  $dV/V$  plots help distinguishing four main remarkable load levels similar to those observed in the deflection plots. CWI results and their relation to damage propagation will be discussed and compared with other sensors in Section 5.1.3.

The formation of crack 1 is first detected by US and DFO sensors. When the load exceeded 18 kN, a first variation in velocity for S02E04 combination is observed from stepwise  $dV/V$  plot (Figure 9c). This decrease in  $dV/V$  followed shortly by other combinations is due to the propagation of the micro crack. The standard  $dV/V$  plots show that this fall in  $dV/V$  value is the highest between the two closest transducers located on the bottom part of the beam (combination S02E04). On the other hand, the smallest variations are observed for combinations S01E02 and S03E04 as the direct waves between these transducers do not bridge through the crack. CC plots follow a similar trend as  $dV/V$  plots.

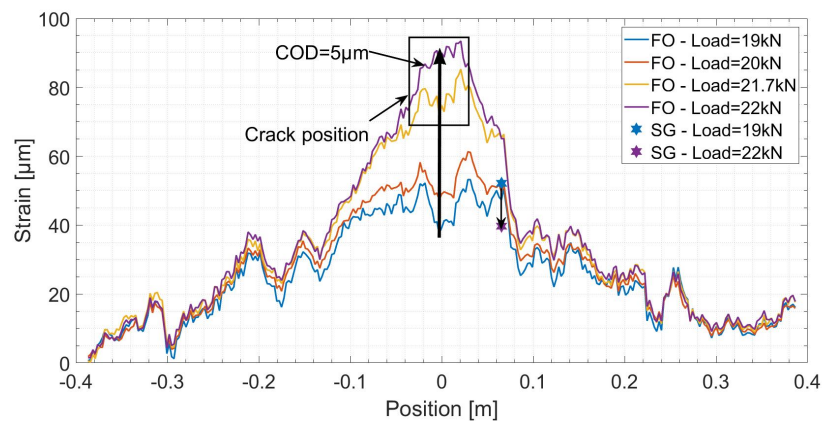
**Figure 10.** Spatial strain distribution over the length of Fiber Optics (FO) Line 1 before and after the creation of the first micro crack.

Figure 10 shows the measured strain versus the position for different load levels. For the specific (cable, glue, concrete) combination used in this experimentation, a crack opening of  $5\ \mu\text{m}$  resulted in an increase to 200% in the strain measured near the location of the crack. On the other hand, the strain measured by SG sensors decreased to 80% at 6 cm far from the crack location. If the crack location were closer to the SG sensors, a bigger rate of strain decrease would have been detected. However, if the crack bridged through the SG sensor, high strain values would have been measured. Since these two cases are rare when instrumenting real scale structures, crack detection using SG sensors is in most cases an indirect detection.

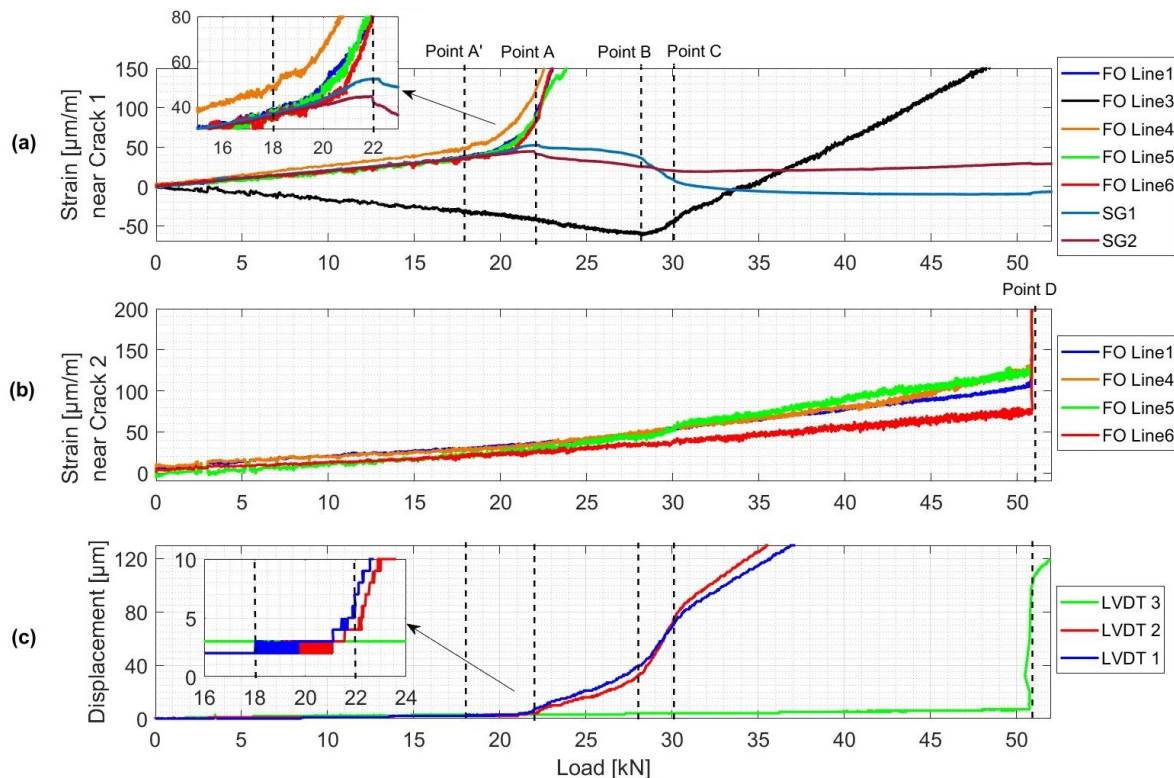
**Figure 11.** (a) Strain variations measured by FO lines and SG sensors near Crack 1. (b) Strain variations measured by FO lines near Crack 2. (c) Horizontal displacements measured by LVDT sensors.

While Figure 9 presents the results of CC and  $dV/V$  calculated from US sensors measurements, Figure 11 shows the DFO strain measurements at the location of cracks 1 and 2 compared to displacements (crack openings) and strains measured respectively by LVDT (1, 2, 3) and SG (1, 2). Cracks 1 and 2 refer to the first crack detected at the center of the beam and the second one 20 cm away from the center (monitored by LVDT 3).

Likewise, FO Line 1 and 4 present first an increase in strain variation near 18 kN, followed shortly by Line 5 and 6 near 20 kN (Figure 11a). However, the change in LVDT 1 and LVDT 2 measurements due to the crack opening occurred when the load reached 21 kN with higher values on the front side of the beam (Figure 11c). The creation of Crack 1 was the reason behind a strain release in concrete. This decrease in strain was detected by SG (1, 2) 6 cm from the crack location near 22 kN (Figure 11a). Finally, LVDT 3 did not show any change in measured displacement.

18 kN and 28 kN. When Crack 1 approaches top rebars, a high  $dV/V$  and  $CC$  changing rates are observed signaling a rapid crack propagation between the top rebars level and the top of the beam until the load reached 30 kN. The beam is then divided into two parts and therefore  $dV/V$  values started increasing for combinations  $S01E02$  and  $S03E04$  (Figure 9b). The fact that the top rebars started working in tension near the crack introduced a sort of asymmetrical damage propagation in the beam. This can be observed from LVDT (1, 2) and SG (1, 2) measurement plots where the CODs and strains measured on the back side of the beam reached higher values than those on the front side between 28 kN and 31 kN (Figure 11c).

When load reached 51 kN, Crack 2 suddenly appeared at 20 cm from the center of the beam. The fact that the crack reached instantaneously a COD of 100  $\mu\text{m}$  led to high variations in strain measured by FO Line (1, 4, 5, 6) (Figure 11b). For US measurement, the  $CC$  and  $dV/V$  for all combinations, except  $S03E04$ , changed significantly (Figure 9). Indeed, transducers (03, 04) are located on the other side of the beam and direct waves do not pass through the second crack. Another piece of compelling evidence is that the beam was separated into two parts.

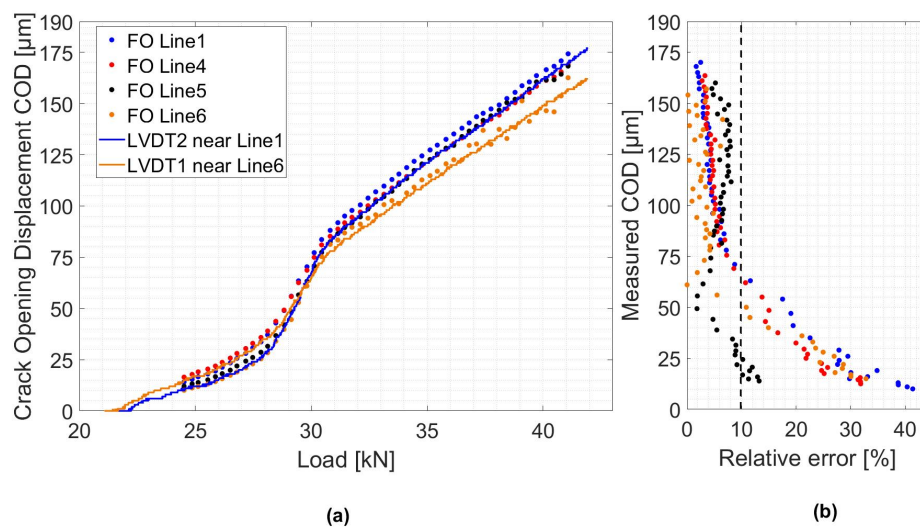
**Figure 12.** (a) Estimated crack openings compared to LVDT measurements. (b) Relative error compared to LVDT measurements.

As mentioned in Section 5.1.1, the CIS distribution (Equation 1) was fitted to the measured strain profiles using the least square method.  $\delta$  and  $\beta$  were selected as variable parameters. Figure 12a shows a comparison between the estimated CODs from different FO Lines and those measured with LVDT sensors. The measured CODs near FO lines 4 and 5 are first determined by assuming a linear variation between the front and back sides values measured by LVDT 1 and 2. Then, the absolute relative error values for each FO Line are calculated (Figure 12b). For all different FO Lines, a relative error of less than 10% is achieved when the COD exceeds 65  $\mu\text{m}$ . While a better accuracy is reached with the increase in the COD, the number of dropout points increases. As a result, and due to a lack of measurement values near the crack location, the fit does not converge for CODs exceeding 175  $\mu\text{m}$ .
