Development of the symmetrical laser shock test for weak bond inspection

M. Sagnard^{a,*}, R. Ecault^b, F. Touchard^c, M. Boustie^c, L. Berthe^a

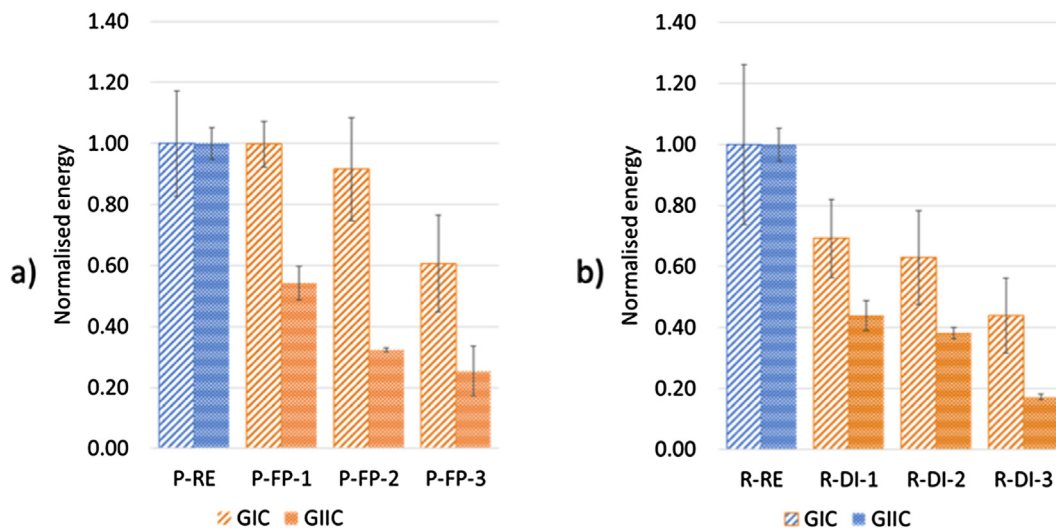
Fig. 5. Mechanical tests for: (a) the production reference sample (P-RE) and the three levels of finger print contamination, low (P-FP-1), medium (P-FP-2) and high (P-FP-3) – (b) the repair reference sample (R-RE) and the three levels of de-icing fluid contamination, low (R-DI-1), medium (R-DI-2) and high (R-DI-3) [22,23].

Fig. 5(a) summarizes the mechanical test results obtained for the production reference, P-RE, sample (blue) and the finger print contamination (orange), and Fig. 5(b) for the repair reference, R-RE, sample (blue) and de-icer contamination (orange). To ease later

comparison with the LASAT, all values have been normalised by the reference sample value. Hence the de-icer results have been normalised using the sound repair sample threshold, and the finger print one by the reference production sample.

Both the GIC and GIIC tests show a general decrease of the bond strength after the contamination. However, because the range of GIC tests' uncertainty bars for a sound and a contaminated sample were overlapping, no direct conclusion could be drawn out. GIIC tests were more consistent and confirmed the loss of adherence/mechanical strength of the contaminated samples.
