Development of the symmetrical laser shock test for weak bond inspection

M. Sagnard^{a,*}, R. Ecault^b, F. Touchard^c, M. Boustie^c, L. Berthe^a

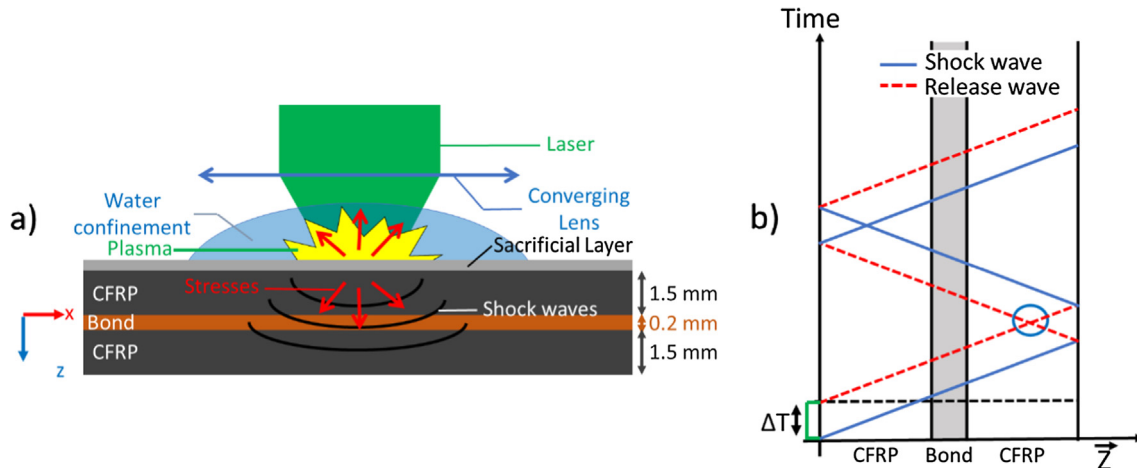
Fig. 1. (a) Representation of a typical LASAT experimental setup and (b) Space-time diagram of a single shot LASAT.

The LASAT uses a laser pulse to generate shock waves within a test sample. Upon reaching the surface of the specimen, the laser creates a dense plasma through the vaporisation of a few micrometres of material. By expanding, the high-pressure plasma transmits part of its energy to the sample in the form of shock waves. Fig. 1(a) depicts this laser shock phenomenon on a bonded Carbon Fibre Reinforced Polymer (CFRP) sample. The sacrificial layer (in grey) is an aluminium adhesive tape (35 μm) which serves two main purposes. It primarily protects the sample from being partially vaporised, instead, it is the aluminium which is sublimated to generate the plasma. Secondly, the pressure generated by this technique highly depends on the laser/matter interaction. By always using the same sacrificial layer, one ensures the interaction – and thus the loading – is the same regardless of the sample material.

The purpose of the confinement material is to increase the generated pressure within the material. It has been shown that such configuration can help reach up to four times the pressure created without any constraining medium [15]. For the coupon samples, water was used as a confinement medium.

The space/time diagram Fig. 1(b) describes the shock wave's

behaviour within the material. The front of the shock wave is represented using solid lines. The release wave, that sets the material back to its initial state, is represented using dotted lines. The shock wave travels all the way to the back-face of the sample and turns into a release wave. Upon crossing the initial release wave, the reflected shock wave generates a high tensile stress (full circle). For a given material, the position of this high tensile stress simply depends on the shock duration which is defined by the laser's pulse duration ΔT .

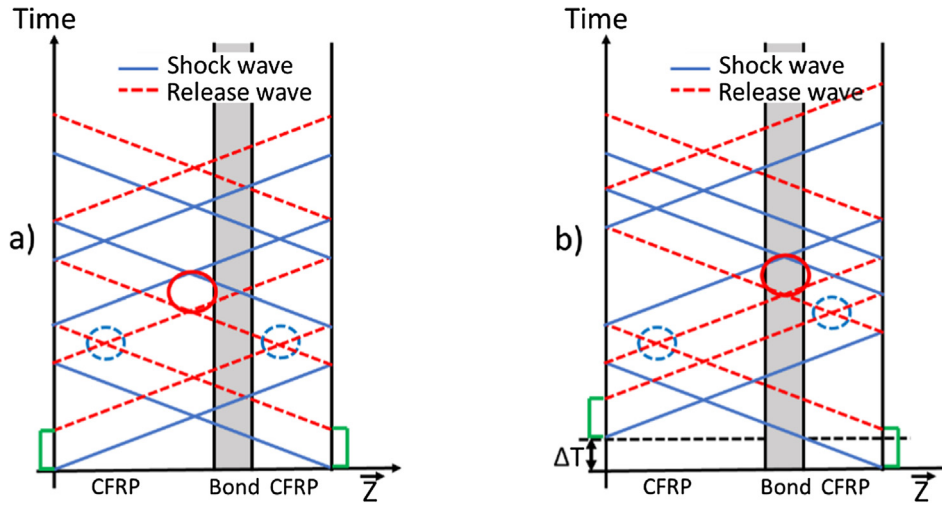
Fig. 2. Time/space diagram of S-LASAT shots: (a) without time delay and (b) with a time delay.

The Symmetrical LAsER Shock Adhesion Test (S-LASAT [19,20]) is proposed to overcome this limitation. This technique consists of generating shock waves from both sides of the tested specimen. As for the single shot setup, high tensile areas are generated on each opposite side of the sample (dotted circles in Fig. 2(a)). However, a higher tensile stress is created at the intersection of the two reflected shock waves (solid circle) and its location does not exclusively rely on the pulse duration.

The high tensile stress location can be shifted by applying a time delay between each laser pulse (Fig. 2(b)). The required time delay can be calculated using Eq. (1):

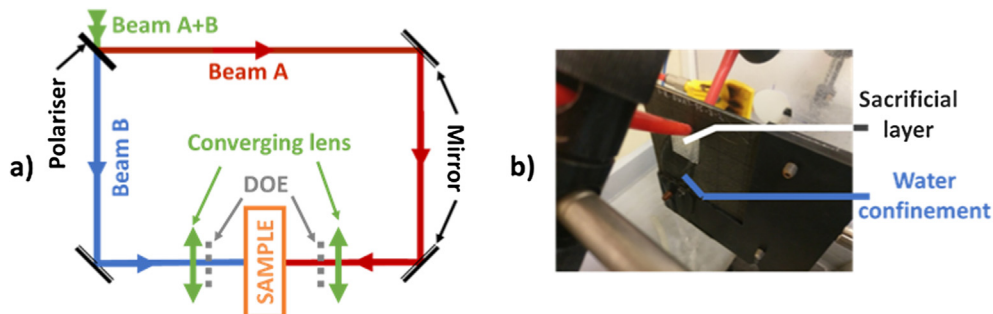
Fig. 3. (a) Schema of the experimental setup. (b) Close up on the sample setup.

A Nd:Yag laser is used to generate a pulse of 7 ns which can deliver up to 2x7J. To create a symmetrical shot, the Gaïa laser used on the Hephaïstos platform is composed of two lasers which beams are polarised by 90° from one another. Thanks to a polariser, two distinct beams, referred to as Beam A and Beam B, are created and transported through optics to both sides of the tested sample (Fig. 3(a)).

Prior to the shot, the tested area was protected using an aluminium adhesive tape, and the zone was confined using a water trickle to make sure at least 1 mm of water covered the sample during the test (Fig. 3(b)).

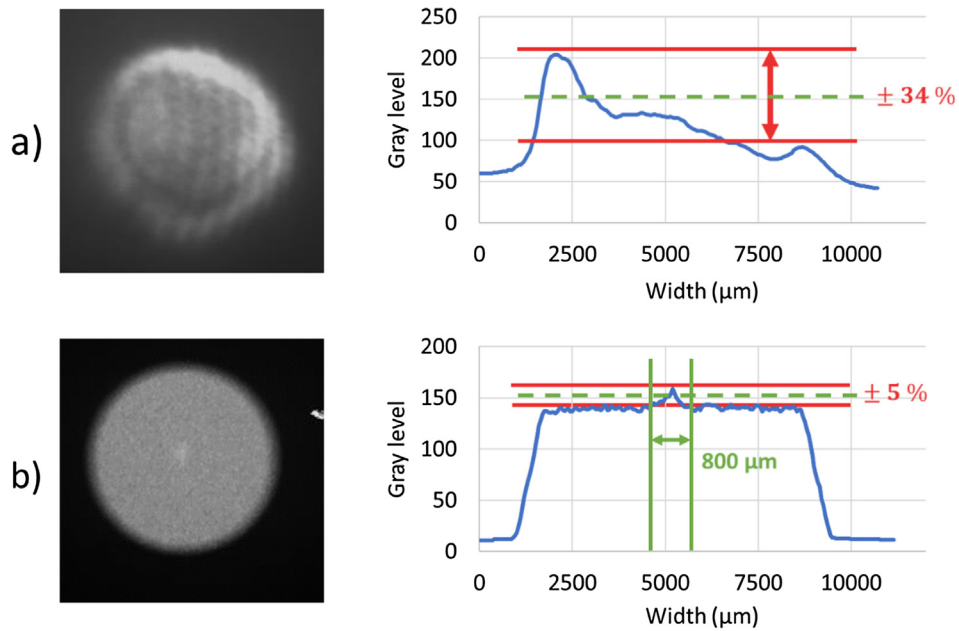
Fig. 4. Spatial repartition of the laser intensity on beam A (a) before DOE were included in the experimental setup and (b) after DOE were included in the experimental setup.

Compared to the last work [13], Diffractive Optical Elements (DOE) were added on both beam paths. This optics makes for a better control of the spatial repartition of the pressure on top of the sample. These serve to break down the initial laser beam, and reform it to assure a good homogeneity of the laser at the focal spot. Fig. 4(a) shows the laser repartition, at the focal spot, with and without DOE. One can observe a wide important intensity variation before the DOE ($\pm 34\%$ compared to the mean value). Moreover, this variation occurred over the whole spot area. After these optics were included in the experimental setup, a much smoother repartition can be observed (Fig. 4(b)), very close from a top-hat signal, with only a small and very localised intensity variation.

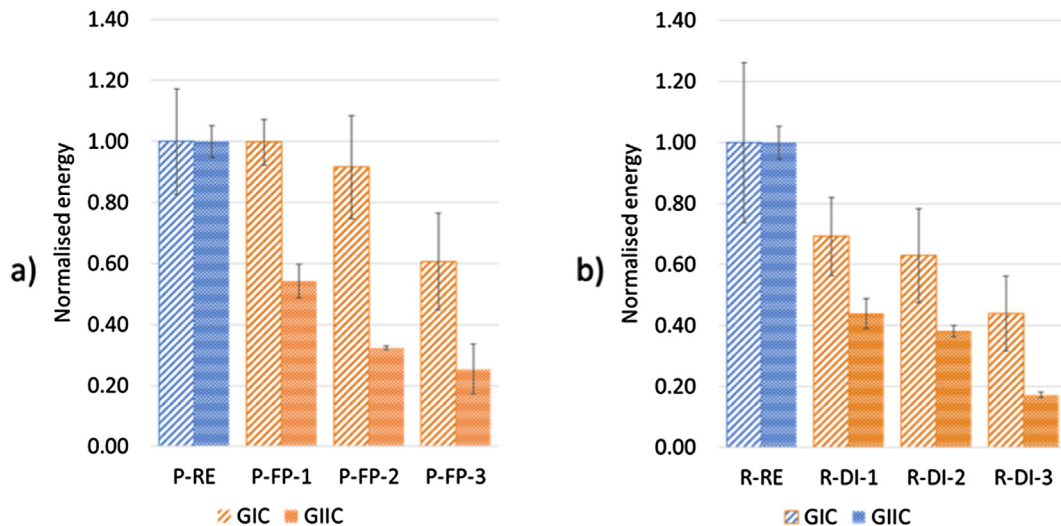
Fig. 5. Mechanical tests for: (a) the production reference sample (P-RE) and the three levels of finger print contamination, low (P-FP-1), medium (P-FP-2) and high (P-FP-3) – (b) the repair reference sample (R-RE) and the three levels of de-icing fluid contamination, low (R-DI-1), medium (R-DI-2) and high (R-DI-3) [22,23].

Fig. 5(a) summarizes the mechanical test results obtained for the production reference, P-RE, sample (blue) and the finger print contamination (orange), and Fig. 5(b) for the repair reference, R-RE, sample (blue) and de-icer contamination (orange). To ease later

comparison with the LASAT, all values have been normalised by the reference sample value. Hence the de-icer results have been normalised using the sound repair sample threshold, and the finger print one by the reference production sample.

Both the GIC and GIIC tests show a general decrease of the bond strength after the contamination. However, because the range of GIC tests' uncertainty bars for a sound and a contaminated sample were overlapping, no direct conclusion could be drawn out. GIIC tests were more consistent and confirmed the loss of adherence/mechanical strength of the contaminated samples.

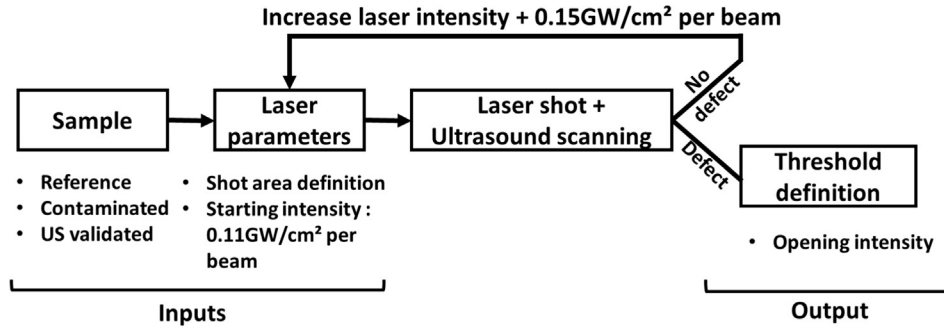
Fig. 6. Block scheme of the experimental procedure.

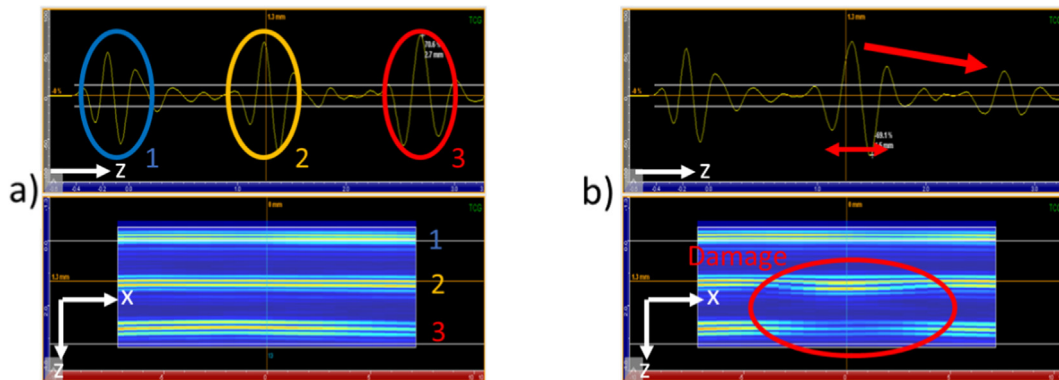
Fig. 7. A-Scan and B-Scan of the bonded CFRP assembly: (a) no damage (b) with damage.

For ultrasonic testing, a 32 elements linear probe was used, with a frequency of 5 MHz. CFRPs act as a low-pass filter, limiting the probe scanning frequency. The sample is composed of three different layers: a CFRP laminate, the adhesive bond, and the second CFRP laminate. Each one of these layers has a specific material impedance that is detected by ultrasounds. Fig. 7(a) is a typical signal obtained for a sound sample. The upper signal is a A-Scan. It is a 1D local measurement and each spike (marked 1, 2 and 3) is due to an impedance modification in the scanned part. In this case, 1 is the signal obtained when the ultrasonic wave first encounters the sample, 2 is the signature signal of the adhesive bond, and 3 is the signal obtained when ultrasounds reach the back of the sample. The lower image, called B-Scan, is a 2D cross-section cartography of the sample.

Ultrasounds cannot go through empty area, typically here disbondings. The signal is blocked, and little to no information is available after the opening. With A-Scan, it can be spotted by a loss of amplitude of one of the echoes. For example, the A-Scan from Fig. 7(b) shows a loss of signal from the back-face echo (3) as well as a widening of the bond echo. The B-Scan confirms the damage location on the bond, and thus, the occultation of the signal below it. Each time the sample was scanned from both sides to assure no defaults were hidden by the damaged bond.

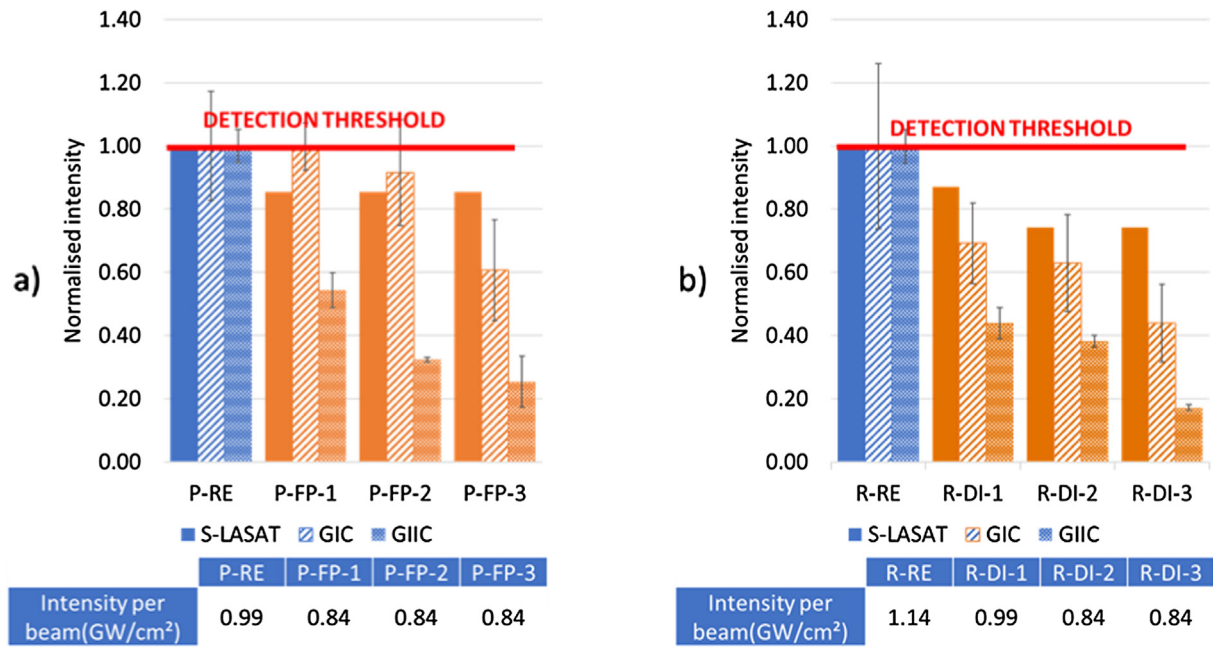
Fig. 8. Normalised results comparison between S-LASAT and the mechanical tests for: (a) the production reference sample (P-RE) and the three levels of finger print contamination, low (P-FP-1), medium (P-FP-2) and high (P-FP-3) – (b) the repair reference sample (R-RE) and the three levels of de-icing fluid.

Results for the finger print and the di-icer contaminations are presented in Fig. 8. To confirm the ability of the S-LASAT to spot a specific contamination, the measured energy required to open the faulty bond must be lower than the one obtained for the reference sample. Since data has been normalised, a contamination correctly isolated must be below the 1.0 mark (represented by the red line entitled “detection threshold” in Fig. 8).

As the GIC and GIIC test showed, the contamination of the sample modified the adherence strength of the sample. The S-LASAT showed the same results: a contaminated bond requires less laser intensity loading to be opened than a healthy one. The same observation was made for both contaminations.

In the case of the finger print sample, the technique did not differentiate the three levels of contamination. However, unlike standard mechanical tests that apply a constant load increase, the LASAT was performed using a load step, limiting the results’ accuracy. A smaller intensity step size could give more precise results. However, even with

such intervals, the technique was able to differentiate the second and third level of the de-icer contamination.

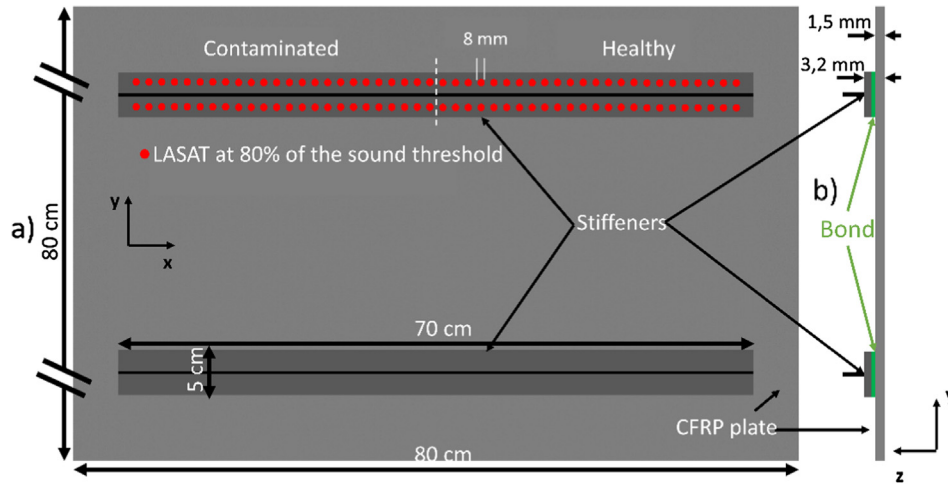
Fig. 10. Production panel: (a) front view with laser shot position and (b) side view with specified thicknesses.

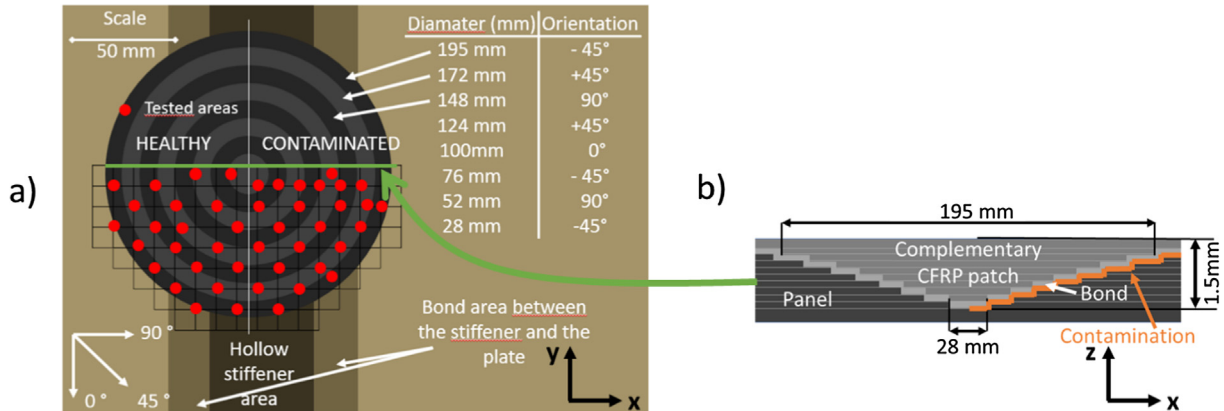
Fig. 11. (a) figure of the shot pattern realised on the repair panel and (b) cross-section of the repair patch geometry.

The repair panel has been cut out of a A350 structure. The middle part of the sample has been grinded all the way to the fibres in a conic shape. Half of the surface was contaminated with both finger print and de-icing fluid solutions (Fig. 11(b)). The hole created in the panel was then patched, starting from the centre to the edge, with the missing CFRP ring (cf. Fig. 11(b)) while keeping the original lay-up of the part (ring diameter and orientation in Fig. 11(a)). The composite was then cured by GMI's tool ANITA EZ0901 hot bonder.

This part had hollow stiffeners on one side, making it impossible to test in this area using a symmetrical shot configuration. It is represented by the dark bar on Fig. 11(a): the darker section is the hollow part and the lighter sections on either side show the areas where the stiffener is assembled onto the panel. Thus, there is a total of three different areas on the patch. The first one only features the repair patch. The S-LASAT

can be applied normally (Fig. 11(b)). The second area above the hollow part was tested using the single shot setup since only one face was available. The third one features both the patch and the zone where the stiffeners have been bonded. These areas then have two bonds: the first one between the plate and the stiffener, and a second one between the plate and the repair patch. S-LASAT can be used, but the extra thickness coming from the stiffeners must be considered.
