## Development of the symmetrical laser shock test for weak bond inspection

Maxime Sagnard, Romain Ecault, F. Touchard, M. Boustie, Laurent Berthe

Maxime Sagnard, Romain Ecault, F. Touchard, M. Boustie, Laurent Berthe. Development of the symmetrical laser shock test for weak bond inspection. *Optics and Laser Technology*, 2019, 111, pp.644-652. 10.1016/j.optlastec.2018.10.052 . hal-02063467

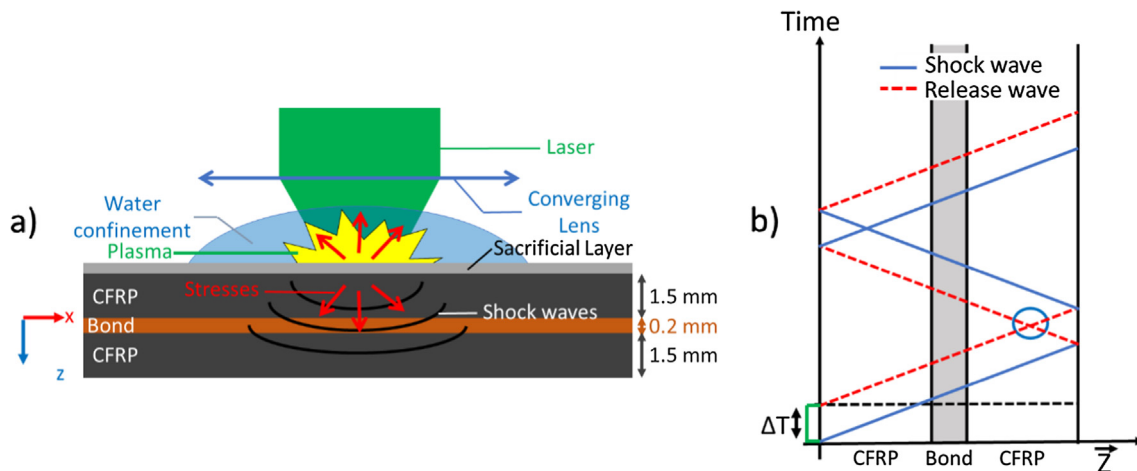
Fig. 1. (a) Representation of a typical LASAT experimental setup and (b) Space-time diagram of a single shot LASAT.

The LASAT uses a laser pulse to generate shock waves within a test sample. Upon reaching the surface of the specimen, the laser creates a dense plasma through the vaporisation of a few micrometres of material. By expanding, the high-pressure plasma transmits part of its energy to the sample in the form of shock waves. Fig. 1(a) depicts this laser shock phenomenon on a bonded Carbon Fibre Reinforced Polymer (CFRP) sample. The sacrificial layer (in grey) is an aluminium adhesive tape (35  $\mu\text{m}$ ) which serves two main purposes. It primarily protects the sample from being partially vaporised, instead, it is the aluminium which is sublimated to generate the plasma. Secondly, the pressure generated by this technique highly depends on the laser/matter interaction. By always using the same sacrificial layer, one ensures the interaction – and thus the loading – is the same regardless of the sample material.

The space/time diagram Fig. 1(b) describes the shock wave's

behaviour within the material. The front of the shock wave is represented using solid lines. The release wave, that sets the material back to its initial state, is represented using dotted lines. The shock wave travels all the way to the back-face of the sample and turns into a release wave. Upon crossing the initial release wave, the reflected shock wave generates a high tensile stress (full circle). For a given material, the position of this high tensile stress simply depends on the shock duration which is defined by the laser's pulse duration  $\Delta T$ .

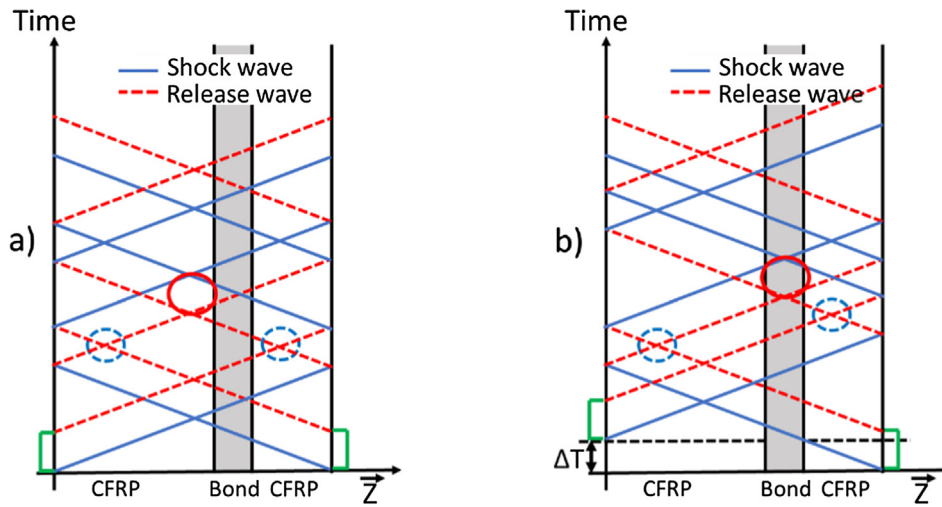
Fig. 2. Time/space diagram of S-LASAT shots: (a) without time delay and (b) with a time delay.

The Symmetrical LAsER Shock Adhesion Test (S-LASAT [19,20]) is proposed to overcome this limitation. This technique consists of generating shock waves from both sides of the tested specimen. As for the single shot setup, high tensile areas are generated on each opposite side of the sample (dotted circles in Fig. 2(a)). However, a higher tensile stress is created at the intersection of the two reflected shock waves (solid circle) and its location does not exclusively rely on the pulse duration.

The high tensile stress location can be shifted by applying a time delay between each laser pulse (Fig. 2(b)). The required time delay can be calculated using Eq. (1):

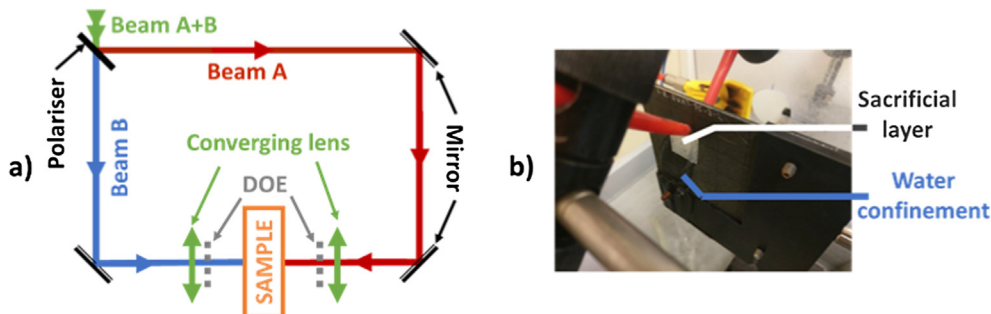
Fig. 3. (a) Schema of the experimental setup. (b) Close up on the sample setup.

A Nd:Yag laser is used to generate a pulse of 7 ns which can deliver up to  $2 \times 7 \text{ J}$ . To create a symmetrical shot, the Gaïa laser used on the Hephaïstos platform is composed of two lasers which beams are polarised by  $90^\circ$  from one another. Thanks to a polariser, two distinct beams, referred to as Beam A and Beam B, are created and transported through optics to both sides of the tested sample (Fig. 3(a)).

Prior to the shot, the tested area was protected using an aluminium adhesive tape, and the zone was confined using a water trickle to make sure at least 1 mm of water covered the sample during the test (Fig. 3(b)).

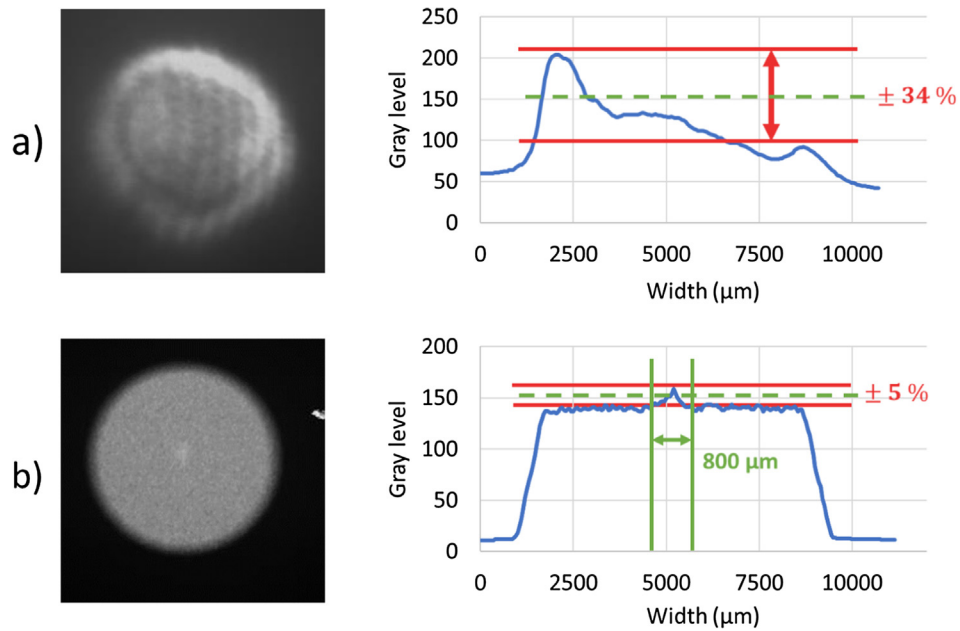
Fig. 4. Spatial repartition of the laser intensity on beam A (a) before DOE were included in the experimental setup and (b) after DOE were included in the experimental setup.

Compared to the last work [13], Diffractive Optical Elements (DOE) were added on both beam paths. This optics makes for a better control of the spatial repartition of the pressure on top of the sample. These serve to break down the initial laser beam, and reform it to assure a good homogeneity of the laser at the focal spot. Fig. 4(a) shows the laser repartition, at the focal spot, with and without DOE. One can a wide important intensity variation before the DOE ( $\pm 34\%$  compared to the mean value). Moreover, this variation occurred over the whole spot area. After these optics were included in the experimental setup, a much smoother repartition can be observed (Fig. 4(b)), very close from a top-hat signal, with only a small and very localised intensity variation.

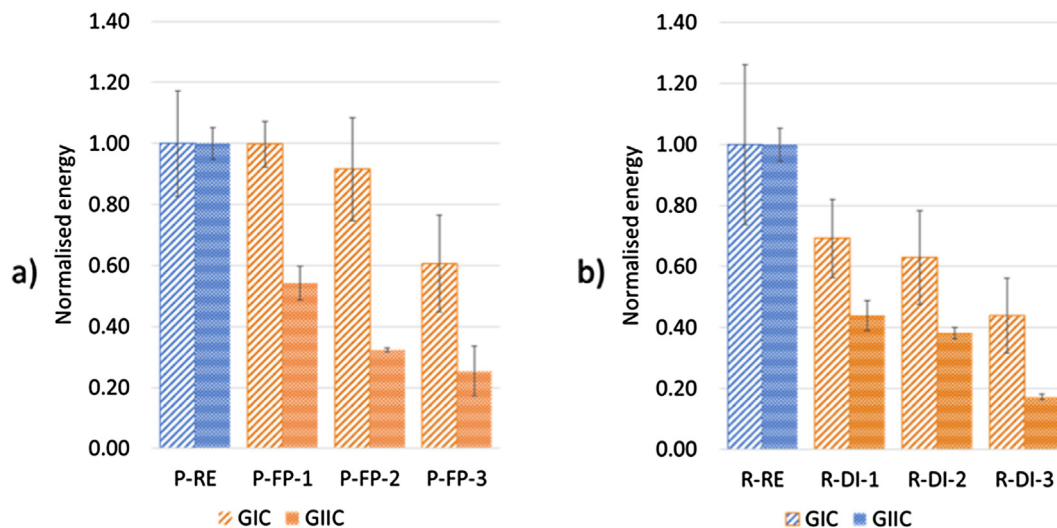
Fig. 5. Mechanical tests for: (a) the production reference sample (P-RE) and the three levels of finger print contamination, low (P-FP-1), medium (P-FP-2) and high (P-FP-3) – (b) the repair reference sample (R-RE) and the three levels of de-icing fluid contamination, low (R-DI-1), medium (R-DI-2) and high (R-DI-3) [22,23].

Fig. 5(a) summarizes the mechanical test results obtained for the production reference, P-RE, sample (blue) and the finger print contamination (orange), and Fig. 5(b) for the repair reference, R-RE, sample (blue) and de-icer contamination (orange). To ease later

comparison with the LASAT, all values have been normalised by the reference sample value. Hence the de-icer results have been normalised using the sound repair sample threshold, and the finger print one by the reference production sample.

Both the GIC and GIIC tests show a general decrease of the bond strength after the contamination. However, because the range of GIC tests' uncertainty bars for a sound and a contaminated sample were overlapping, no direct conclusion could be drawn out. GIIC tests were more consistent and confirmed the loss of adherence/mechanical strength of the contaminated samples.

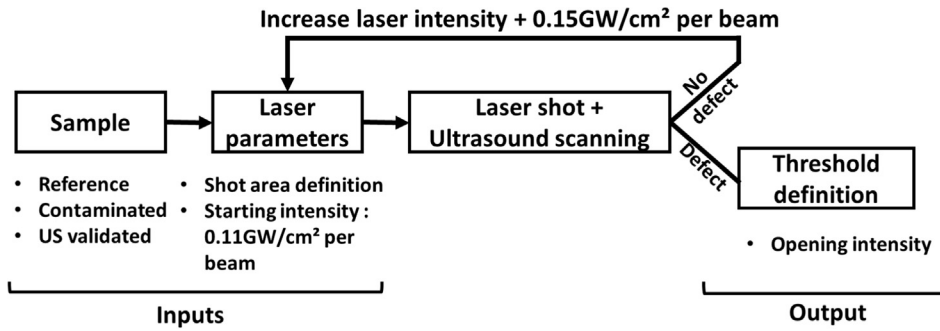
Fig. 6. Block scheme of the experimental procedure.

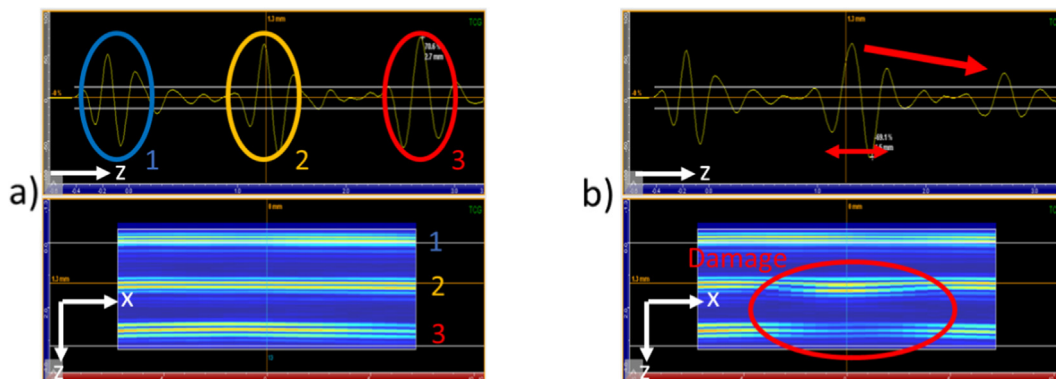
Fig. 7. A-Scan and B-Scan of the bonded CFRP assembly: (a) no damage (b) with damage.

For ultrasonic testing, a 32 elements linear probe was used, with a frequency of 5 MHz. CFRPs act as a low-pass filter, limiting the probe scanning frequency. The sample is composed of three different layers: a CFRP laminate, the adhesive bond, and the second CFRP laminate. Each one of these layers has a specific material impedance that is detected by ultrasounds. Fig. 7(a) is a typical signal obtained for a sound sample. The upper signal is a A-Scan. It is a 1D local measurement and each spike (marked 1, 2 and 3) is due to an impedance modification in the scanned part. In this case, 1 is the signal obtained when the ultrasonic wave first encounters the sample, 2 is the signature signal of the adhesive bond, and 3 is the signal obtained when ultrasounds reach the back of the sample. The lower image, called B-Scan, is a 2D cross-section cartography of the sample.

Ultrasounds cannot go through empty area, typically here disbondings. The signal is blocked, and little to no information is available after the opening. With A-Scan, it can be spotted by a loss of amplitude of one of the echoes. For example, the A-Scan from Fig. 7(b) shows a loss of signal from the back-face echo (3) as well as a widening of the bond echo. The B-Scan confirms the damage location on the bond, and thus, the occultation of the signal below it. Each time the sample was scanned from both sides to assure no defaults were hidden by the damaged bond.

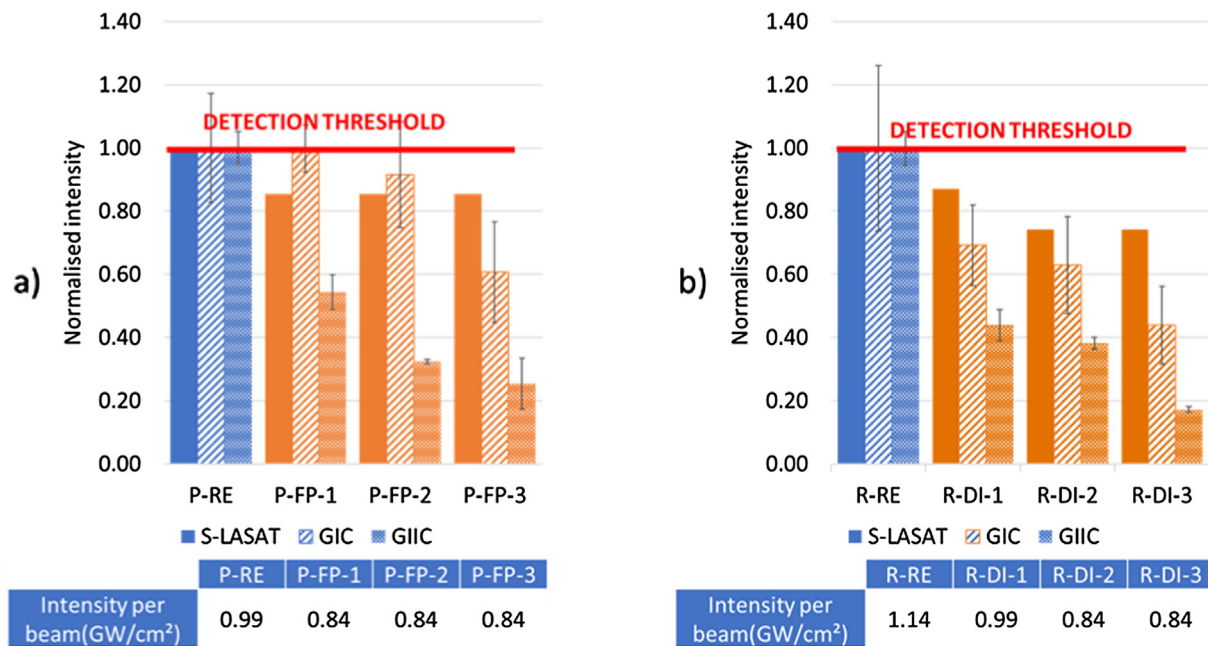
Fig. 8. Normalised results comparison between S-LASAT and the mechanical tests for: (a) the production reference sample (P-RE) and the three levels of finger print contamination, low (P-FP-1), medium (P-FP-2) and high (P-FP-3) – (b) the repair reference sample (R-RE) and the three levels of de-icing fluid.

Results for the finger print and the di-icer contaminations are presented in Fig. 8. To confirm the ability of the S-LASAT to spot a specific contamination, the measured energy required to open the faulty bond must be lower than the one obtained for the reference sample. Since data has been normalised, a contamination correctly isolated must be below the 1.0 mark (represented by the red line entitled “detection threshold” in Fig. 8).

As the GIC and GIIC test showed, the contamination of the sample modified the adherence strength of the sample. The S-LASAT showed the same results: a contaminated bond requires less laser intensity loading to be opened than a healthy one. The same observation was made for both contaminations.

In the case of the finger print sample, the technique did not differentiate the three levels of contamination. However, unlike standard mechanical tests that apply a constant load increase, the LASAT was performed using a load step, limiting the results’ accuracy. A smaller intensity step size could give more precise results. However, even with

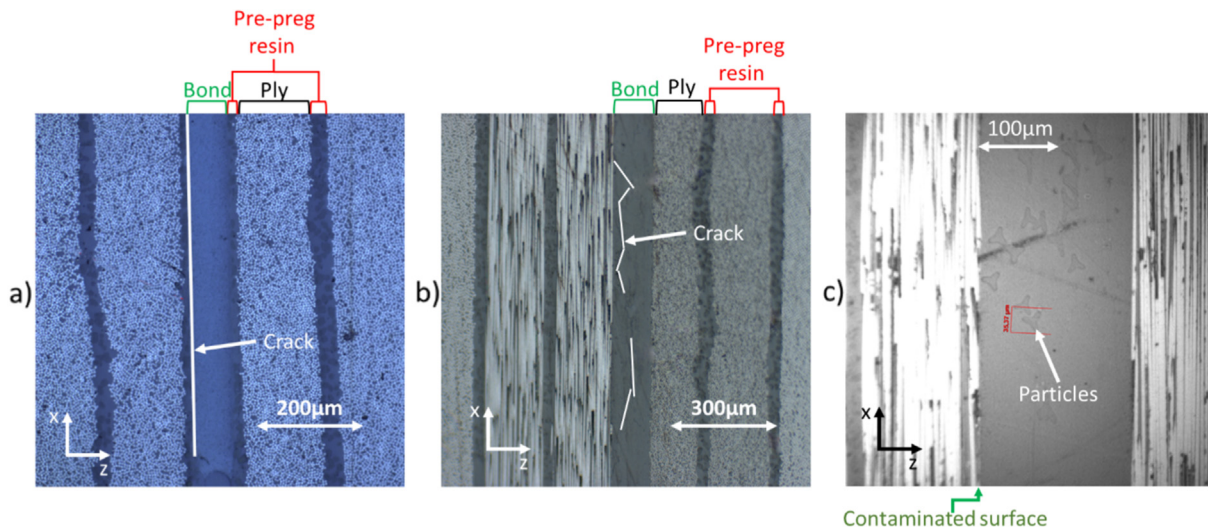
Fig. 9. Photomicrographs of the bond after damage created by S-LASAT: (a) production reference sample [13], (b) repair reference sample [13], and (c) highest degree of de-icing fluid contamination.

Important differences have been spotted however when comparing the damage patterns of the repair and production reference samples. In the production reference sample, the disbonding seemed to propagate mainly between the epoxy from the pre-impregnated CRFP and the

bond (Fig. 9(a)). However, cracks appeared primarily in the centre of the bond for a repair sample (Fig. 9(b)). The difference of bonding surfaces (CFRP fibres vs epoxy) could explain this variance as well as the presence of the knit carrier within the production bond.

Following the same study process, micrographs were realised on both sets of contaminated samples. The damage inside the FP contaminated samples was similar to the one observed before: creation of a disbonding between the epoxy from the pre-impregnated CFRP and the bond. However, no clear crack pattern was found for DI samples, instead microcracks were observed. This type of defect is harder to detect using linear ultrasounds and may not be spotted in the case of a lower contamination. A closer study of the specimen also revealed particles probably from the Safeway KF (Fig. 9(c)).

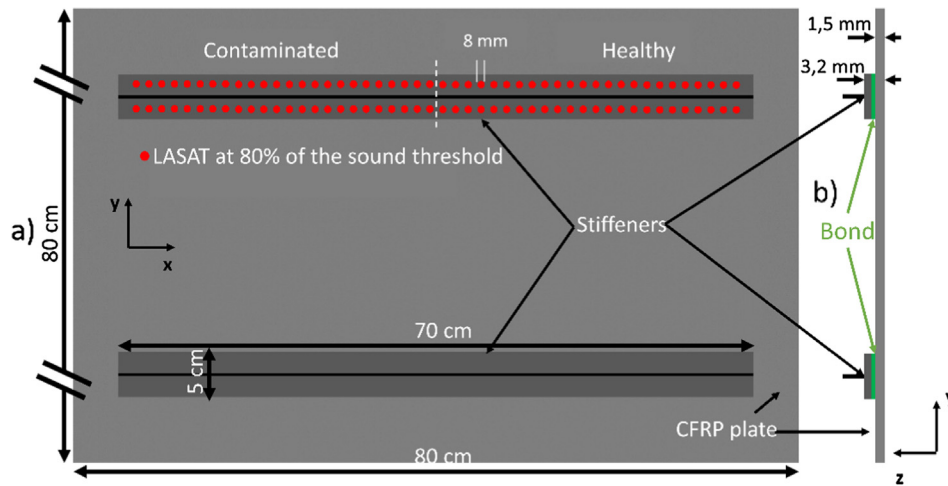
Fig. 10. Production panel: (a) front view with laser shot position and (b) side view with specified thicknesses.

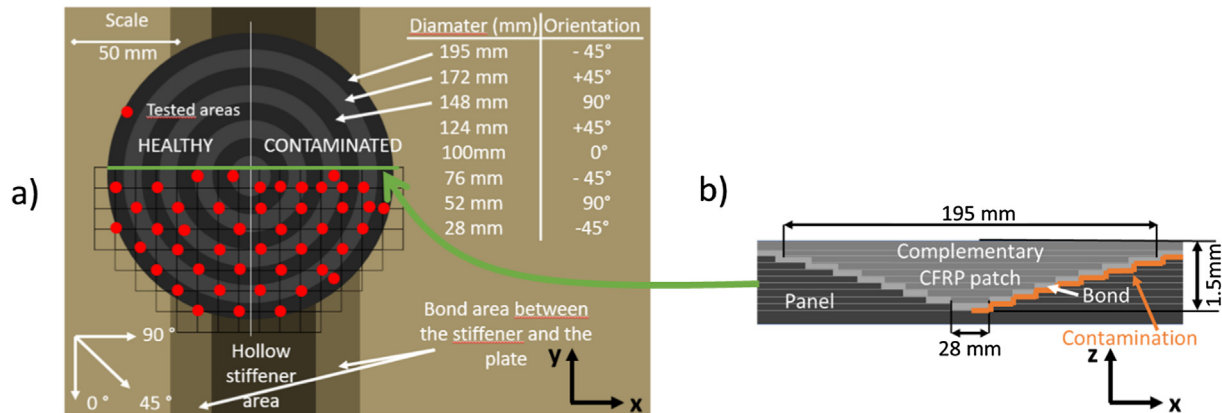
Fig. 11. (a) figure of the shot pattern realised on the repair panel and (b) cross-section of the repair patch geometry.

The repair panel has been cut out of a A350 structure. The middle part of the sample has been grinded all the way to the fibres in a conic shape. Half of the surface was contaminated with both finger print and de-icing fluid solutions (Fig. 11(b)). The hole created in the panel was then patched, starting from the centre to the edge, with the missing CFRP ring (cf. Fig. 11(b)) while keeping the original lay-up of the part (ring diameter and orientation in Fig. 11(a)). The composite was then cured by GMI's tool ANITA EZ0901 hot bonder.

This part had hollow stiffeners on one side, making it impossible to test in this area using a symmetrical shot configuration. It is represented by the dark bar on Fig. 11(a): the darker section is the hollow part and the lighter sections on either side show the areas where the stiffener is assembled onto the panel. Thus, there is a total of three different areas on the patch. The first one only features the repair patch. The S-LASAT

can be applied normally (Fig. 11(b)). The second area above the hollow part was tested using the single shot setup since only one face was available. The third one features both the patch and the zone where the stiffeners have been bonded. These areas then have two bonds: the first one between the plate and the stiffener, and a second one between the plate and the repair patch. S-LASAT can be used, but the extra thickness coming from the stiffeners must be considered.

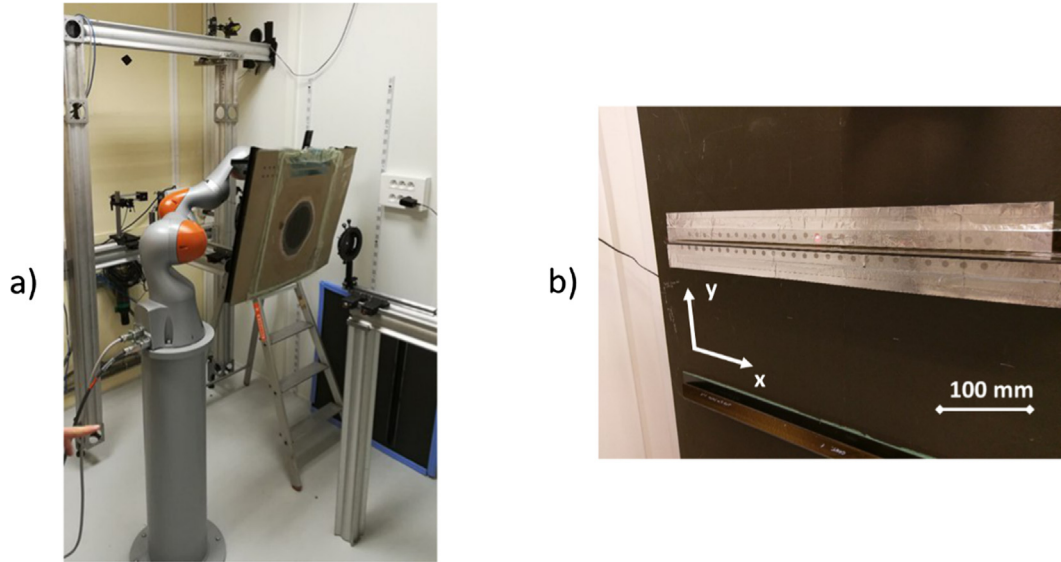
Fig. 12. (a) New experimental setup with the repair panel placed on the robot and (b) one of the stiffener of the production panel after laser shots.

These parts were too big to fit into the initial experimental setup. A robot has been installed to move the piece around, and the optics had to be rearranged (Fig. 12(a)). The water confinement was not feasible either. Instead, a solid constraining material in the form of a thick transparent adhesive layer was used. Its confinement capabilities are comparable to the water in the intensity range  $0-3 \text{ GW/cm}^2$ . Tests on the coupon sample have also validated this choice. The sacrificial layer is the same as before. Fig. 12(b) is a picture of the production panel. Two bands of sacrificial aluminium tape were placed on the stiffener.

They are covered by the transparent confinement tape. The “dots” are areas that have been test using S-LASAT. This panel is ready to undergo a full ultrasonic scan to find the opened areas.
