Preservation of historical buildings: understanding of corrosion mechanisms of metallic rebars in concrete

Abstract

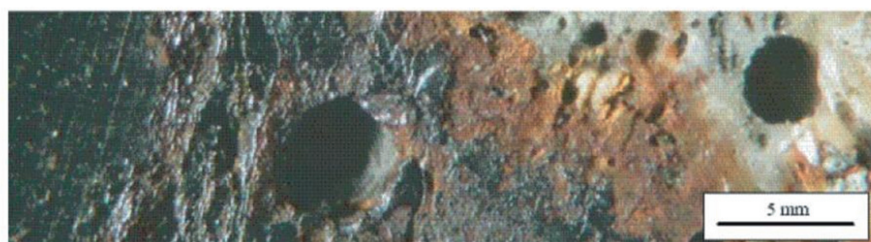
Figure 1: Microphotography and schematic representation of a transverse section of an iron rebar corroded in a hydraulic binder after Chitty (Chitty et al. 2006)

Indeed, iron or steel bars embedded in several types of mortars and concrete for ten up to a hundred years were examined, revealing the presence of a several hundreds micrometers-thick oxides layer surrounding the remaining metallic core (Chitty et al. 2005a; Chitty et al. 2005b; Chitty et al 2007). Two distinct zones were identified on the corrosion pattern (see figure 1):

- the Dense Product Layer (DPL) on contact with the metal,

mainly formed of iron oxy-hydroxides (goethite, α -FeOOH), streaked with maghemite (γ -Fe₂O₃) /magnetite (Fe₃O₄) strips;

- the Transformed Medium (TM), composed of iron oxy-hydroxides and several minerals characteristic of the mortar. This layer can extend several millimetres around the metallic core and contains high iron quantities coming from the metal. The formation of this layer is supposed to be due to a dissolution-precipitation process of the corrosion products.

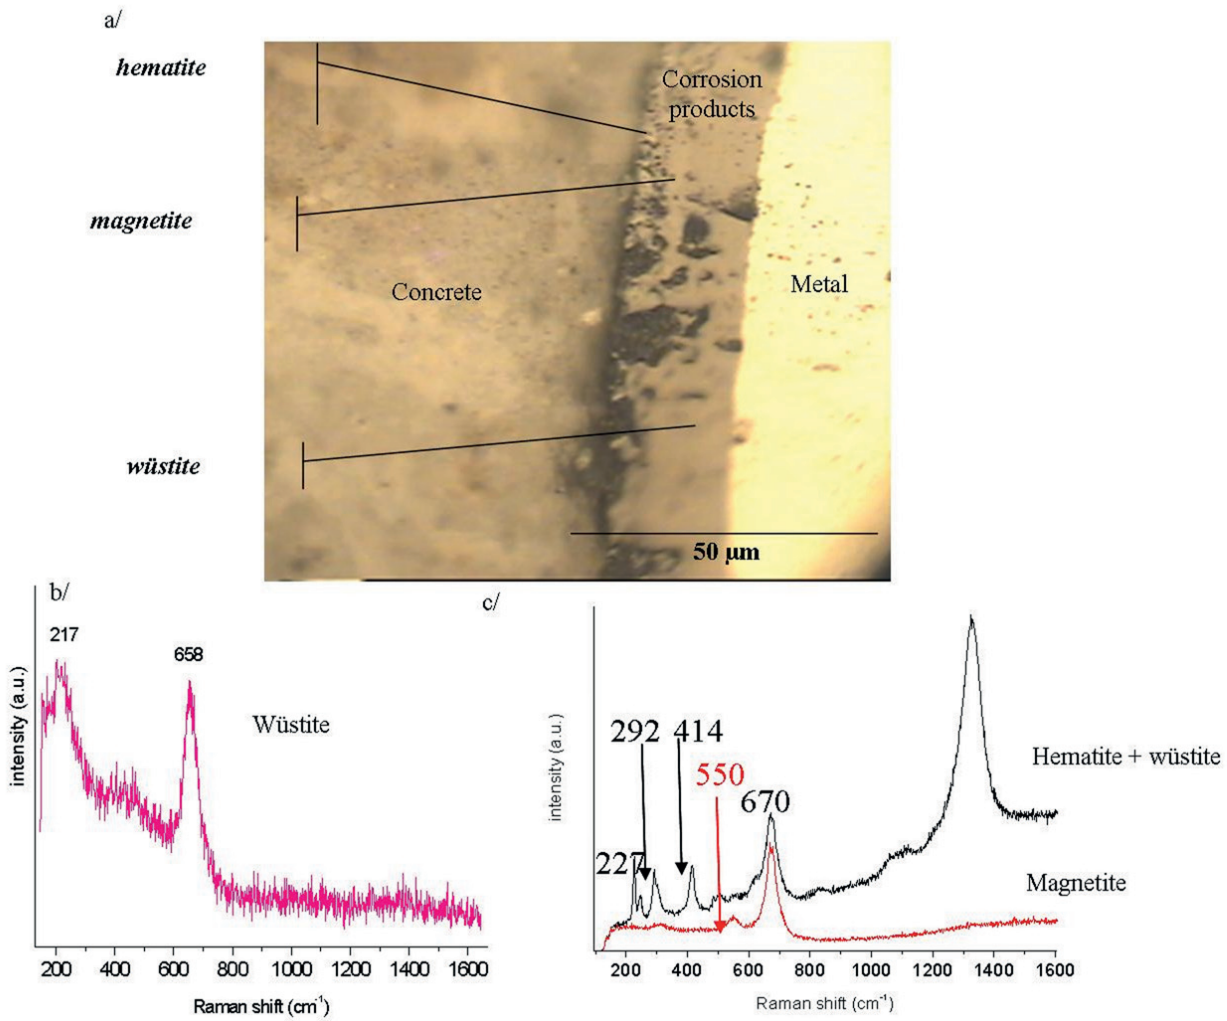
Figure 3: Microphotography (a) and Raman spectra (b and c) of a corrosion layer of the first type, 532 nm, 80 µW, 300s acquisition, “Bourse du Travail” sample

On the first type of layout, corrosion scales were analyzed by Raman micro-spectroscopy (see figures 3 and 6). They are mainly composed of magnetite (Fe_3O_4) surrounding the metallic core, but some wüstite (FeO) could be observed as a dense layer in contact with the metal. This last phase was mainly identified on the Air purifier and the Union Trade Center samples. Locally, on the external part of the corrosion layer, haematite ($\alpha\text{-Fe}_2\text{O}_3$) was detected. The succession of these three phases from the metallic core to the external zone is characteristic of a high temperature corrosion layout (over 570°C). In fact wüstite can not form below this temperature. Its presence could be due to hot working of the rebars before the casting. Therefore the rebars would have been directly embedded in the concrete

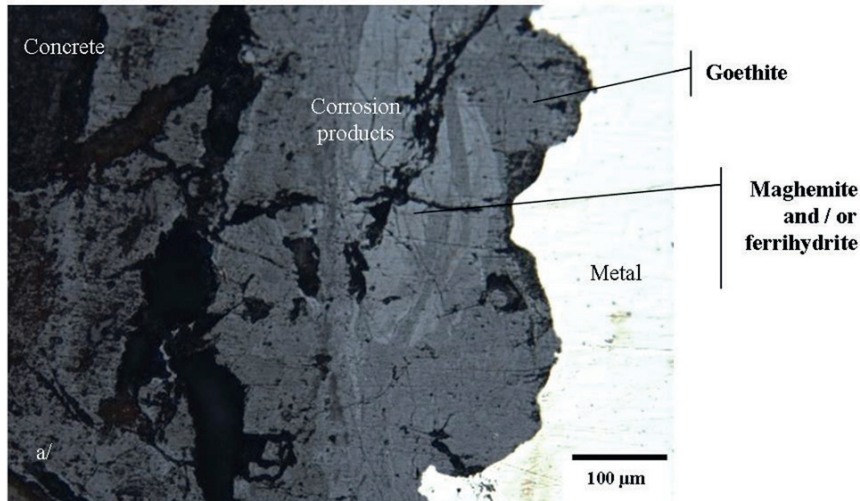
Figure 5: Microphotography (a) and Raman spectra (b and c) of a corrosion layer of the third type, 532 nm, 80 μ W, 300s acquisition

The third type of corrosion layer is only formed of oxy-hydroxides (figure 5 and 6). The main one is goethite, but some akaganeite (β -FeOOH, containing chloride) can also be locally present in confined areas, located on the external part of the corrosion layers. Lepidocrocite (γ -FeOOH) is more present in the external part of the layer. Moreover, at some locations, the corrosion layers present lighter marbling containing less crystallized phases more difficult to identify with Raman spectroscopy and interpreted as ferrihydrite (of chemical formula still not determined) or of feroxyhite (δ -FeOOH).
