Preservation of historical buildings: understanding of corrosion mechanisms of metallic rebars in concrete

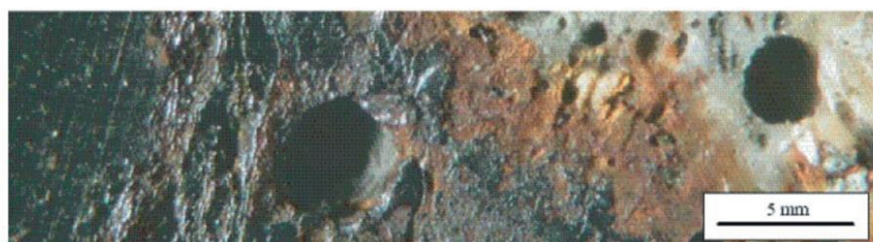
Figure 1: Microphotography and schematic representation of a transverse section of an iron rebar corroded in a hydraulic binder after Chitty (Chitty et al. 2006)

Indeed, iron or steel bars embedded in several types of mortars and concrete for ten up to a hundred years were examined, revealing the presence of a several hundreds micrometers-thick oxides layer surrounding the remaining metallic core (Chitty et al. 2005a; Chitty et al. 2005b; Chitty et al 2007). Two distinct zones were identified on the corrosion pattern (see figure 1):

- the Dense Product Layer (DPL) on contact with the metal,

mainly formed of iron oxy-hydroxides (goethite, α -FeOOH), streaked with maghemite (γ -Fe₂O₃) / magnetite (Fe₃O₄) strips; • the Transformed Medium (TM), composed of iron oxy-hydroxides and several minerals characteristic of the mortar. This layer can extend several millimetres around the metallic core and contains high iron quantities coming from the metal. The formation of this layer is supposed to be due to a dissolution-precipitation process of the corrosion products.
