## **Preservation of historical buildings: understanding of corrosion mechanisms of metallic rebars in concrete**

# Preservation of historical buildings: understanding of corrosion mechanisms of metallic rebars in concrete

## Abstract

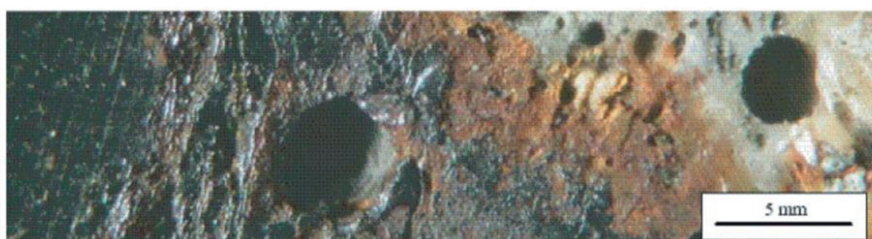
Figure 1: Microphotography and schematic representation of a transverse section of an iron rebar corroded in a hydraulic binder after Chitty (Chitty et al. 2006)

Indeed, iron or steel bars embedded in several types of mortars and concrete for ten up to a hundred years were examined, revealing the presence of a several hundreds micrometers-thick oxides layer surrounding the remaining metallic core (Chitty et al. 2005a; Chitty et al. 2005b; Chitty et al 2007). Two distinct zones were identified on the corrosion pattern (see figure 1):

- the Dense Product Layer (DPL) on contact with the metal,

mainly formed of iron oxy-hydroxides (goethite,  $\alpha$ -FeOOH), streaked with maghemite ( $\gamma$ -Fe<sub>2</sub>O<sub>3</sub>) / magnetite (Fe<sub>3</sub>O<sub>4</sub>) strips;

- the Transformed Medium (TM), composed of iron oxy-hydroxides and several minerals characteristic of the mortar. This layer can extend several millimetres around the metallic core and contains high iron quantities coming from the metal. The formation of this layer is supposed to be due to a dissolution-precipitation process of the corrosion products.

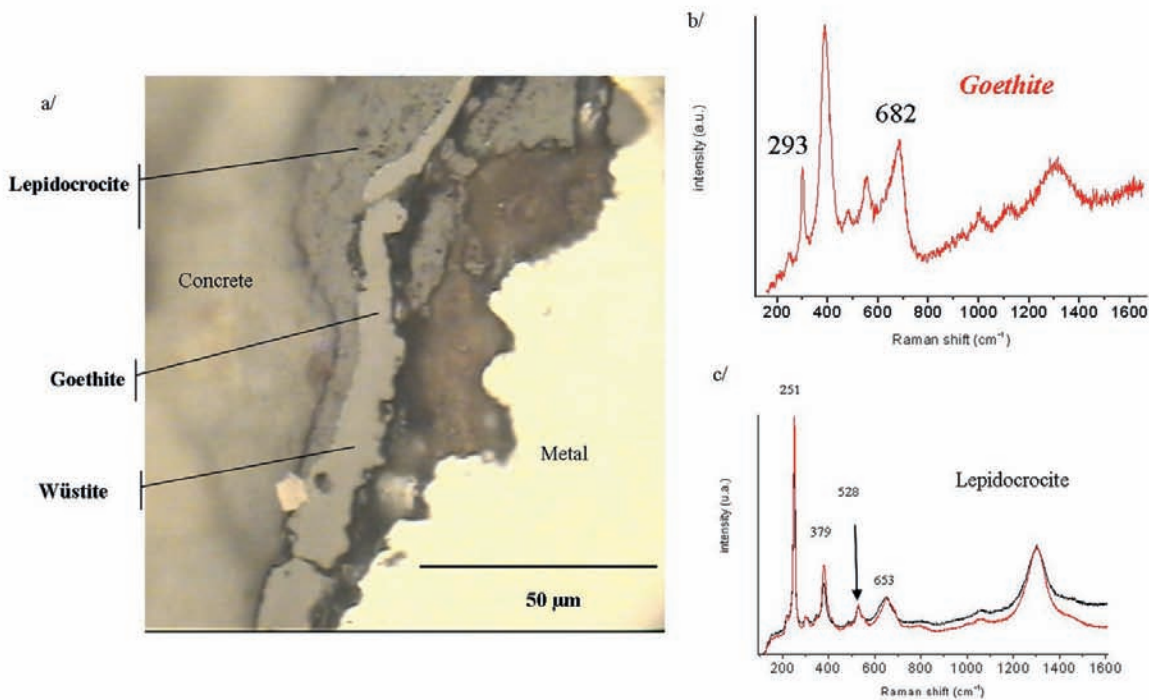
Figure 4: Microphotography (a) and Raman spectra (b and c) of a corrosion layer of the second type, 532 nm, 80  $\mu$ W, 300 s acquisition, ONERA sample

In the second type of corrosion form, in addition to the thin corrosion layers of the first type, thicker ones were also observed. They contain wüstite or magnetite strata surrounded by goethite (see figures 4 and 6) and sometimes lepidocrocite on the external part of the corrosion products.
