Preservation of historical buildings: understanding of corrosion mechanisms of metallic rebars in concrete

Abstract

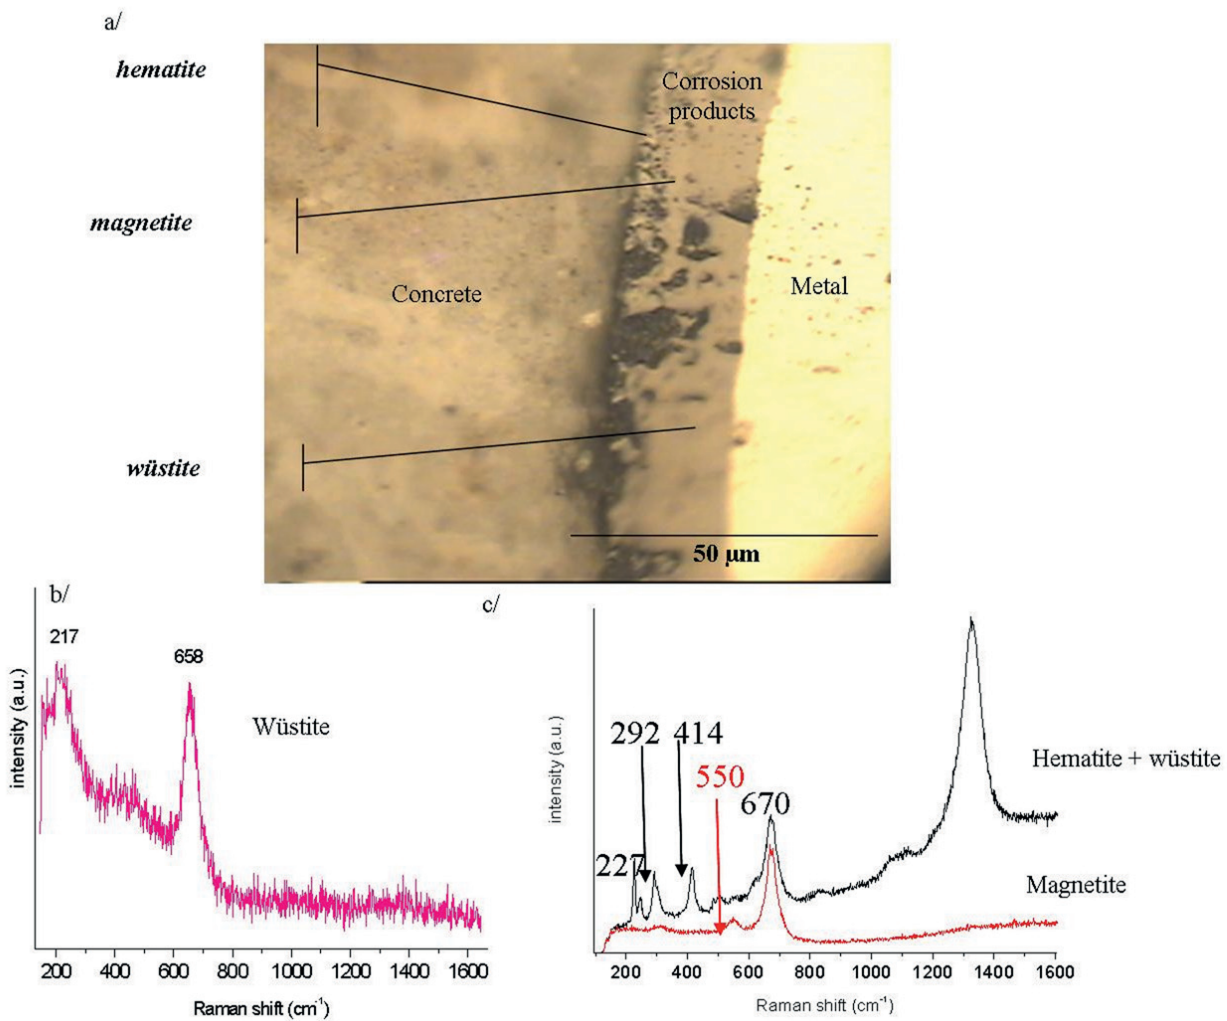
Figure 3: Microphotography (a) and Raman spectra (b and c) of a corrosion layer of the first type, 532 nm, 80 µW, 300s acquisition, “Bourse du Travail” sample

On the first type of layout, corrosion scales were analyzed by Raman micro-spectroscopy (see figures 3 and 6). They are mainly composed of magnetite (Fe_3O_4) surrounding the metallic core, but some wüstite (FeO) could be observed as a dense layer in contact with the metal. This last phase was mainly identified on the Air purifier and the Union Trade Center samples. Locally, on the external part of the corrosion layer, haematite ($\alpha\text{-Fe}_2\text{O}_3$) was detected. The succession of these three phases from the metallic core to the external zone is characteristic of a high temperature corrosion layout (over 570°C). In fact wüstite can not form below this temperature. Its presence could be due to hot working of the rebars before the casting. Therefore the rebars would have been directly embedded in the concrete
