## **Preservation of historical buildings: understanding of corrosion mechanisms of metallic rebars in concrete**

# Preservation of historical buildings: understanding of corrosion mechanisms of metallic rebars in concrete

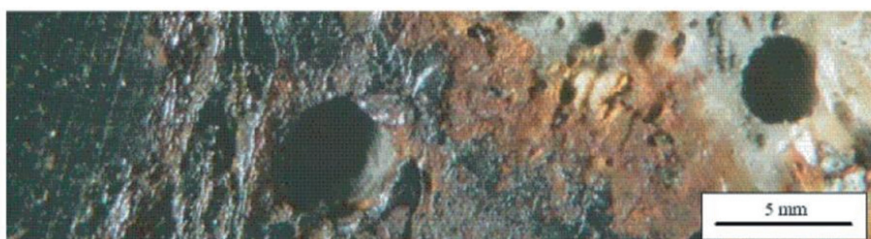
Figure 1: Microphotography and schematic representation of a transverse section of an iron rebar corroded in a hydraulic binder after Chitty (Chitty et al. 2006)

Indeed, iron or steel bars embedded in several types of mortars and concrete for ten up to a hundred years were examined, revealing the presence of a several hundreds micrometers-thick oxides layer surrounding the remaining metallic core (Chitty et al. 2005a; Chitty et al. 2005b; Chitty et al 2007). Two distinct zones were identified on the corrosion pattern (see figure 1):

mainly formed of iron oxy-hydroxides (goethite,  $\alpha$ -FeOOH), streaked with maghemite ( $\gamma$ -Fe<sub>2</sub>O<sub>3</sub>) / magnetite (Fe<sub>3</sub>O<sub>4</sub>) strips;

- the Transformed Medium (TM), composed of iron oxy-hydroxides and several minerals characteristic of the mortar. This layer can extend several millimetres around the metallic core and contains high iron quantities coming from the metal. The formation of this layer is supposed to be due to a dissolution-precipitation process of the corrosion products.

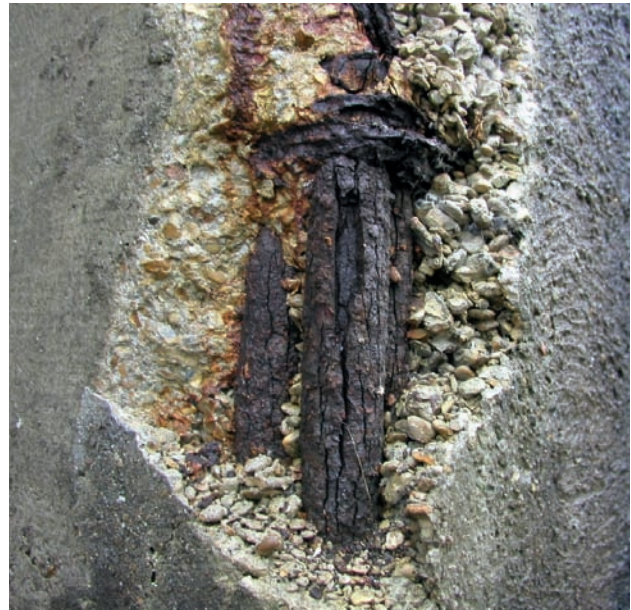
Figure 2: Concrete spalling observed on ONERA site

In the Meudon ONERA “air purifier”, built in 1950, a generalized spalling phenomenon was observed, visibly linked to the corrosion of the rebars. In some spalled areas, thick corrosion layers were observed (see figure 2). But surprisingly, this con-

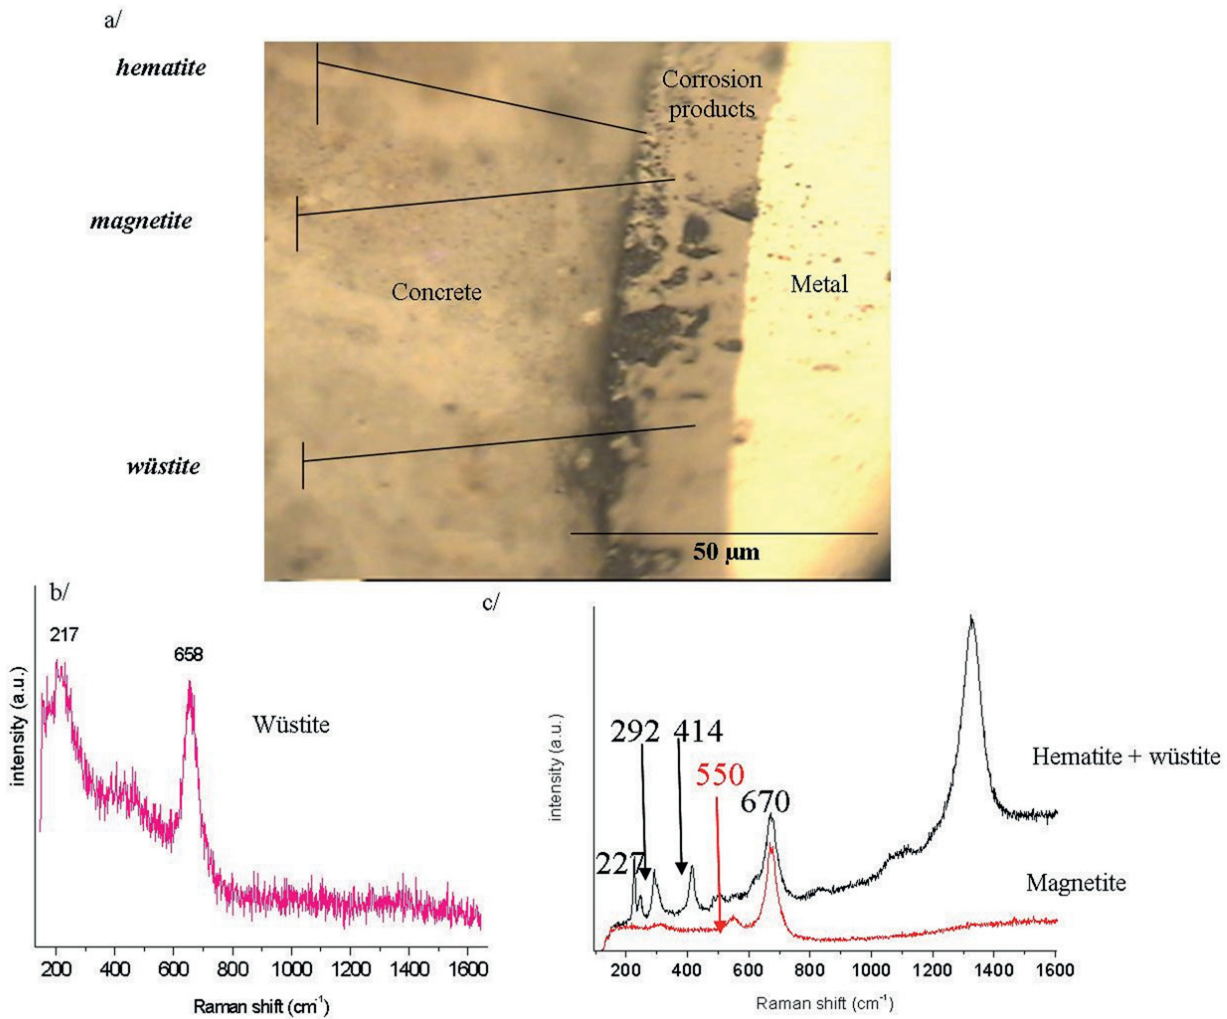
Figure 3: Microphotography (a) and Raman spectra (b and c) of a corrosion layer of the first type, 532 nm, 80 µW, 300s acquisition, “Bourse du Travail” sample

On the first type of layout, corrosion scales were analyzed by Raman micro-spectroscopy (see figures 3 and 6). They are mainly composed of magnetite ( $\text{Fe}_3\text{O}_4$ ) surrounding the metallic core, but some wüstite ( $\text{FeO}$ ) could be observed as a dense layer in contact with the metal. This last phase was mainly identified on the Air purifier and the Union Trade Center samples. Locally, on the external part of the corrosion layer, haematite ( $\alpha\text{-Fe}_2\text{O}_3$ ) was detected. The succession of these three phases from the metallic core to the external zone is characteristic of a high temperature corrosion layout (over 570°C). In fact wüstite can not form below this temperature. Its presence could be due to hot working of the rebars before the casting. Therefore the rebars would have been directly embedded in the concrete

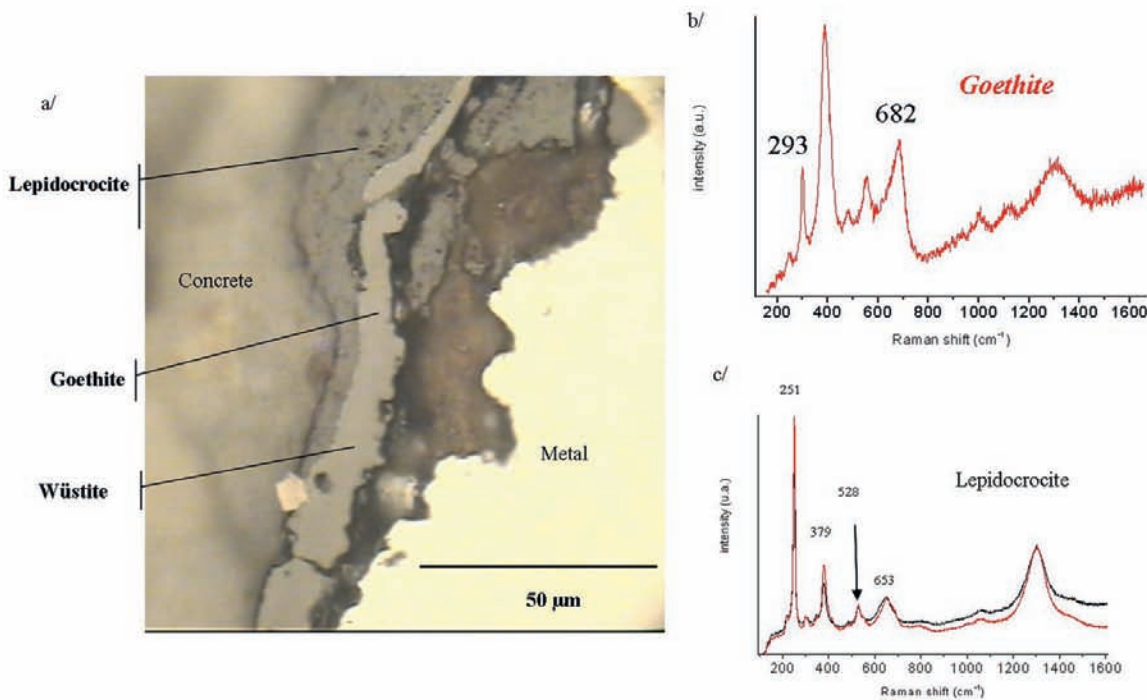
Figure 4: Microphotography (a) and Raman spectra (b and c) of a corrosion layer of the second type, 532 nm, 80  $\mu$ W, 300 s acquisition, ONERA sample

In the second type of corrosion form, in addition to the thin corrosion layers of the first type, thicker ones were also observed. They contain wüstite or magnetite strata surrounded by goethite (see figures 4 and 6) and sometimes lepidocrocite on the external part of the corrosion products.

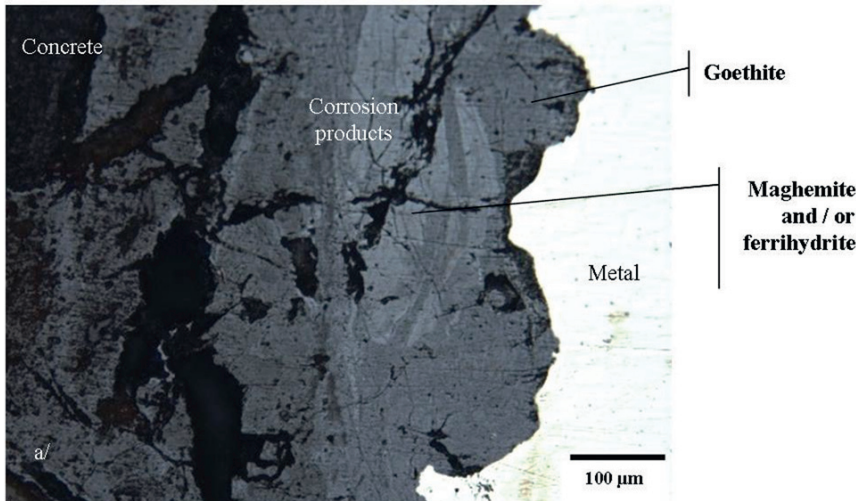
Figure 5: Microphotography (a) and Raman spectra (b and c) of a corrosion layer of the third type, 532 nm, 80  $\mu$ W, 300s acquisition

The third type of corrosion layer is only formed of oxy-hydroxides (figure 5 and 6). The main one is goethite, but some akaganeite ( $\beta$ -FeOOH, containing chloride) can also be locally present in confined areas, located on the external part of the corrosion layers. Lepidocrocite ( $\gamma$ -FeOOH) is more present in the external part of the layer. Moreover, at some locations, the corrosion layers present lighter marbling containing less crystallized phases more difficult to identify with Raman spectroscopy and interpreted as ferrihydrite (of chemical formula still not determined) or of feroxyhite ( $\delta$ -FeOOH).

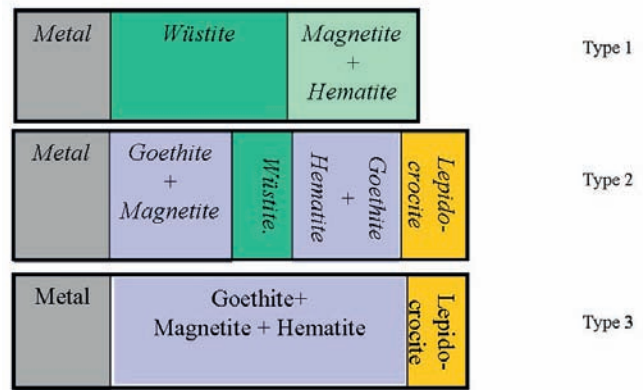
Figure 6: Hypothesis of evolution of the corrosion form from type 1 to type 3

The probable succession of the different observed corrosion layouts is exposed on figure 6. First a thin corrosion layer is formed on the rebars during their handling by hot working. This layer is made of wüstite or magnetite and could passivate the metal. After a certain period, corrosion products characteristic of aerated confined medium and mainly composed of goethite are observed surrounding the wüstite/magnetite layer.

This indicates on one hand that the corrosion front progresses inside the material (i.e. from the hot temperature layer to the metal) and on the other hand that corrosion products probably grow in the external zones by dissolution and precipitation, but this hypothesis has to be confirmed. An important point is that the hot temperature phases (i.e. magnetite and wüstite) react during the aerated corrosion processes and that they can completely disappear from the corrosion layout: in some cases, neither wüstite nor magnetite was detected in the thick iron oxy-hydroxide layer. It is also interesting to observe that these different corrosion forms can be observed on the same rebar so that the corrosion rate is not heterogeneous around the metal. Thick corrosion layers have been correlated to two kinds of defaults in the concrete:
