Preservation of historical buildings: understanding of corrosion mechanisms of metallic rebars in concrete

Delphine D. Neff, Marie-Victoire Elisabeth, Valerie L'Hostis, Emmanuel Cailleux, Laurent Vincent, Annick Texier, Ludovic Bellot-Gurlet, Philippe Dillmann

Abstract

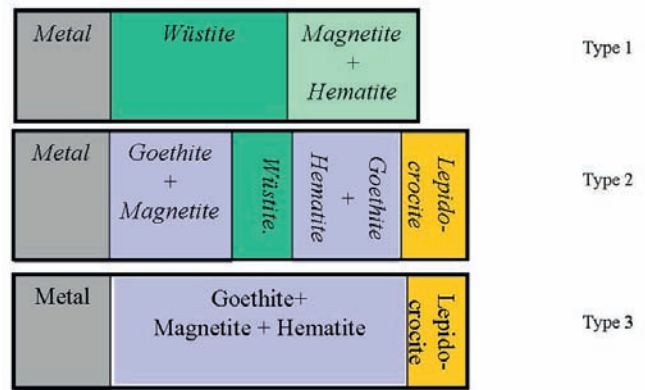
Figure 6: Hypothesis of evolution of the corrosion form from type 1 to type 3

The probable succession of the different observed corrosion layouts is exposed on figure 6. First a thin corrosion layer is formed on the rebars during their handling by hot working. This layer is made of wüstite or magnetite and could passivate the metal. After a certain period, corrosion products characteristic of aerated confined medium and mainly composed of goethite are observed surrounding the wüstite/magnetite layer.

This indicates on one hand that the corrosion front progresses inside the material (i.e. from the hot temperature layer to the metal) and on the other hand that corrosion products probably grow in the external zones by dissolution and precipitation, but this hypothesis has to be confirmed. An important point is that the hot temperature phases (i.e. magnetite and wüstite) react during the aerated corrosion processes and that they can completely disappear from the corrosion layout: in some cases, neither wüstite nor magnetite was detected in the thick iron oxy-hydroxide layer. It is also interesting to observe that these different corrosion forms can be observed on the same rebar so that the corrosion rate is not heterogeneous around the metal. Thick corrosion layers have been correlated to two kinds of defaults in the concrete:
