## DAMAGE EVOLUTION IN WOOD UNDER TENSILE LOADING MONITORED BY ACOUSTIC EMISSION

**Keywords:** Wood, Acoustic Emission, Damage evolution, Failure mechanisms

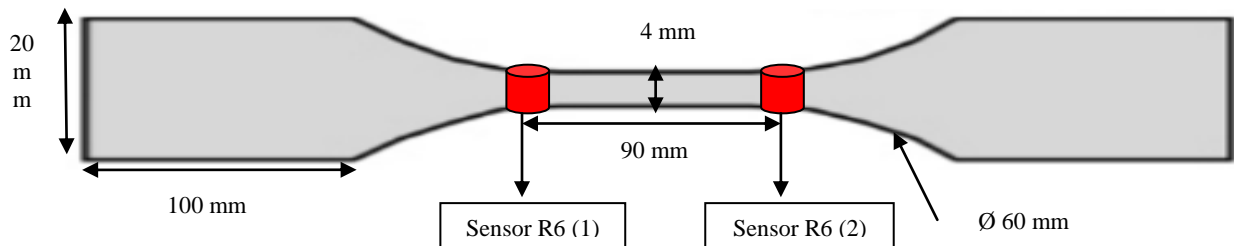
Tensile specimens with dog-bone shape have been prepared from the three species of wood with nominal dimensions according to NF B51-017 (350 mm overall length, 100 mm length, 20 mm width and 20 mm thickness in grip section, 90 mm length, 20 mm width and 4 mm thickness in the calibrated section (Figure 1). All specimens have the length in longitudinal direction and the width in radial direction. To prevent crushing on the specimen by the grips, four tabs in steel of length 60 mm were glued to the ends of the specimen using bicomponent epoxy resin (ESK-48).

**Figure 1:** Tensile specimen and sensors position

Figure 1 schematizes also the positions of AE sensors on the tested specimen. In order to locate AE events, two R6 $\alpha$  sensors were placed on the front side of the tensile specimen one on the top and another on the bottom of the calibrated section. Sensors were fixed with clamps. In order to avoid any loss of acoustic signal at the transducer-sample interface, silicone-free vacuum grease was used to couple the sensors to the surface of specimens. The AE data are recorded with help of an Euro Physical Acoustics system composed by a PCI8 board. The acquisition is computed by using AEWin/SAMOS software. The analog filter frequency is set up between 20 and 400 kHz and the acquired signals are preamplified by 40 dB. The environmental noise was filtered using a threshold of 35 dB. The timing parameters, peak definition time (PDT), hit definition time (HDT) and hit lockout time (HLT) are set at 40, 200 and 300  $\mu$ s, respectively [6]. These parameters are verified by Pencil-lead breaks (Hsu-Nielsen source) [7] before the beginning of tests. The same sources are used to calculate the wave velocities. These latter are given in table 1. Wave velocity is species dependent. In fact, it increases with the increasing of raw density of the material [8].

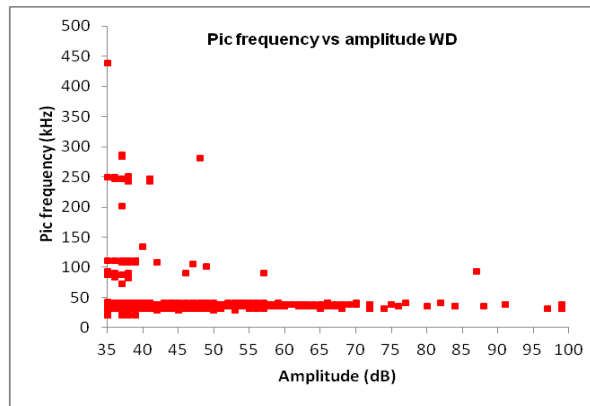
Wood is a very heterogeneous and a highly attenuative material. For these reasons, a preliminary study was done to select the suitable sensors for wood materials. In the literature the sensors used for monitoring damage in wood have resonant frequencies between 150 and 300 kHz [1-5]. But a recent study [2] indicated that in the cases of wood fracture process the maximum Power Spectral Density (PSD) defined as the distribution of energy over the frequency, resided in a low frequency area around 60 kHz. So in order to properly assess the frequency portion of the signal, resonant frequency of the sensor should be carefully taken into account. In this context, four types of piezoelectric sensors were tested in order to select the suitable one: three resonant sensors R15 $\alpha$ , R6 $\alpha$  and R3 $\alpha$  with resonant frequency respectively 150 kHz, 60 kHz and 30 kHz, and one wideband sensor (WD) (frequency band-width between 100 kHz and 1 MHz) are tested. Results of wideband sensor showed that the frequency of damage in wood is situated between 30 kHz and 50 kHz (Figure 2). Consequently, R3 $\alpha$  and R6 $\alpha$  sensors are the most convenient for wood damage monitoring. In this research work, both of R3 $\alpha$  and R6 $\alpha$  sensors were used simultaneously. After analyses of the signals recorded by these sensors, it is found that the R6 $\alpha$  sensors gives better results concerning localization of the events. Therefore we will limit our analyses on the results recorded by R6 $\alpha$  sensor in the next parts of this paper.

**Figure 2:** Pic frequency vs amplitude of WD sensor showing the concentration of hits in a frequency range between 30 kHz and 50 kHz.

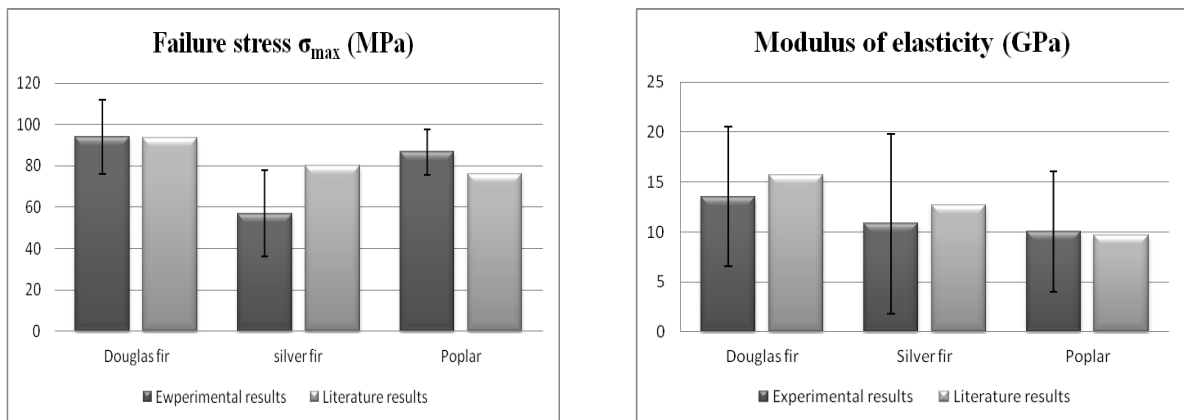
The fracture stress and the modulus of elasticity for the three woods determined from the tensile tests are shown in Figure 3. It is shown that the tensile strength of Douglas fir is 65% greater than that of silver fir, and 8% greater than that of popular, respectively. These results are compared with those obtained in reference [9] (Figure 3). Good correlation can be pronounced for Douglas fir, but not for silver fir and popular wood. The failure stress for three woods in reference [9] seems following the same variation of their density. But it is not really the case regarding the measurement on the woods tested in our study. Concerning the Young's modulus, it seems density dependent (Figure 3) since Douglas fir is stiffer than the

two other species. Furthermore, silver fir and poplar fir have equivalent stiffness and close densities (Table 1).

Figure 3: Mechanical properties for the three tested wood species

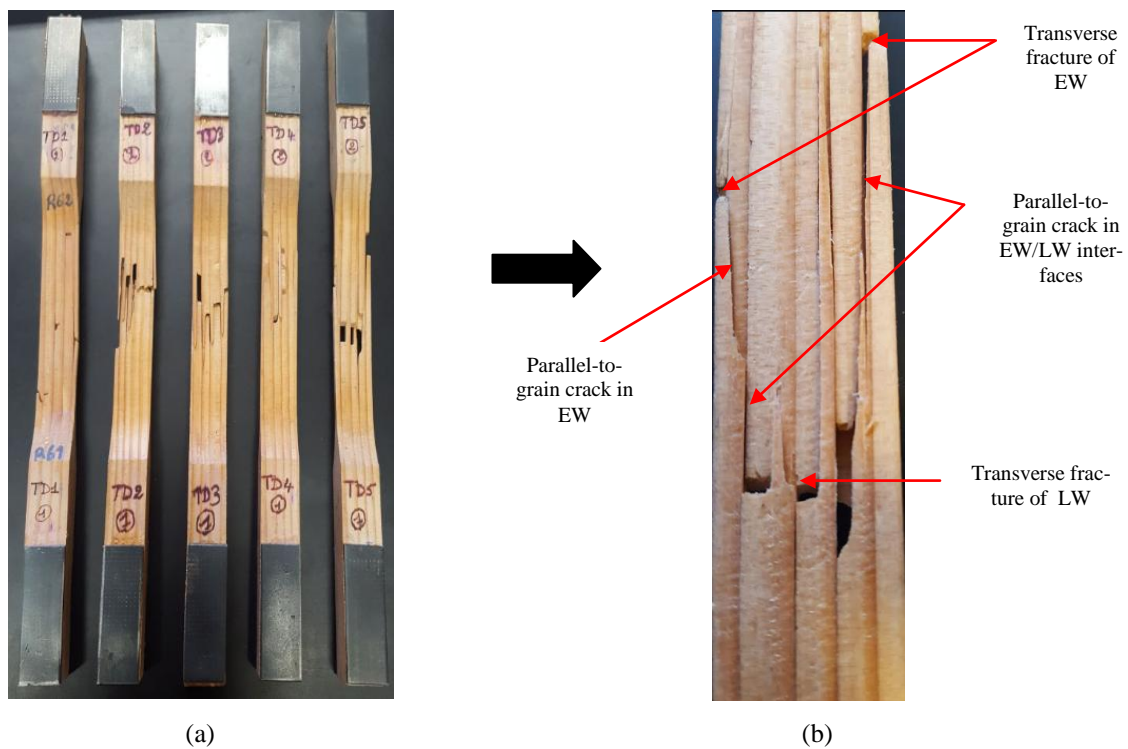
The examination of fracture surface of Douglas fir specimens reveals different damage mechanisms: transverse fracture in earlywood (EW) tracheid, transverse fracture in latewood tracheid (LW) and the parallel-to-grain crack propagation along the EW/LW interfaces and in the EW (Figure 4 a-b).

Figure 4: (a) Failure patterns observed for Douglas fir specimens (b) Failure modes in TD5 fracture surface

Even though the damage process for each Douglas specimen could not be exactly the same, a typical damage process in Douglas specimen can be proposed. Under tensile loading, the different stiffness between earlywood (EW) and latewood (LW) generates a shear stress at the EW/LW interfaces, which is the weakest layer because the density of wood between EW and LW changes abruptly [12]. Micro-cracks should initiate or at EW/LW interfaces or in EW, where the strength is much lower than that in LW. Their growth and coalescence conduce to longitudinal crack propagation. This process is sometimes accompanied by the fibre breaking in EW [13]. The transverse fracture in EW generates a tensile/flexion coupling effect, which accentuates even more the fibre breaking in EW. When the crack growth attains EW/LW interfaces levels, under shear stress (mode II) and peel stress (mode I), the longitudinal crack propagation (parallel-to-grain) along EW/LW interfaces will occur. And then, one of the latewood layers breaks, the rest of specimen cannot support the higher load and final fracture occurs [13]. On fracture surfaces, the longitudinal crack growth in EW and at EW/LW interfaces was evident, and the fiber breaking in EW is so shown stair-shaped.

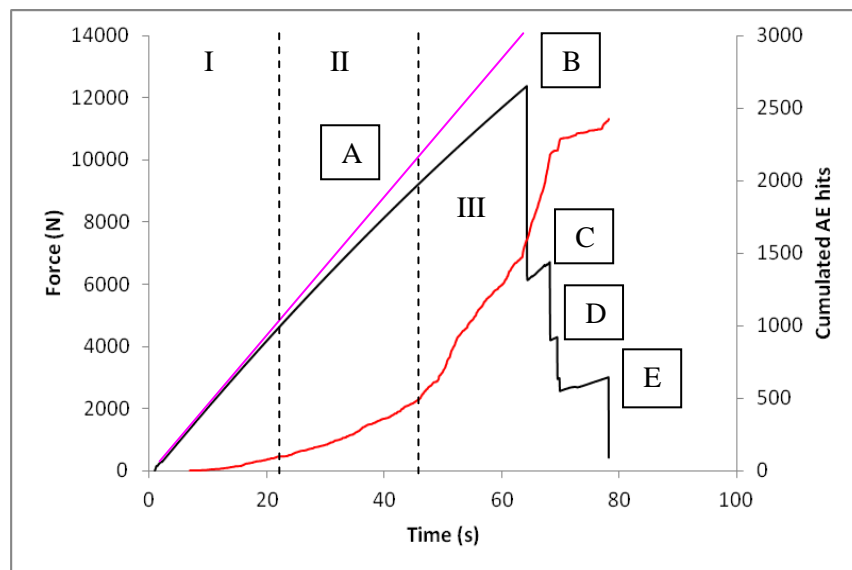
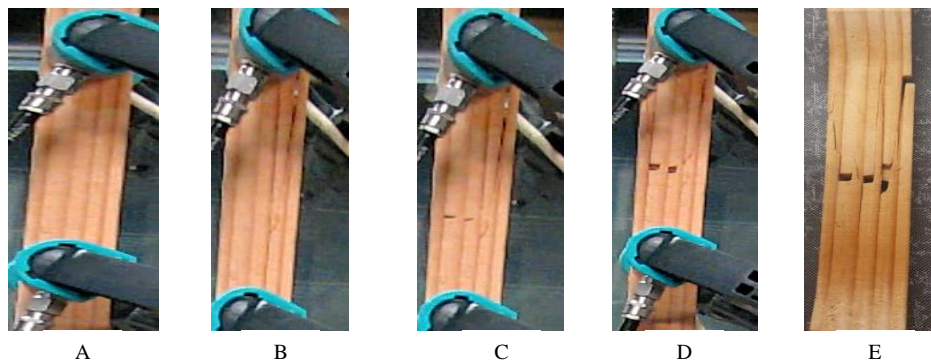
As an example we will focus on TD5 specimen to correlate the AE data with damage mechanisms. Figure 5 shows the evolution of the load and of AE parameters in term of cumulative

AE hits as a function of the testing time. In general, the load/time curve could be decomposed in three stages based on cumulative AE hits. In the linear deformation part, some emissions have been observed. In their study [10] suggested that the random AE signals observed in the elastic deformation stage are the result of the non uniform stress field resulting from non-homogeneity of wood structure. Actually, reorientations in wood structure are observed, which lead to adaptation for new conditions of loading [10]. When it entered into the non-linear deformation part (part II), the rate of cumulated AE hits increased. This rapid increase could be attributed to inter-laminar shear in planes of weakness like earlywood/latewood interfaces [8]. In this stage parallel-to grain micro-cracks in EW/LW transition zones are developed. Then, the specimen entered to the fracture stage (part III) which leads to a sharp increase in cumulative AE hit. As damage in the specimen intensified, macro-cracking took place and the first visible crack was found at  $t=64.3s$ , herein a sharp drop of the load can be observed (Figure 5- Point B). A transverse crack in the EW appeared, and then the crack propagated longitudinally in the EW/LW interfaces. Successively, a second, a third visible crack across EW occurred at  $t=68.2s$  and at  $t=69.47s$ , respectively (Figure 5 – Point C and Point D), they are accompanied by the longitudinal crack growth or in EW tracheid, or at the EW/LW interface. Thereafter, the rate of cumulated AE hits increased as the damage continued to progress until the fourth and final fracture at  $t=78.1 s$  (Figure 5- Point E). The several drops of load indicate that the specimen still had high load-bearing capacity after the first visible fracture [11].

**Figure 5:** Force vs time, cumulative hits vs time and damage scenario of TD5 specimen

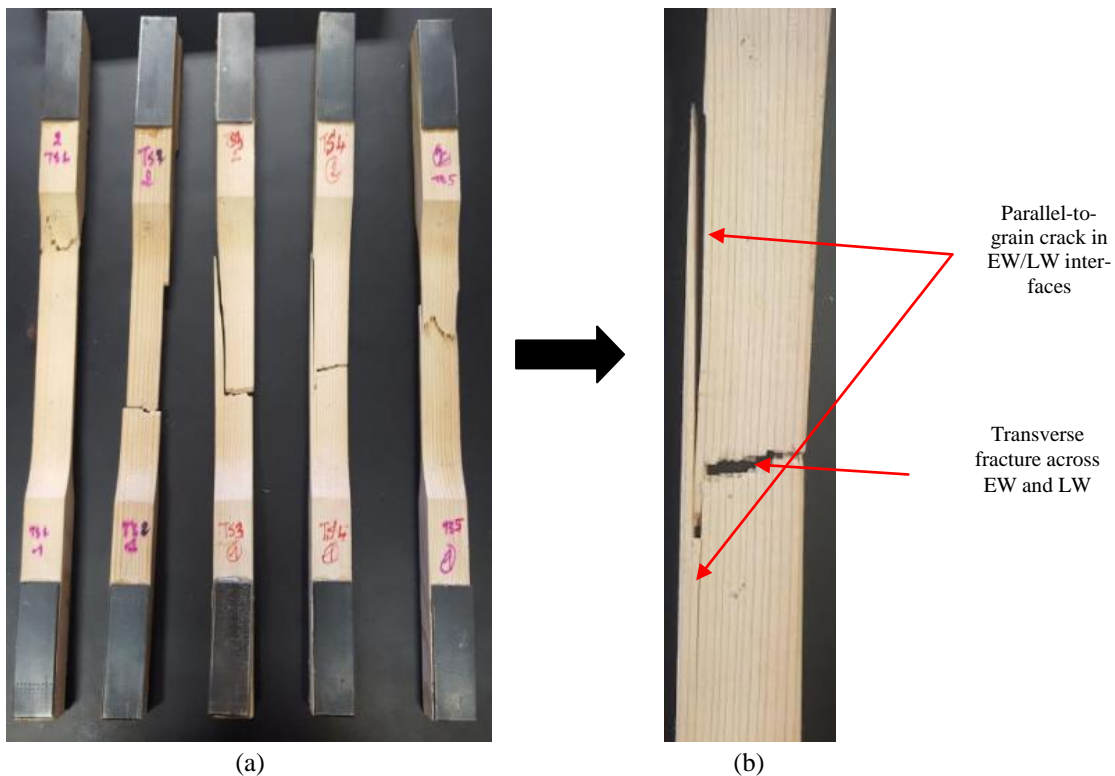
Silver fir specimens under tensile loading failed usually in brittle manner (Figure 6). Much less crack propagation parallel-to-grain direction were observed along EW/LW interfaces or/and in the EW. The fracture surfaces appear more flat and demonstrate simultaneous transverse fracture in earlywood tracheid and in latewood tracheid.

The representative specimen TS4 (Figure 6-b) displays transverse crack that extend entirely through the sample width across the EW and the LW. Some longitudinal crack propagations have been also seen along EW/LW interfaces.

**Figure 6:** (a) Failure patterns observed for silver fir specimens (b) Failure modes in TS4 specimen

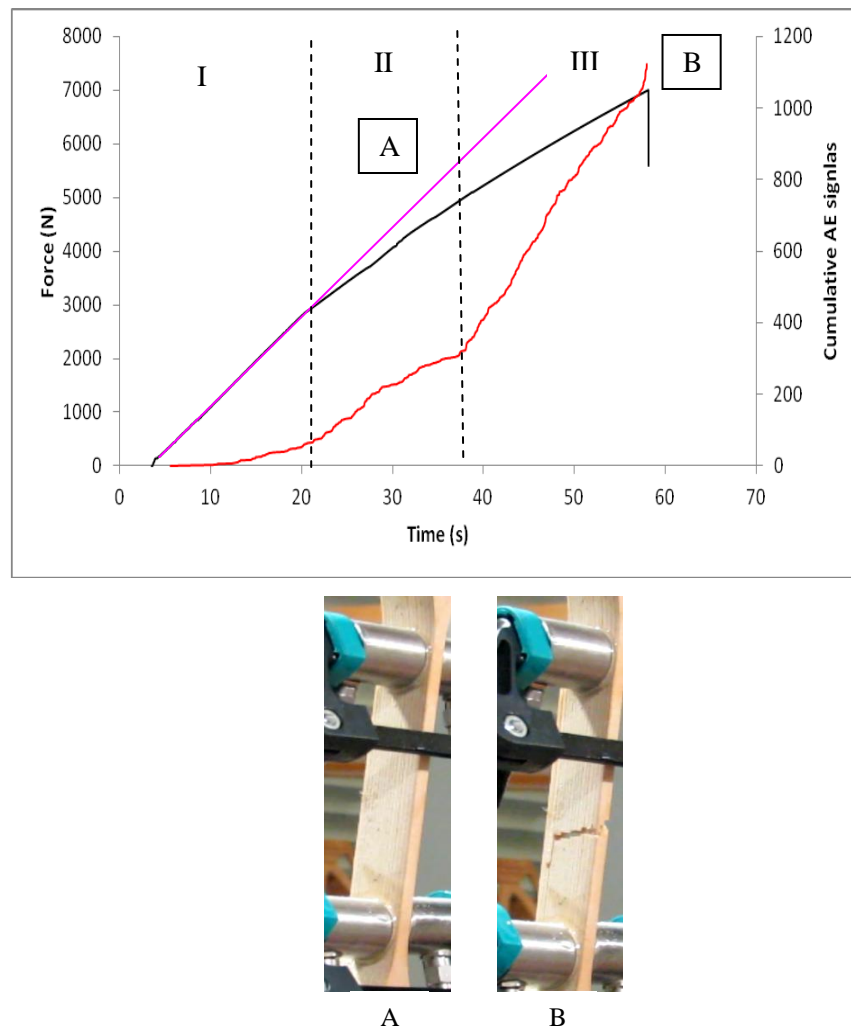
Figure 7 shows the evolution of the load and of cumulative AE hits as a function of the testing time for the specimen TS4. Under low load (Part I), silver fir generated few emissions. In the second part (Part II), the cumulative AE hits increased with the load rise. Emissions in this stage can be attributed to micro-cracking in cells of earlywood since the structure of wood with narrow rings consists principally of earlywood tracheid [14]. The brittle fracture across EW starts with a significant increase in the rate of cumulated AE hits (Part III). When the EW is sufficiently damaged, the LW can no longer withstand the applied loads, the final fracture occurred. Actually the latewood has to be more resistant as in silver fir as the walls of latewood cells are much thicker than those of earlywood cells. Moreover at the last part of the test, the tensile/flexion coupling due to the transverse crack promotes the longitudinal crack propagation at EW/LW interface.

**Figure 7:** Force vs time, cumulative hits vs time and damage scenario of TS4 specimen

In conclusion, silver fir has narrow growth rings, the specimens under tensile loading failed usually in brittle manner. The micro-cracking initiates firstly in the EW, the development of the micro-cracks leads to fiber breaking in the EW. When there are enough fibers broken in the EW, the transverse fracture in the LW occurs. The transverse crack across the section produces a tensile/flexion coupling effect, which promotes the longitudinal crack propagation at EW/LW interfaces, under mode I due to peel stress and mode II due to shear stress.

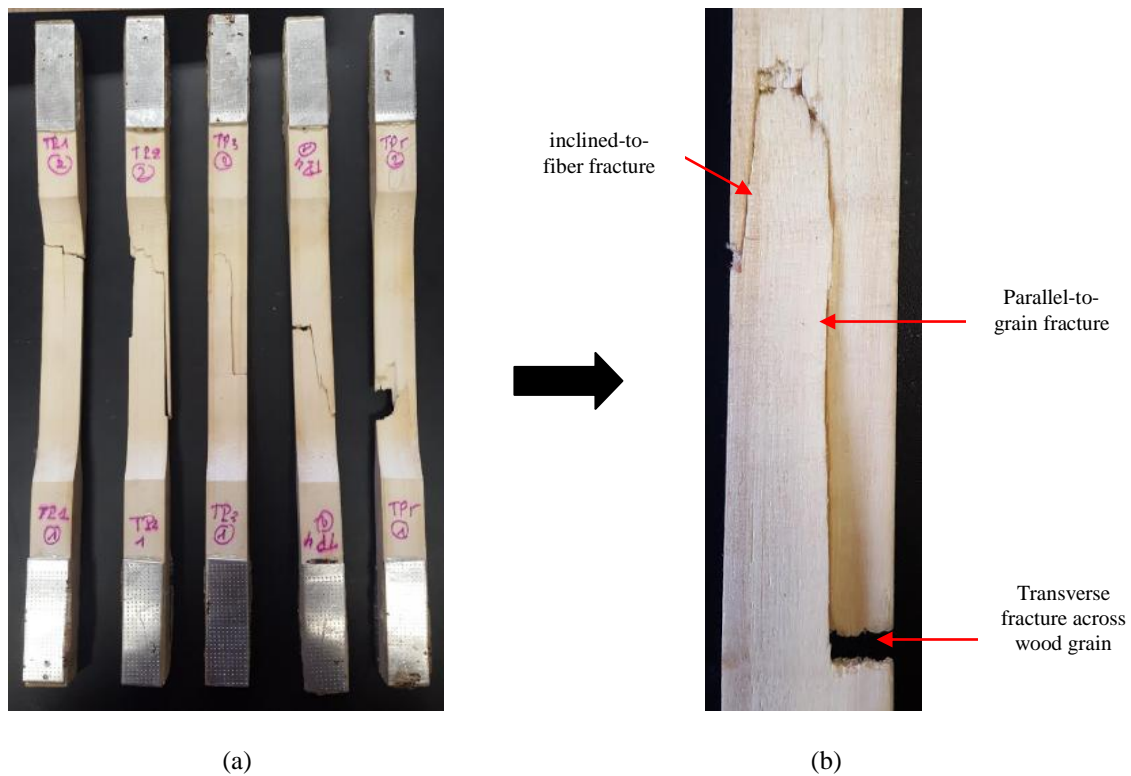
Poplar is a hardwood and considered as quasi homogeneous material, because no transition from earlywood (EW) and latewood (LW) can be distinguished. The specimens shown in Figure 8-a display combination of tension and shear fracture, because the fracture surface of all specimens runs partially across wood grain and partially inclined to the grain direction. The specimens TP3 and TP4 display a large part of the shear fracture where the fracture surface is inclined to the fibers. Moreover, more or less longitudinal macro-cracking was also observed in the specimens.

**Figure 8:** Failure patterns observed for poplar specimens (b) Failure modes in TP3 specimen

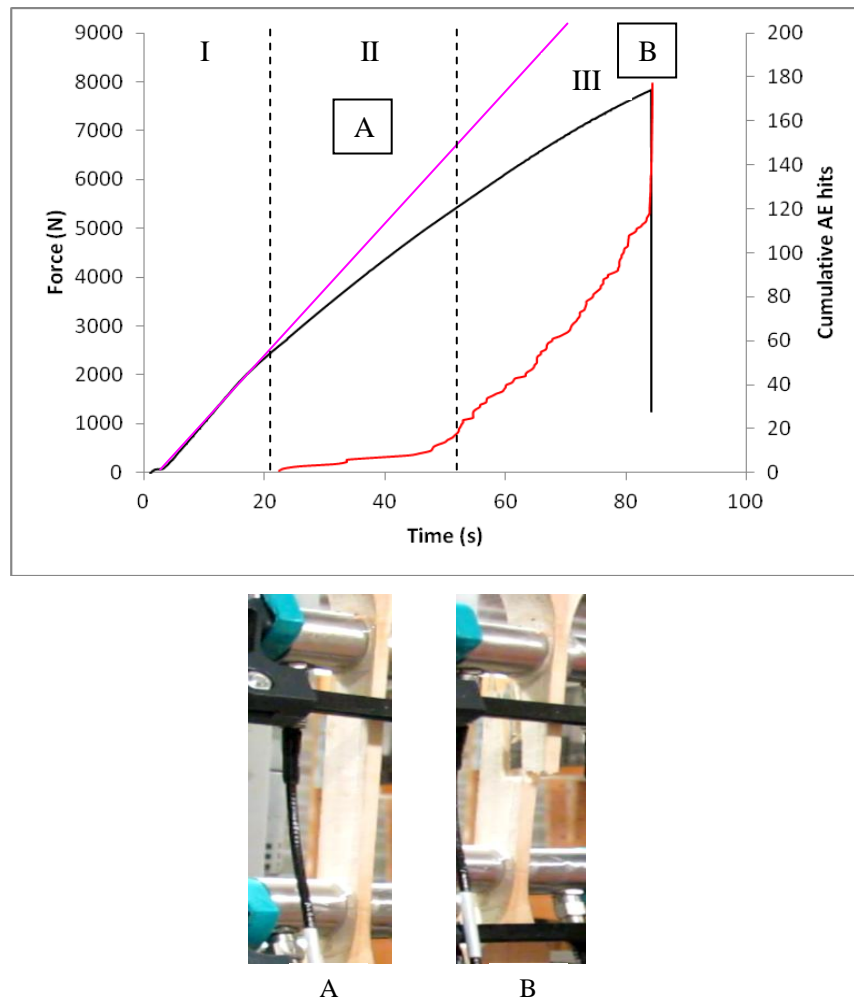
For the representative specimen TP3 (Figure 8-b), the analysis of the AE cumulative hits during tensile test allows to divide the damage process in three parts (Figure 9). Part I is characterized by an absence of detectable acoustic emission. Poplar specimen (TP3) starts to generate acoustic signals at  $t=22.43s$  in part II. Then, the cumulative AE hit increased slightly with the load increase. At this stage the signals can come from the initiation and development of micro-cracking across wood cells since they are considered as the main spot of mechanical weakness in bulk wood specimens. The early stage in part III is characterized by a remarkable increase in cumulative AE hits, herein the damage mechanisms could be the growth of micro-cracks and the arrest of crack propagation at a vessel level, a mechanism specific to hardwood. At final fracture of the specimen, the load drops sharply and the cumulative AE hits suddenly rises when the visible cracks appeared at  $t=84.32s$  (Figure 9-Point B). Acoustic emission activity in this stage is mainly attributed to fiber breakage. Actually, in the final fracture process, under the effect of the stress concentration around the micro-cracks, the fibers of the wood could be broken, forming cross-grain macro-cracks. In the same time the growth and the coalescence of these micro-cracks could also follow the direction parallel-to-grain due to the shear stress induced by wood structure at fiber/fiber interfaces. When a cross-grain crack

meets a parallel-to-grain crack, their coalescence results in a crack inclined to the grain direction.

**Figure 9:** Force vs time, cumulative hits vs time and damage scenario of TP3 specimen

Consequently, the damage scenario of the tested poplar wood under tensile loading could be supposed as following: the damage process is started by micro-cracking in the wood cells. The growth of micro-cracks can be stopped at a vessel due to hardwood structure. Final fracture of the specimen occurs in a brittle manner. When a packet of fibers are broken simultaneously, instable crack propagation can be observed across-to-grain, parallel-to-grain as well as in the direction inclined to wood grain.

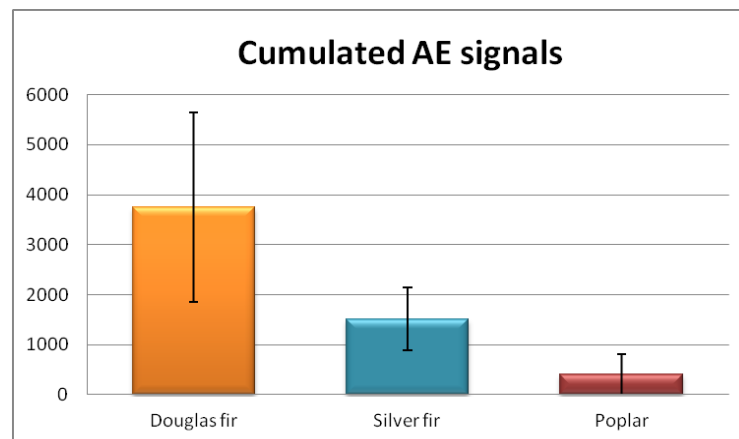
The three wood species studied here show in general three stages of AE activity during tensile loading. But the total cumulative hits are quite different between species. Douglas fir generates higher total AE signals: more than twice of cumulated AE signals of silver fir and nine times more than cumulated AE signals of poplar (Figure 10). This investigation agrees well with the findings in reference [4], which indicated that the higher is the contrast between early and latewood in annual ring, the higher AE cumulative counts should be expected during tensile parallel to grain loading. Moreover the important difference in AE responses between softwoods (Douglas fir and silver fir) and hardwood (poplar) can be also explained by

**Figure 10:** Cumulated AE signals of tested wood species

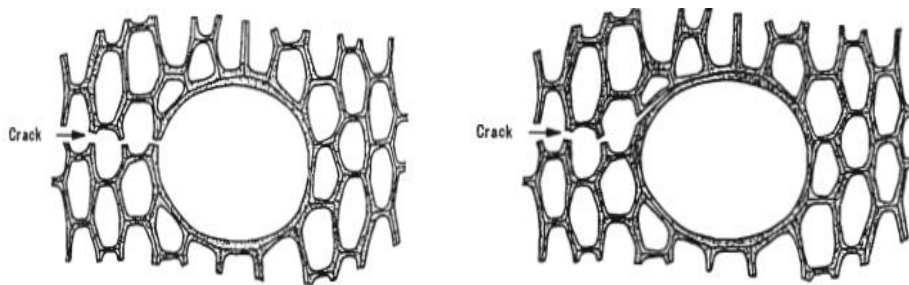
the higher energy consumed when the crack propagate in softwood [15]. Furthermore, hardwood requires a high stress levels for macro-crack initiation and its structure holds crack arrest components. In fact, vessels in hardwood species can stop the crack propagation [16]: the crack tends to open the vessel or deviates around the vessel and then stooped (Figure 11). Despite the crack arrest, the crack propagates in brittle manner in hardwood species [15]. These reasons explain why the poplar wood remained silent in early stage of loading and released less emission hits until the final fracture. Furthermore, wood structure contains radially oriented parenchyma called rays. They provide a mechanically strong structure which inhibits the crack propagation [17-18]. In fact, the volumetric proportion and the size of rays are different between soft and hardwood. The conifers wood contains around 5-10% of rays while it is around 10-32% in hardwood [19]. Therefore, the rays could strengthen poplar wood to crack growths more than the two softwoods (Douglas fir and silver fir) which explains the small AE signals generated during poplar damage.

**Figure 11:** Crack arrest at a vessel [16]
