Damage assessment of ancient masonry churches stroked by the Central Italy earthquakes of 2016 by the non-smooth contact dynamics method

Abstract

Keywords Non-smooth contact dynamics · Central Italy earthquake · Historical structures · Apennine churches · Damage survey

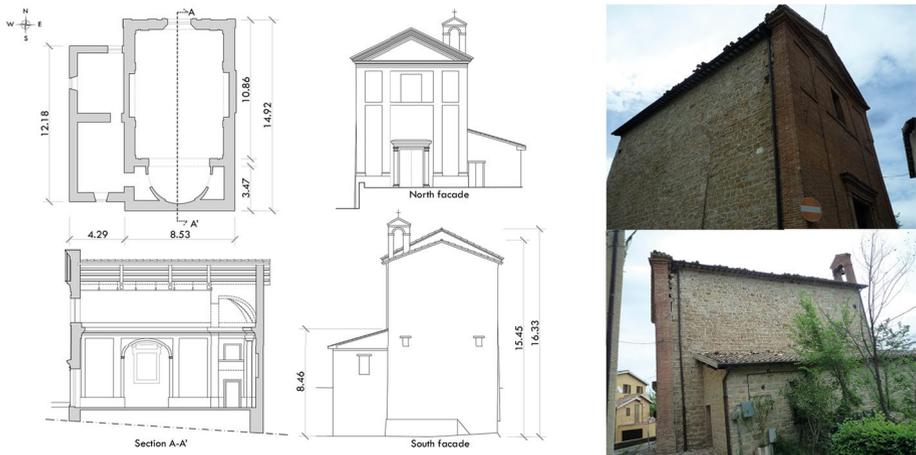
It was built in the thirteenth century and erected in place of a church seriously damaged by a quake occurred in 1799. During the seismic event of Umbria-Marche in 1997, the church had a structural failure of the foundation; the retrofitting intervention was executed in 1999. The church has a unique nave of 8.53 m wide, 14.92 m long and with a maximum height of 16 m. The thickness of the walls is in the range 0.7–0.8 m. The bearing structure is made with disordered rubble stone masonry; the façade is covered by brick masonry. The triumphal arch separates the apse from the nave area. The arch is embedded in a brickwork board, with a circularly molded opening that is about 0.6 m thick. On one side there is an annex that has a rectangular shape with dimensions of 12.18 m × 4.29 m and a maximum height of 8.46 m (Fig. 4).

Fig. 4 Geometric configuration of Sant'Anna's church, Camerino

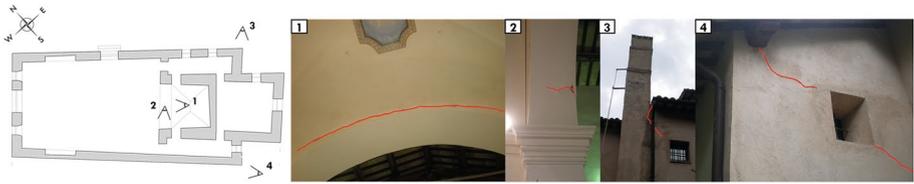
The major crack appeared on the barrel vault of the apse. Minor cracks are widespread on all the complex. The cracks between the church and the bell-gable underline the possible activation of the overturning mechanism, Fig. 11.

Fig. 11 Damage survey in Madonna of Valcora Sanctuary in Fiuminata after the Central Italy Earthquakes of 2016
