# **Damage assessment of ancient masonry churches stroked by the Central Italy earthquakes of 2016 by the non-smooth contact dynamics method**

Francesco Clementi, Angela Ferrante, Ersilia Giordano, Frédéric Dubois, Stefano Lenci

## Abstract

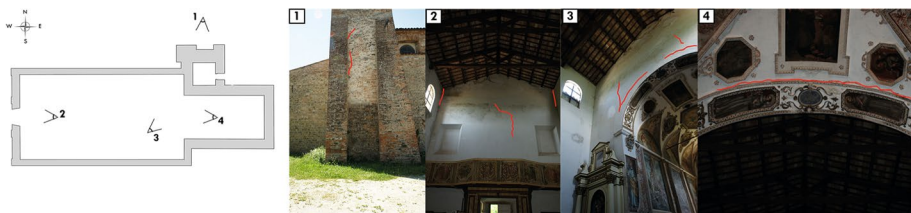
The major cracks appeared on the barrel vault of the apse, decorated with rich stuccos. The presence of a crack, between the bell-tower and the apse, suggest the possibility of the activation of bell tower rotation as also reported in the AEDES<sup>®</sup> (Zuccaro and Cacace 2015) fast sheet. Some little cracks were developed between the façade and the walls of the nave, on the middle of façade, on the triumphal arch and the connection between the north wall and the bell-tower, Fig. 7.

Fig. 7 Damage survey in the church of San Francesco in Montefortino after the Central Italy Earthquakes of 2016

Comparing the control points #1 and #3, Fig. 15, namely those on the main façade and on the triumphal arch, at varying of the main shocks we can observe that the resultant displacement of #1 is bigger than #3 for the shocks of 24th August and 26th October but becomes comparable with the shock of 30th October, and this confirms what happened in situ, i.e., that the major damages were associated with the main seismic action, where also some residual displacement is noticeable. In fact, comparing the enlargement of Fig. 15 with Figs. 16, 17, and 18, we see an evident out-of-plane displacement of the main façade (with more significant displacement on the top of it) and an in-plane action of the triumphal arch, and incidentally, confirm the real damages in Fig. 7.

occurred on the vault on the apse, namely point #4, where an evident collapse is noticeable with the main shock of the sequence, and again the damage is comparable to the real one reported in Fig. 7.

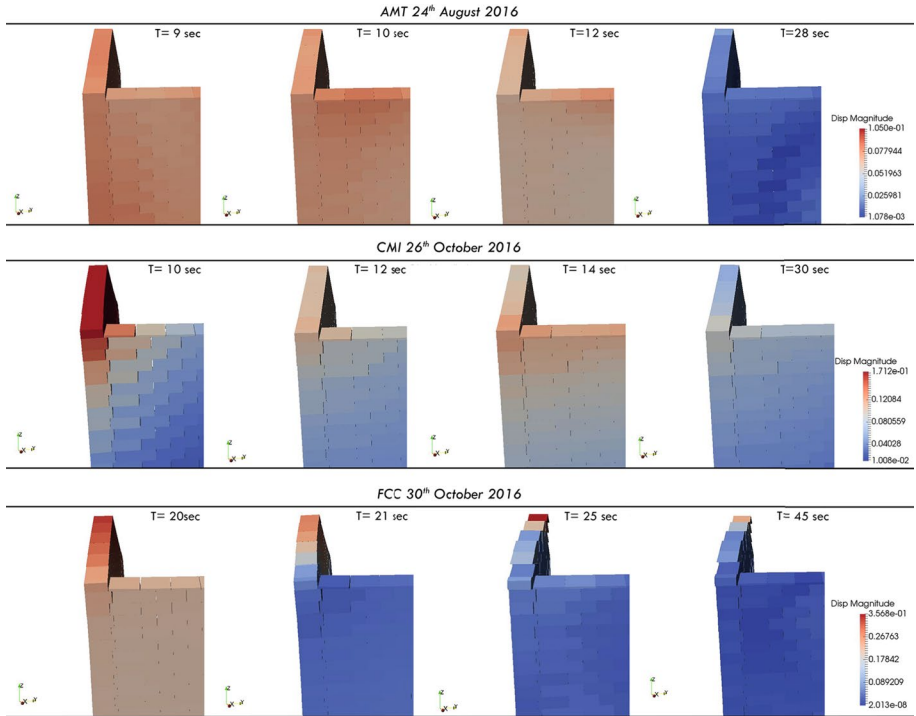
Fig. 25 Failure mechanism of the facade of Sant'Anna in Camerino (MC)

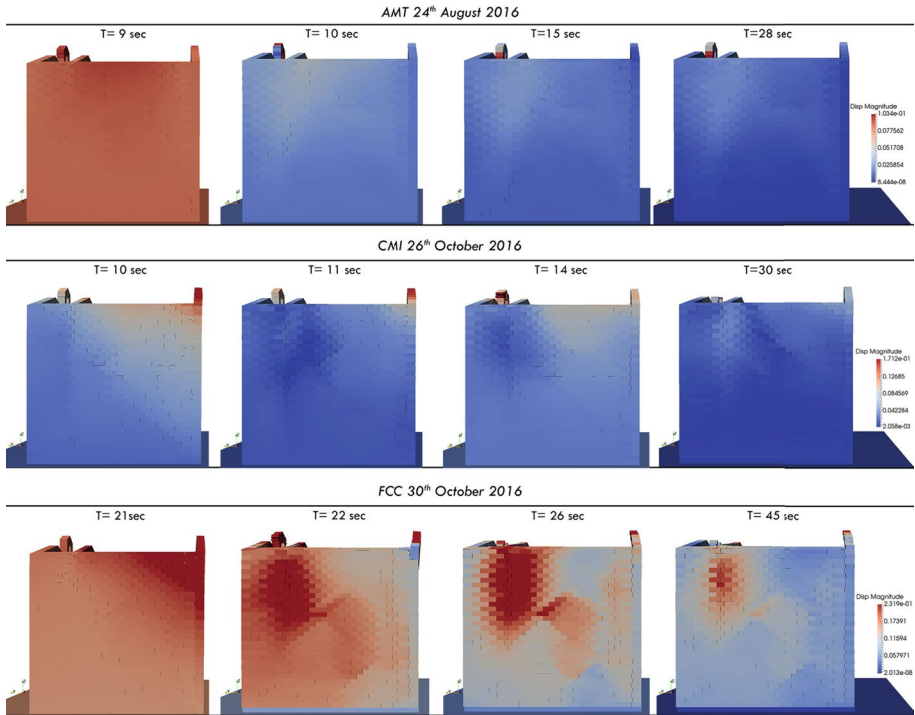
For the earthquake of the 26th October, a quite similar behavior is observed except for the control points #1 and #2, which have an opposite behavior compared to what we saw before. With the first jump of the velocity (see Fig. 14b) we can see an increase on the displacement of the main façade (#1), that corresponds to a more visible overturning mechanism in Fig. 25 to which follows an increase in the vertical seismic action that strongly stresses the bell-gable until it collapses. Then a general higher deformation along the church is noticeable if compared to the previous case, with some more evident misalignment of the blocks in the out-of-plane direction in the left upper part of the wall of the nave (Fig. 26), corresponding to the connection with the triumphal arch.

**Fig. 26** Failure mechanism of the façade, wall, and steeple of Sant'Anna in Camerino (MC)
