Corrosion of rebars embedded in ancient concrete: correlation between on site testing and corrosion products identification

Corrosion of Rebars Embedded in Ancient Concrete : Correlation between on Site Testing and Corrosion Products Identification

T 71

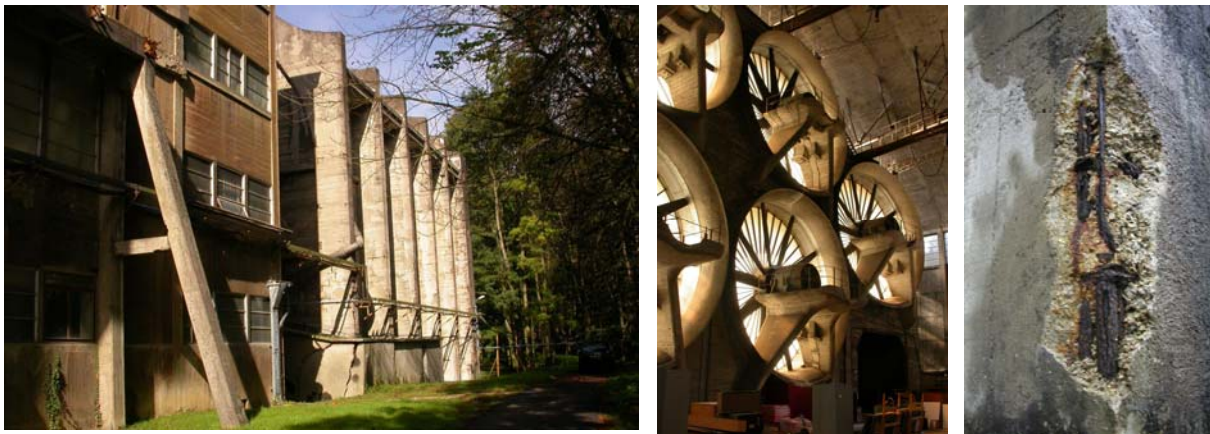
Figures 1, 2 and 3 : The air purifier (on the left) is an extension of the Meudon wind tunnel (in the center). It is locally very decayed, with large spalling areas (on the right) often linked to honeycombing.

Tests were performed on the extension of a wind tunnel, built in 1950 in the western suburb of Paris (Figs 1 and 2). On the eastern façade, of this ancient air purifier, numerous honeycombing and spalling areas were visible on the pillars, with locally very thick oxides layers (Fig. 3). Due to the age of the building, a carbonation induced corrosion was suspected.

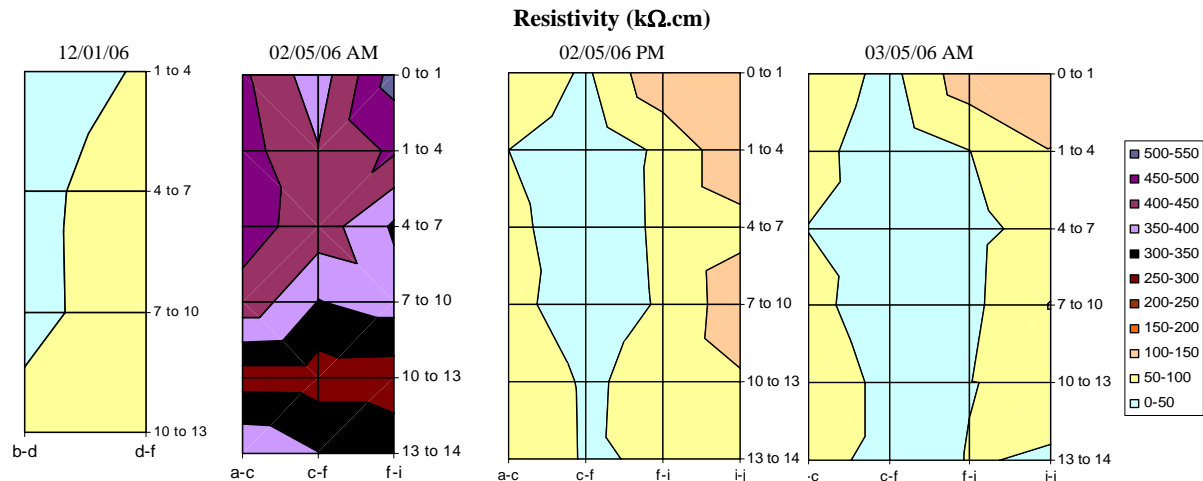
Figures 6, 7, 8 and 9 : Resistivity mapping realized in winter time (12/01/06) ; and in springtime after standard moistening (02/05/06 AM), after heavy moistening (02/05/06 PM), and after heavy and repeated moistening (03/05/06 AM).

In winter time (12/01/06, 5.2°C, 70% RH), resistivity values ranging between 9 and 30 were measured (Fig. 6), indicating a suitable moisture content for electrochemical measurements, with a moderate corrosion risk.

The first measurements performed in springtime (02/05/06 AM, 15.4°C, 53.3% RH, Fig. 7) after “standard” preliminary moistening, lead to resistivity values between 273 and 521 $\text{k}\Omega\cdot\text{cm}$, indicating that the concrete was clearly too dry.

After heavy moistening, a new series of measurements was carried out (02/05/06 PM, 18.5°C, 43.8% RH, Fig. 8), and resistivity values between 19 and 144 kΩ.cm were collected, indicating that the concrete was then wet enough for electrochemical measurements, even if the corrosion risk stayed moderate to low.

The day after, a last set of resistivity measurement was performed (03/05/07 PM, 19.7°C, 54.3% RH, Fig. 9), after heavy and repeated wetting of the testing area. Values very close to the previous ones, ranging between 10 and 133 kΩ.cm, were measured.

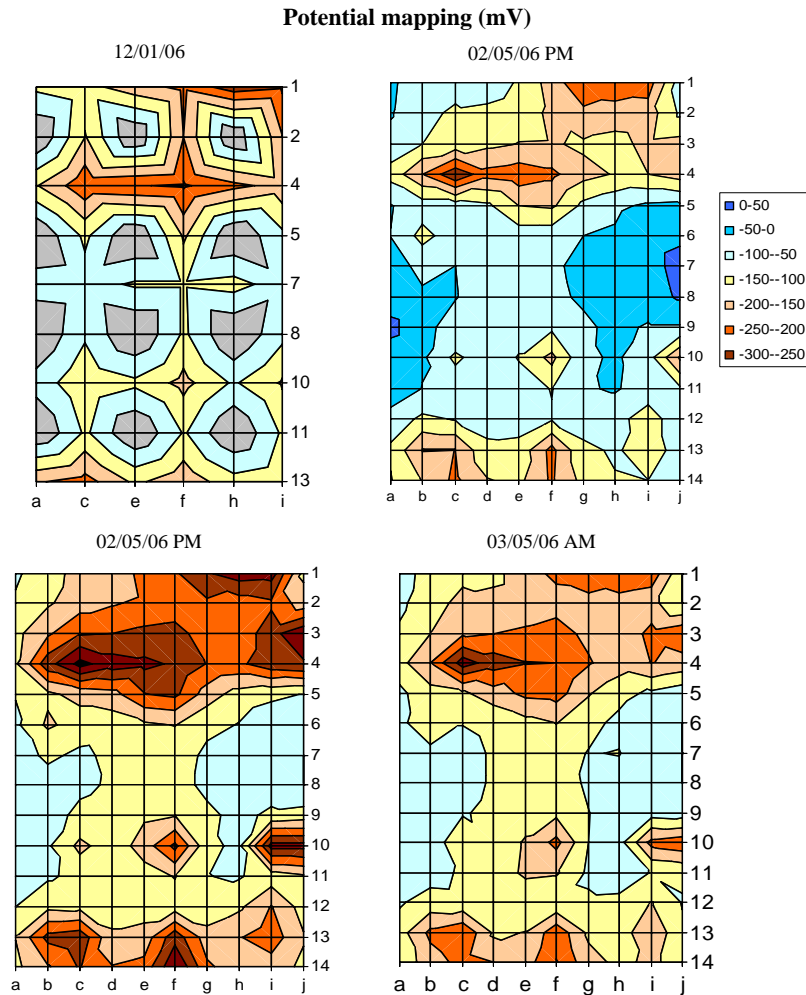
Figures 10, 11, 12 and 13 : Potential mapping realized in winter time (12/01/06) ; and in springtime after standard moistening (02/05/06 AM), after heavy moistening (02/05/06 PM), and after heavy and repeated moistening (03/05/06 AM).

On the first mapping, realized in winter time (12/01/06, 5.2°C, 70% RH, Fig. 10), potential values quite high, ranging between -69mV and -275 mV were measured. According to the ASTM standard it would indicate a low corrosion probability, but clear potential gradients were observed on the top two horizontal rebars (lines 1 and 4), and on the bottom of the testing area, indicative of a probable corrosion.

Then on the second mapping, performed in springtime (02/05/06 AM, 15.4°C, 53.3%RH, Fig. 11), even higher potential values were obtained (between -292mV and +15mV), confirming the resistivity measurement, indicating that the concrete was very dry. But on the same time, evident potential gradients were observed at the same location as in the winter measurements (i.e., on the top two horizontal rebars = lines 1 and 4, and on the bottom of the two first vertical rebars = lines c and f). Finally, the third and fourth potential maps respectively obtained after heavy wetting (02/05/06 PM, 18.5°C, 43.8% RH, Fig. 12) and heavy and repeated wetting (03/05/06 AM, 19.7°C, 54.3% RH, Fig. 13) were almost similar. The potential values drastically decreased (ranging between -20 and -367 mV) compared to the previous ones, but the same singular points were observed ; an additional one appearing more obviously on the fourth horizontal rebar (line 10).
