# Entire Life Time Monitoring of Filament Wound Composite Cylinders Using Bragg Grating Sensors: III. In-Service External Pressure Loading

Hilario Hernández-Moreno, Francis Collombet, Bernard Douchin, Dominique Choqueuse, Peter Davies

**Applied Composite Materials**

June 2009, Volume 16, Number 3 : Pages 135-147

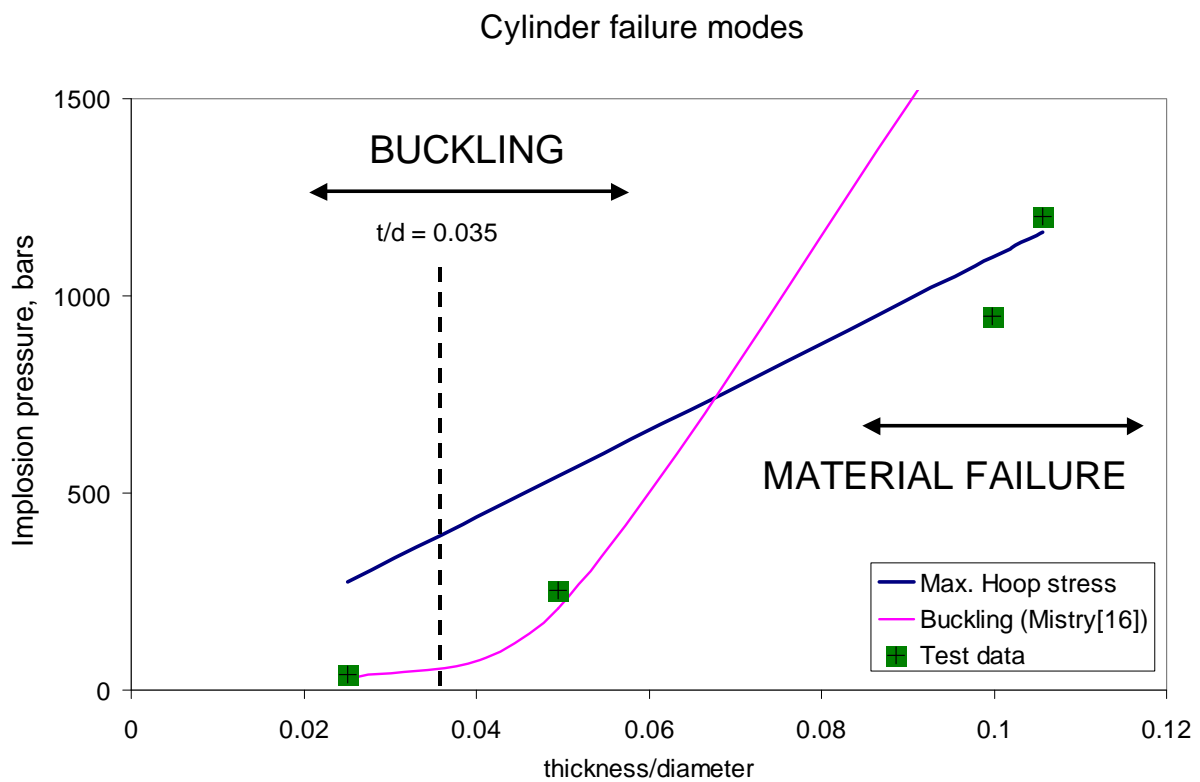
Figure 1. Implosion pressure versus thickness to mean diameter ( $t/d$ ) ratio, showing transition between buckling and material failure modes.

Several recent publications have described the response of glass/epoxy composite cylinders to external pressure [11-14]. Two failure modes can occur; buckling, usually associated with thin walled tubes, and material failure in compression observed in thicker cylinders. Figure 1 shows the two failure regions, together with some IFREMER data for  $\pm 55^\circ$  glass/epoxy cylinders. The limit between the two modes depends on the choice of failure criteria, both for buckling and material failure, and there is still considerable debate over the appropriate choice for this type of loading [15]. An analytical expression for buckling proposed by Mistry et al. [16] is plotted in Figure 1, together with a simple maximum hoop stress criterion for which the critical value is taken as 500 MPa for material failure. Given the uncertainty in predicting implosion pressures most applications rely on qualification testing. This is performed in pressure vessels, on tubes which are closed by metallic end plates. The design of these end closures, which determine the test boundary conditions, is particularly important when thick wall tubes are tested if premature failure is to be avoided [17] [18]. In a test cylinder, strain sensors (strain gages) are placed on the structure at the moment when the specimen is being prepared for testing, so the initial strain within the material is unknown, though sometimes it can be estimated. One aim of the present study is to include the specimen residual strain, which is measured during fabrication, in the design of the pressure vessel. For this it was necessary to demonstrate that the same Bragg gratings could be used to follow both manufacturing and pressure testing.

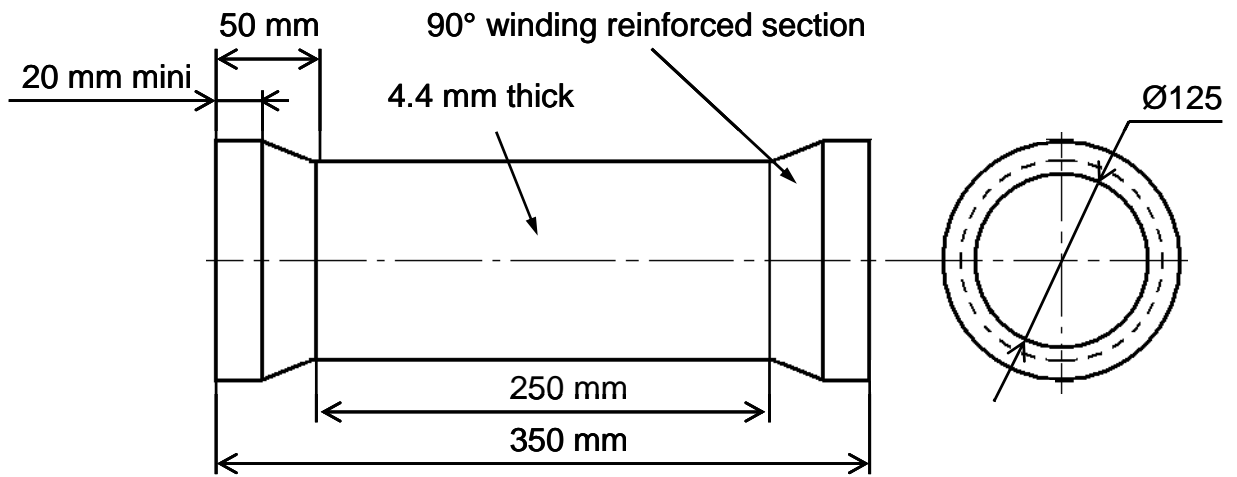
Figure 2. General dimensions of specimen with machined ends.

reinforced with 3.5 mm width glass fibre rovings (1200 tex). The epoxy resin system used is a mixture of Araldite LY 5052 and hardener HY 5052. Winding angle is  $\pm 55^\circ$  with respect to the cylinder axis. The number of layers is 7 (one filament wound layer is composed of the equivalent of two unidirectional layers, at  $+55^\circ$  and  $-55^\circ$ ). The specimen has zones of reinforcing fibers at both ends with a winding angle of  $90^\circ$ . These allow plane surfaces to be obtained by a machining operation in order to form the interfaces with metallic closures (Figure 2), [20]. The instrumented specimen used for pressure testing here was cylinder 37 (see Part II [8]), which has one rhomboid pattern in the circumferential direction. The Bragg gratings are located at mid-length of the cylinder, between the first and second reinforcement layers near the inner surface. Based on the results from previous tests (Figure 1) these are thin wall cylinders with a  $t/d$  ratio of 0.035, and would be expected to fail during pressure testing by buckling.

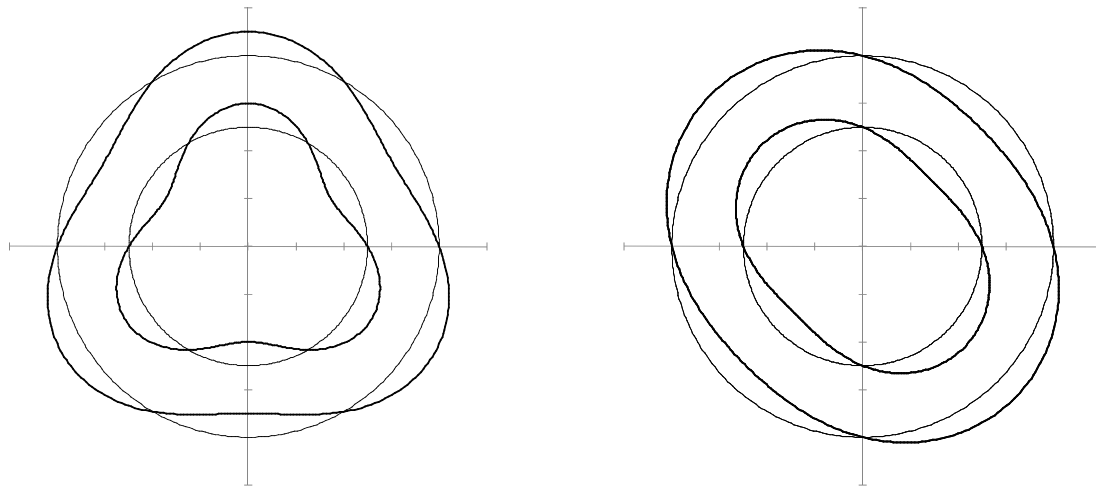
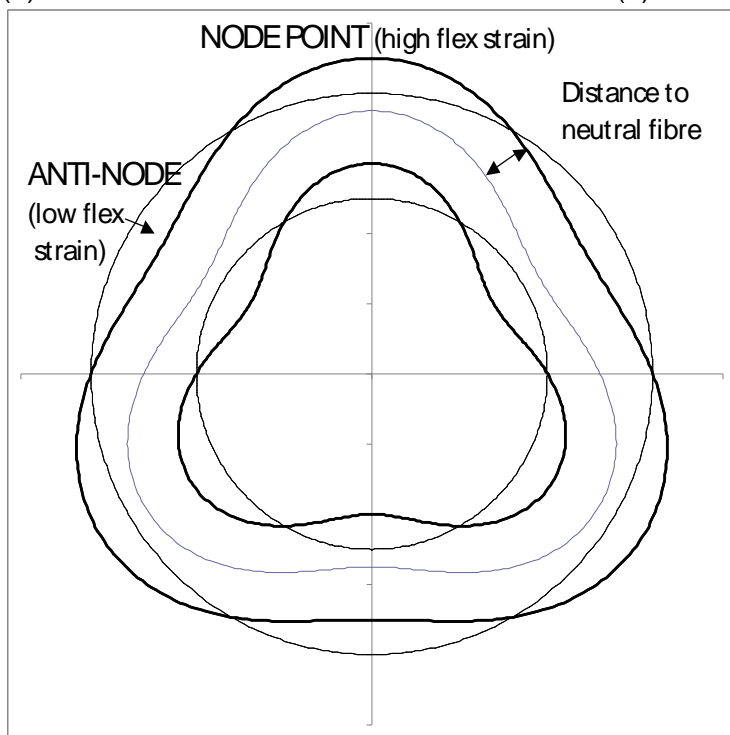
Figure 3. a) Mode 2, b) Mode 3 mode-shapes and c) Strain sensitivity at different points.

Taking into account the failure mode of cylinders under pressure (buckling) the sensor must be placed on the structure at the adequate location in order to be sensitive to the resulting deformation. The sensor was therefore placed in the mid-section of the cylinder, between the first and the second ply of the structure. In plane deformations of the central part of the cylinder correspond to the sum of the global compression deformation of the structure and the flexural deformation induced by the buckling mode of the structure. The flexural deformations of the ring induced by the buckling of the structure for the more common mode-shapes (modes 2 and 3) are shown in figure 3a and 3b. This indicates that the flexural deformation depends on:

The response to flexural deformation of a sensor will be zero if it is placed at a node point of the mode-shape and maximum at the anti-node point, Figure 3c. In the same way the sensor placed on the surface of the material (outer or inner) will have the maximum sensitivity to the flexural deformation while a sensor placed at the mid thickness of the material will not measure any bending strain. In this initial study to validate the use of embedded optical sensors the cylinder was equipped with two Bragg gratings, one placed in the axial direction and the second lying along the circumference, as shown in Figure 4a. Results from fabrication monitoring indicated the presence of residual strains. Residual strains at 21°C for this cylinder at the end of manufacturing were: in the axial direction  $-1025 \mu\epsilon$ , in the circumferential direction  $70 \mu\epsilon$ . For this test, one end closure was provided with a sealed passage tube, in order to connect the optical fibers to the chamber cover. In order to monitor strains during the entire service life of the structure (up to 10 years for some underwater applications) the optical fiber must be carefully protected from the external environment. The main objectives are:

When pressure-strain diagrams are analyzed (Figures 12 and 13), a critical pressure can be observed around 5.5 MPa (the pressure at which the pressure versus strain plot becomes non-linear). Beyond this point, a Bragg grating hysteresis response is observed, which is not detected by the strain gages. The reasons for this hysteresis are not clear, more tests are required to investigate its origins. Observing each diagram between 0 and 5 MPa (before pressure reaches a critical value), the Bragg grating strain response follows a very similar slope to that of the strain gages, within the variations between the strain gages (due to different flexural strains at different points on the mode-shape as indicated in Figure 3c).

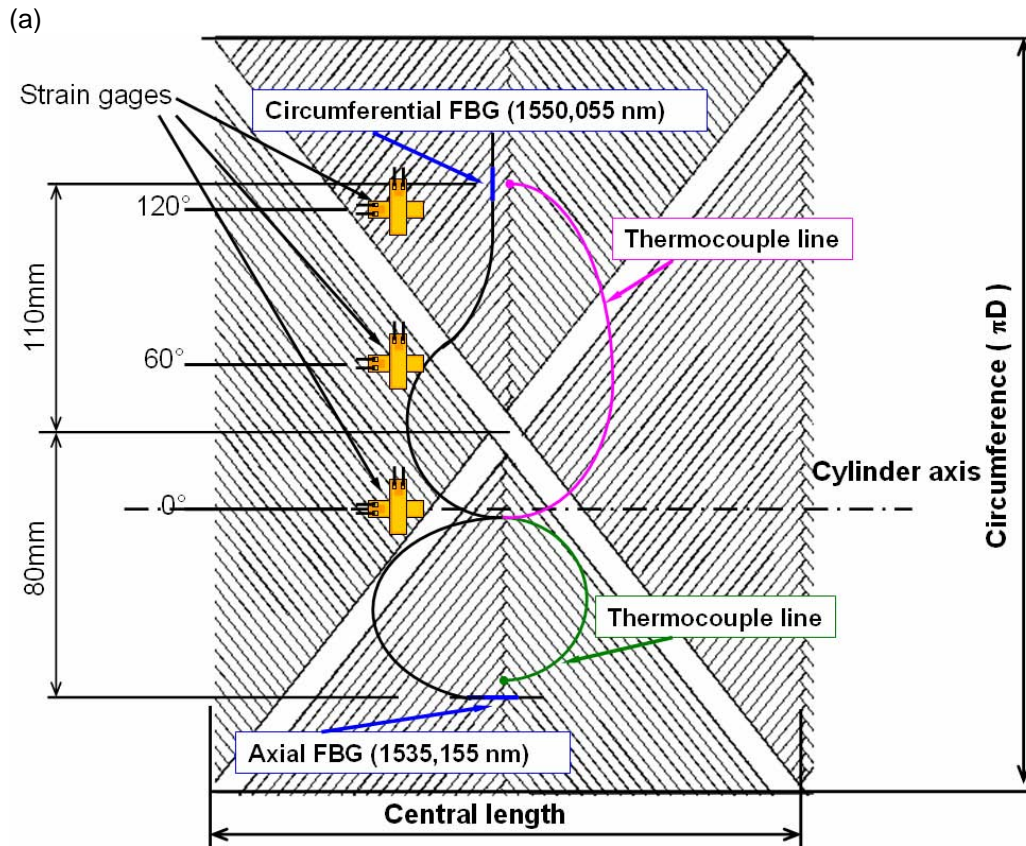
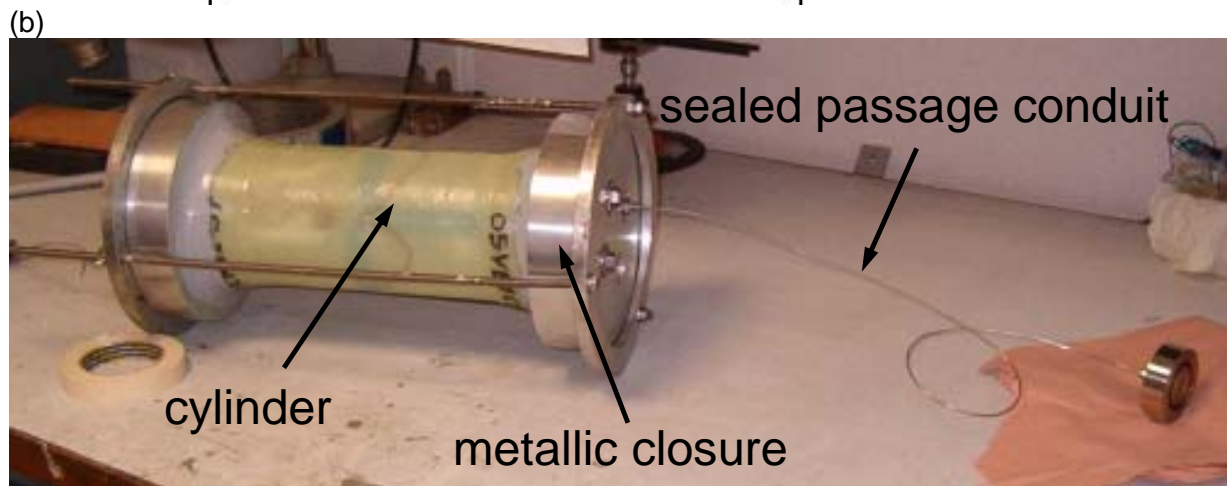
Figure 4. Instrumented cylinder with a) Strain and temperature measurement points, b) Complete cylinder and closure system before external pressure testing in hyperbaric chamber.

This cylinder was also instrumented with strain gages to compare with the Bragg grating results. These were bonded on the inner surface of the cylinder, three in the circumferential direction and three in the axial direction, but only one of the latter functioned correctly during the test. These are also shown on Figure 4a. The conditioned cylinder before testing is shown in figure 4b. The test was performed using the 1000 bar capacity hyperbaric testing chamber shown in figure 5.

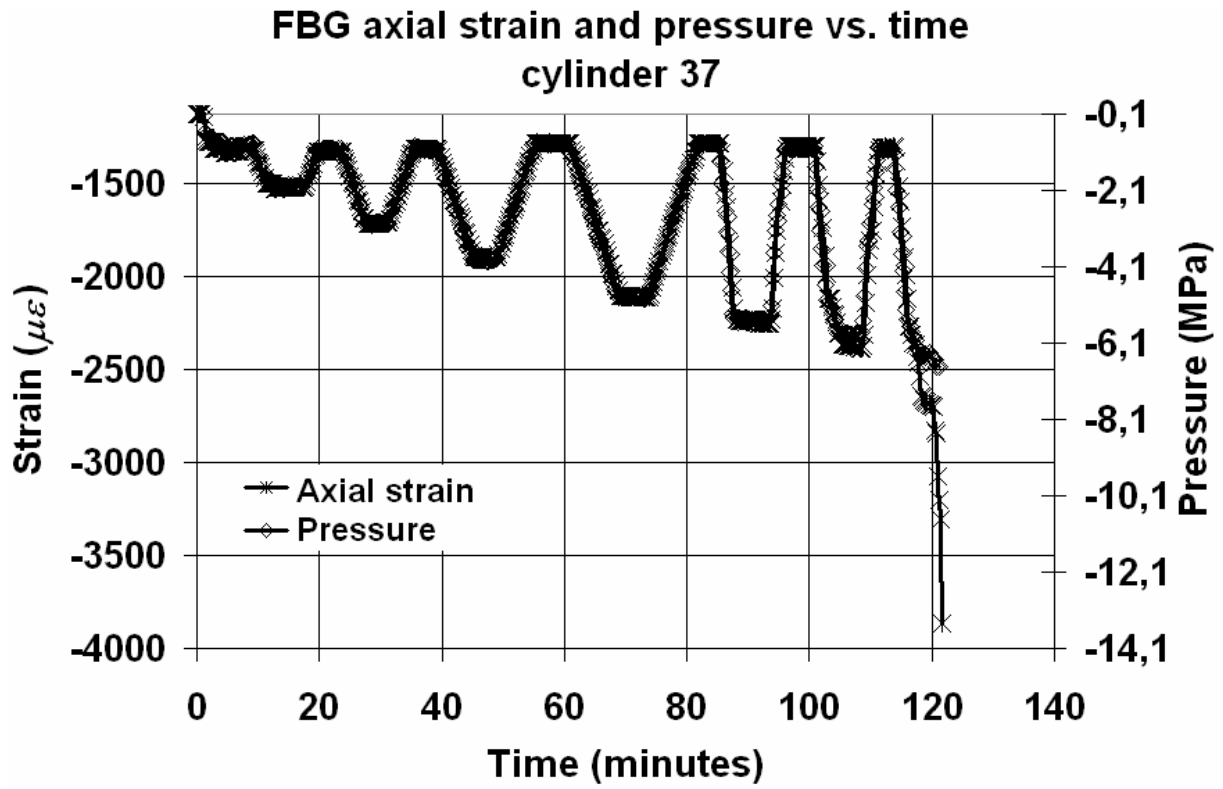
Figure 6. Axial strain from Bragg grating and pressure vs. time.

Loading and unloading pressure cycles were applied, Figures 6 and 7, with pressure increments of 10 bar, starting at 10 bar. Once the pressure had stabilized at 10 bars, the first loading – unloading cycle was composed of a pressure ramp until 20 bar, followed by a constant pressure segment lasting 5 minutes and an unloading ramp to 10 bars. Subsequent cycles have the same shape, but each time the final value is higher by 10 bar. The loading and unloading rate was 1 MPa/min for the first 4 cycles (up to 5 MPa) then increased to 3 MPa/min for the last 3 cycles (up to collapse). During the entire test, strain responses from gages and pressure signals are recorded with a data acquisition system, with a sampling frequency of 4 readings per minute. This sampling frequency is limited by the data acquisition program available, which was developed to interrogate a large number of strain gages inside the pressure vessel via a single connecting cable. Central Bragg grating wavelengths were recorded continuously using a different acquisition system with a higher frequency of 5 Hz. Bragg grating wavelengths are transformed into strains following the

The Bragg grating strain response is initially proportional to pressure (Figures 6 and 7), but for the last three cycles there is a slight deviation, which may indicate a change in shape due to buckling or damage initiation. Bragg grating data is recorded for slightly longer than the pressure data at rupture due to the difference in sampling periods, 15 s for the pressure gage and 0.2 s for Bragg gratings, indicating the functionality of the latter until the last moments of the specimen life.

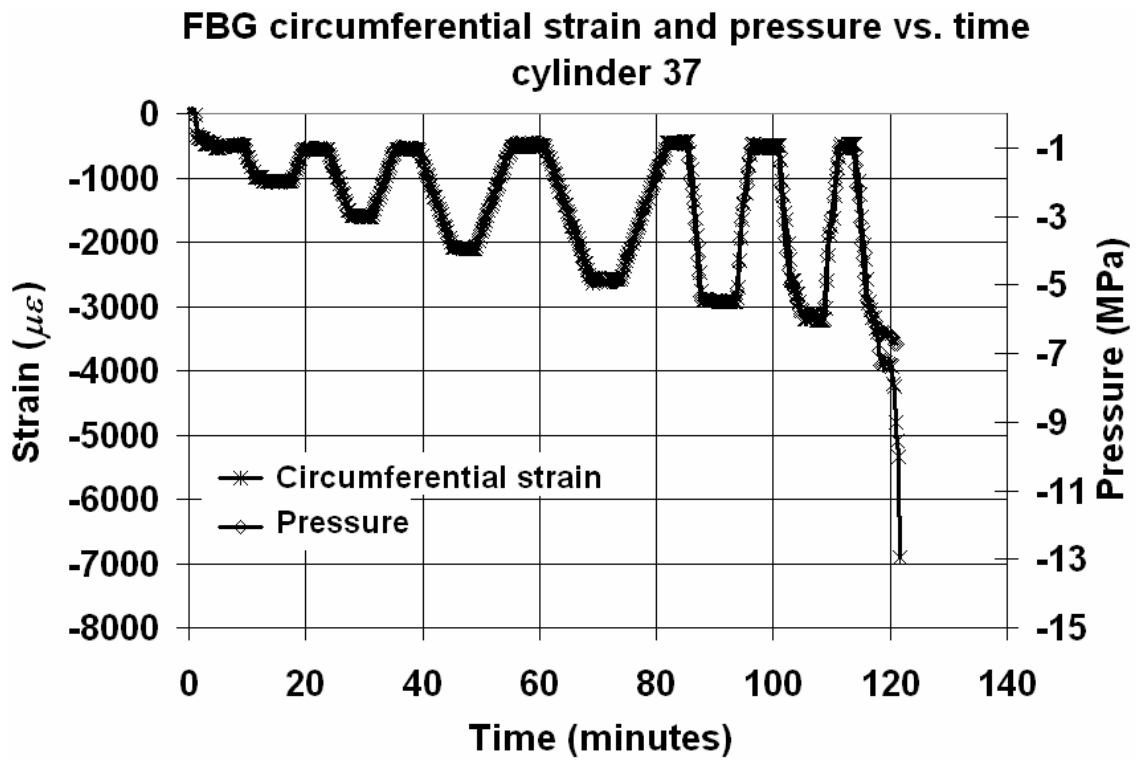
Figure 7. Circumferential strain from Bragg grating and pressure vs. time.

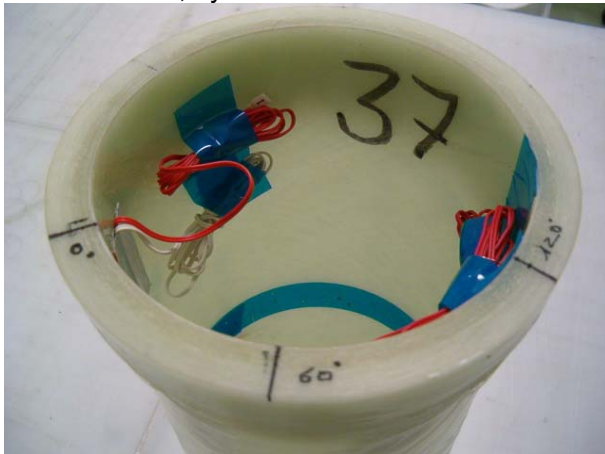
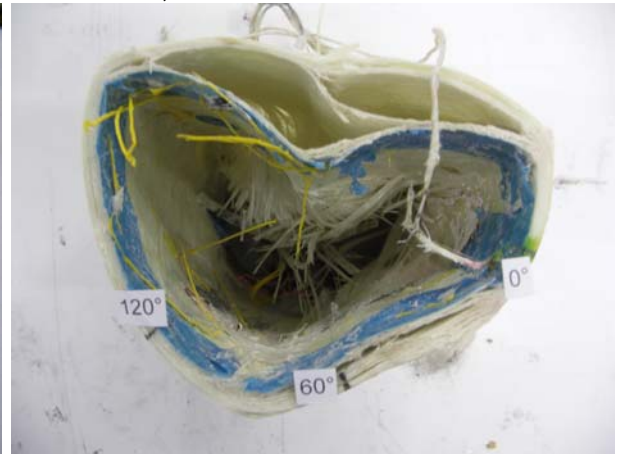
a. Before test, cylinder end

b. After test, mid-section

Figure 8. a) Cylinder before test, b) Cylinder mid-section after implosion, buckled mode  $n=3$ .

Results from the five initial tests to failure indicated a mean value of implosion pressure of 6.5 MPa, with a standard deviation of 0.4 MPa (Table 2), as described previously [19]. In all but one case the cylinders buckled with a 3-lobe circumferential failure mode. The implosion pressure for the test on the cylinder with the Bragg grating was 6.7 MPa, which is within one standard deviation of the mean value obtained on non-instrumented specimens, and showed the same 3-lobe buckling failure mode, Figure 8. This result indicates that the embedded instrumentation has no significant influence on mechanical strength at implosion.

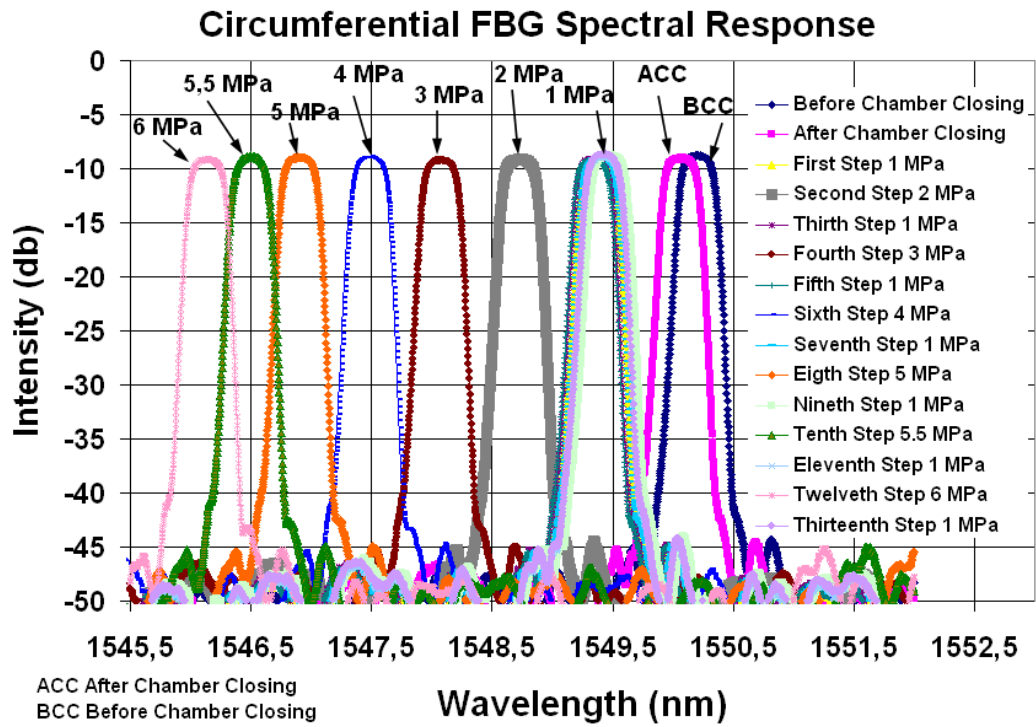
Figure 9. Circumferential FBG spectra during pressure test cycles.

Spectral response of both gratings (axial and circumferential) were recorded at specific points during the test, specifically before and after pressure vessel closure and at the different pressure steps (10, 20, 10, 30, 10, 40, 10, 50, 55, 60, 10 Bar), in order to check for any spectrum shape variation. Examples of circumferential grating spectra are shown in Figure 9, the axial spectra are very similar. Analyzing spectral response it can be seen that throughout the test, the shape of spectra does not vary, this means that loads transverse to the optical fiber axis do not influence the grating response significantly, so the grating response is solely due to membrane strains and temperature (in this case the latter is almost constant).

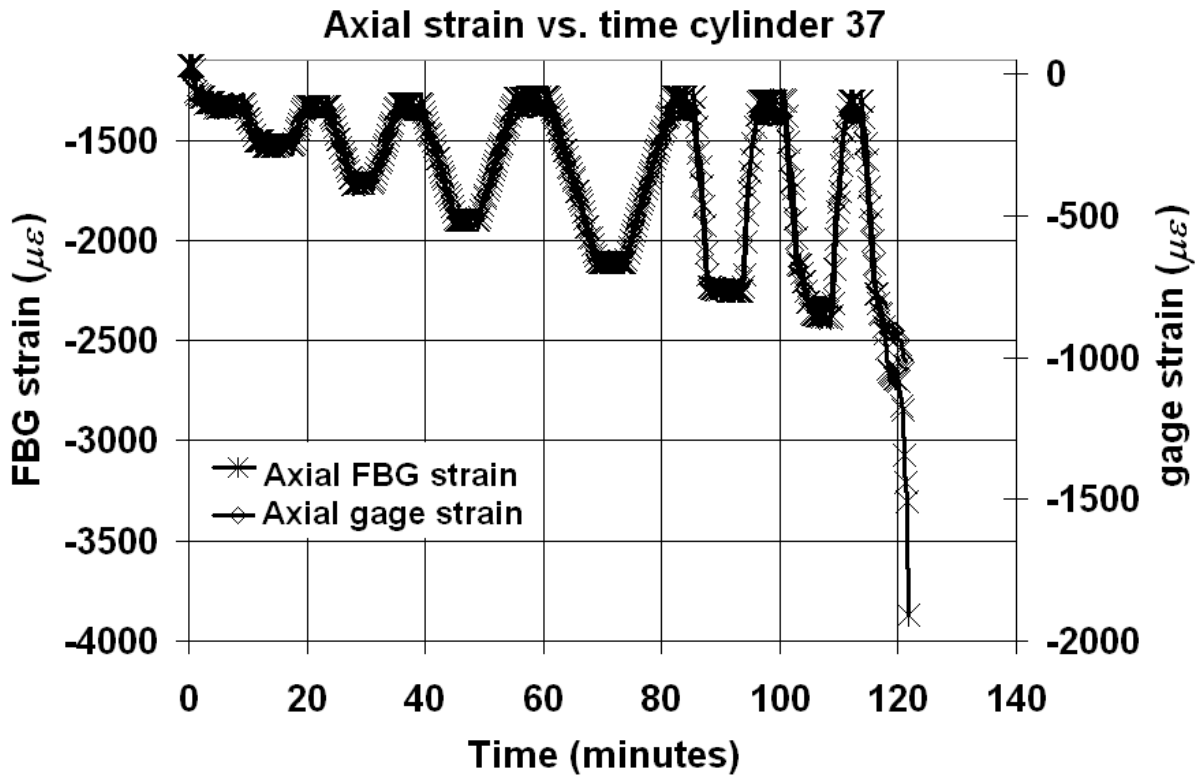
Figure 10. Bragg grating strain response and strain gage placed in axial direction.

The Bragg grating and strain gage responses show similar behavior (see Figures 10 and 11). As noted with respect to pressure, the Bragg grating strain during the last three cycles shows a small deviation compared with the strain gage values. As previously noted the absolute values measured will depend on the location of the measurement points with respect to the buckled shape. As the lobes develop some regions are more highly strained while others are unloaded, due to the induced local flexure. Only three strain gages were bonded round the circumference in this test, and this is not sufficient to represent the evolution of the buckled shape accurately. In order to be sure to capture the buckling mode correctly a larger number of strain gages are needed, and in some large cylinder tests over 100 can be used. In the axial direction the strain gage begins with an almost zero value while the Bragg grating already has  $1128\mu\varepsilon$  (Figure 8). This is due to the fact that the Bragg grating followed the strain evolution from fabrication including residual strain. In the circumferential direction (see Figure 7), this difference is not obvious because the residual strain indicated by the Bragg grating at the beginning is only  $21\mu\varepsilon$ . It is important to note that these residual strains evolved very little (by around 100 micro-strain) in the time between the end of manufacture and the start of the pressure test (6 months). This indicates that these are indeed permanent residual strains, which must be taken into account in cylinder design.

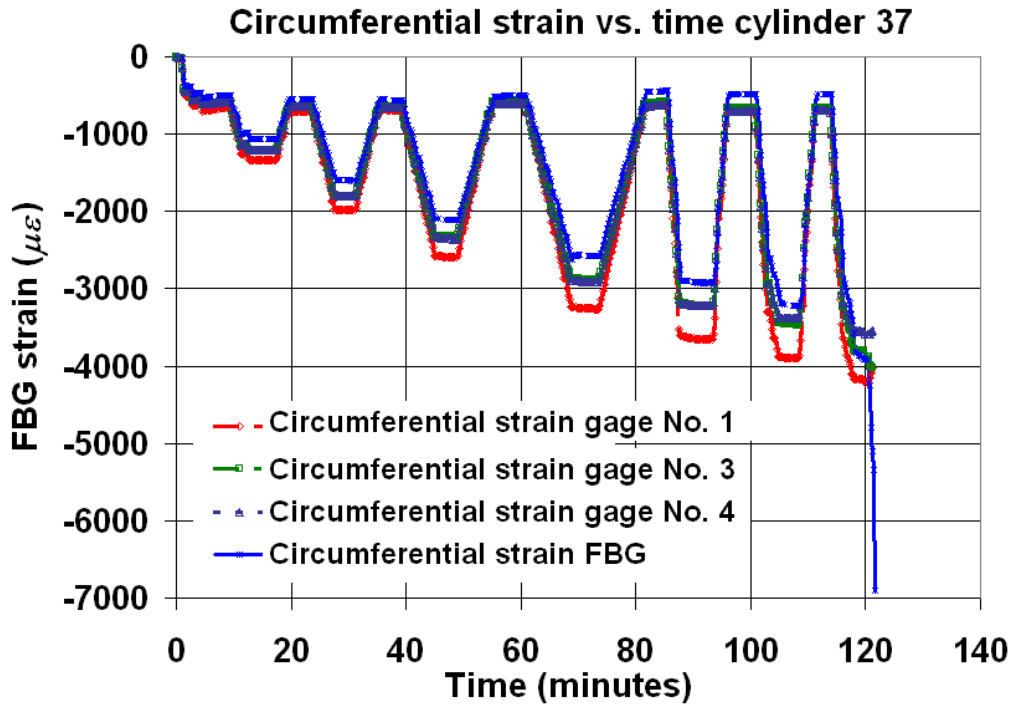
Figure 11. Bragg grating and strain gage response in circumferential direction.

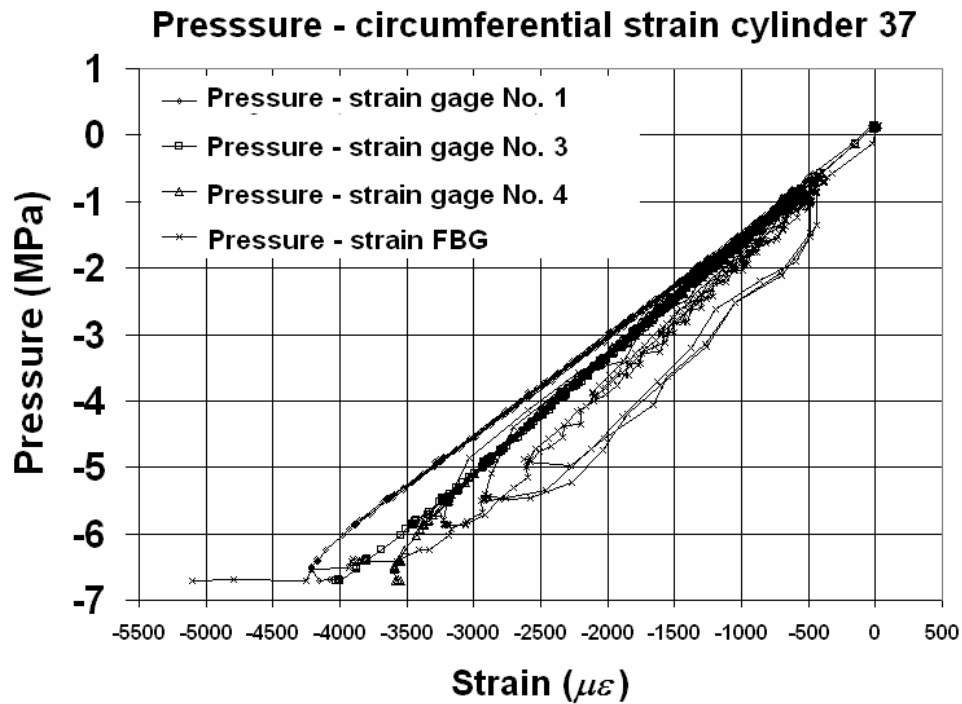
Figure 13. Circumferential pressure-strain plots.
