Entire Life Time Monitoring of Filament Wound Composite Cylinders Using Bragg Grating Sensors: III. In-Service External Pressure Loading

Applied Composite Materials

H. Hernández-Moreno^{1, 2}, F. Collombet^{1,*}, B. Douchin¹, D. Choqueuse³ and P. Davies³

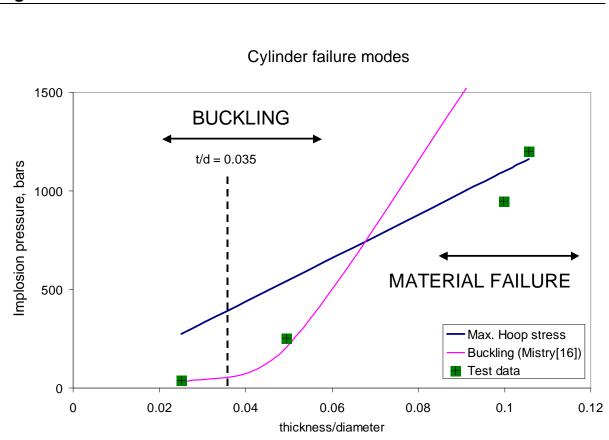
Figure 1. Implosion pressure versus thickness to mean diameter (t/d) ratio, showing transition between buckling and material failure modes.

Several recent publications have described the response of glass/epoxy composite cylinders to external pressure [11-14]. Two failure modes can occur; buckling, usually associated with thin walled tubes, and material failure in compression observed in thicker cylinders. Figure 1 shows the two failure regions, together with some IFREMER data for ±55° glass/epoxy cylinders. The limit between the two modes depends on the choice of failure criteria, both for buckling and material failure, and there is still considerable debate over the appropriate choice for this type of loading [15]. An analytical expression for buckling proposed by Mistry et al. [16] is plotted in Figure 1, together with a simple maximum hoop stress criterion for which the critical value is taken as 500 MPa for material failure. Given the uncertainty in predicting implosion pressures most applications rely on qualification testing. This is performed in pressure vessels, on tubes which are closed by metallic end plates. The design of these end closures, which determine the test boundary conditions, is particularly important when thick wall tubes are tested if premature failure is to be avoided [17] [18]. In a test cylinder, strain sensors (strain gages) are placed on the structure at the moment when the specimen is being prepared for testing, so the initial strain within the material is unknown, though sometimes it can be estimated. One aim of the present study is to include the specimen residual strain, which is measured during fabrication, in the design of the pressure vessel. For this it was necessary to demonstrate that the same Bragg gratings could be used to follow both manufacturing and pressure testing.

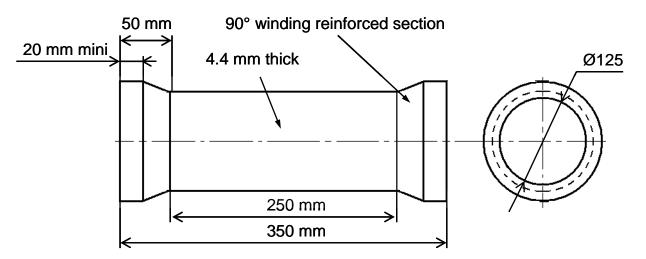
Figure 2. General dimensions of specimen with machined ends.

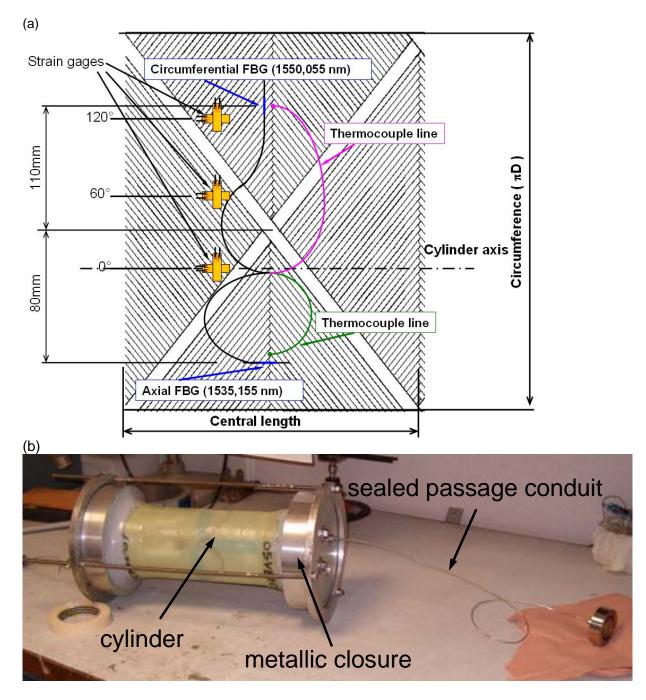
Figure 4. Instrumented cylinder with a) Strain and temperature measurement points, b) Complete cylinder and closure system before external pressure testing in hyperbaric chamber.

This cylinder was also instrumented with strain gages to compare with the Bragg grating results. These were bonded on the inner surface of the cylinder, three in the circumferential direction and three in the axial direction, but only one of the latter functioned correctly during the test. These are also shown on Figure 4a. The conditioned cylinder before testing is shown in figure 4b. The test was performed using the 1000 bar capacity hyperbaric testing chamber shown in figure 5.

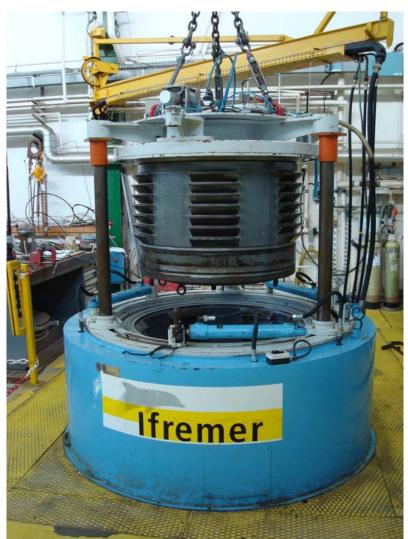
Figure 5. 1000 bar hyperbaric pressure testing chamber.

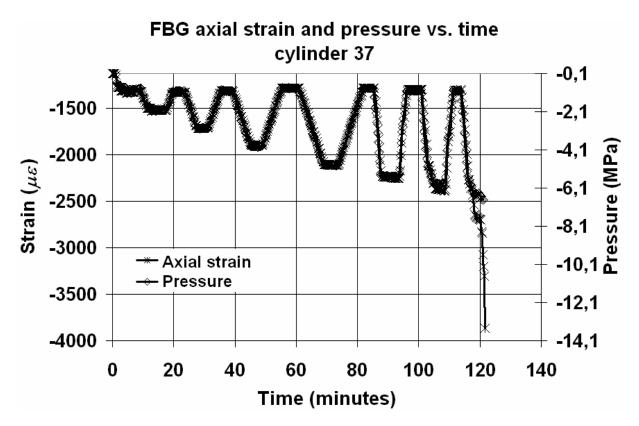
Figure 6. Axial strain from Bragg grating and pressure vs. time.

Loading and unloading pressure cycles were applied, Figures 6 and 7, with pressure increments of 10 bar, starting at 10 bar. Once the pressure had stabilized at 10 bars, the first loading – unloading cycle was composed of a pressure ramp until 20 bar, followed by a constant pressure segment lasting 5 minutes and an unloading ramp to 10 bars. Subsequent cycles have the same shape, but each time the final value is higher by 10 bar. The loading and unloading rate was 1 MPa/min for the first 4 cycles (up to 5 MPa) then increased to 3 MPa/min for the last 3 cycles (up to collapse). During the entire test, strain responses from gages and pressure signals are recorded with a data acquisition system, with a sampling frequency of 4 readings per minute. This sampling frequency is limited by the data acquisition program available, which was developed to interrogate a large number of strain gages inside the pressure vessel via a single connecting cable. Central Bragg grating wavelengths were recorded continuously using a different acquisition system with a higher frequency of 5 Hz. Bragg grating wavelengths are transformed into strains following the

The Bragg grating strain response is initially proportional to pressure (Figures 6 and 7), but for the last three cycles there is a slight deviation, which may indicate a change in shape due to buckling or damage initiation. Bragg grating data is recorded for slightly longer than the pressure data at rupture due to the difference in sampling periods, 15 s for the pressure gage and 0.2 s for Bragg gratings, indicating the functionality of the latter until the last moments of the specimen life.

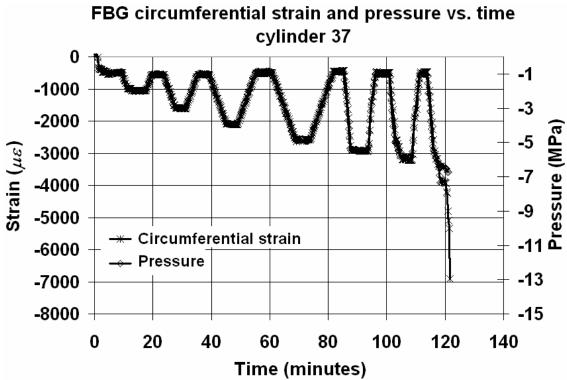
Figure 7. Circumferential strain from Bragg grating and pressure vs. time.

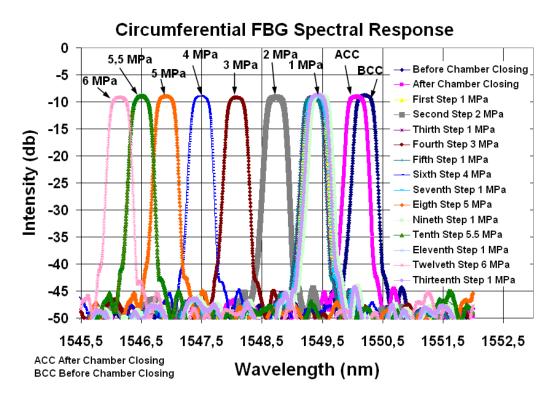
Figure 9. Circumferential FBG spectra during pressure test cycles.

Spectral response of both gratings (axial and circumferential) were recorded at specific points during the test, specifically before and after pressure vessel closure and at the different pressure steps (10, 20, 10, 30, 10, 40, 10, 50, 55, 60, 10 Bar), in order to check for any spectrum shape variation. Examples of circumferential grating spectra are shown in Figure 9, the axial spectra are very similar. Analyzing spectral response it can be seen that throughout the test, the shape of spectra does not vary, this means that loads transverse to the optical fiber axis do not influence the grating response significantly, so the grating response is solely due to membrane strains and temperature (in this case the latter is almost constant).

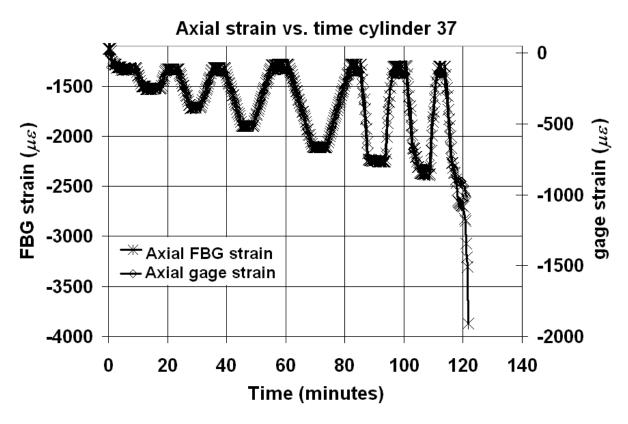
Figure 10. Bragg grating strain response and strain gage placed in axial direction.

The Bragg grating and strain gage responses show similar behavior (see Figures 10 and 11). As noted with respect to pressure, the Bragg grating strain during the last three cycles shows a small deviation compared with the strain gage values. As previously noted the absolute values measured will depend on the location of the measurement points with respect to the buckled shape. As the lobes develop some regions are more highly strained while others are unloaded, due to the induced local flexure. Only three strain gages were bonded round the circumference in this test, and this is not sufficient to represent the evolution of the buckled shape accurately. In order to be sure to capture the buckling mode correctly a larger number of strain gages are needed, and in some large cylinder tests over 100 can be used. In the axial direction the strain gage begins with an almost zero value while the Bragg grating already has $1128\mu\varepsilon$ (Figure 8). This is due to the fact that the Bragg grating followed the strain evolution from fabrication including residual strain. In the circumferential direction (see Figure 7), this difference is not obvious because the residual strain indicated by the Bragg grating at the beginning is only $21 \mu \epsilon$. It is important to note that these residual strains evolved very little (by around 100 micro-strain) in the time between the end of manufacture and the start of the pressure test (6 months). This indicates that these are indeed permanent residual strains, which must be taken into account in cylinder design.

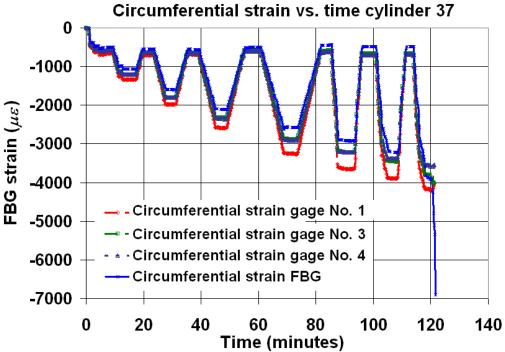
Figure 11. Bragg grating and strain gage response in circumferential direction.

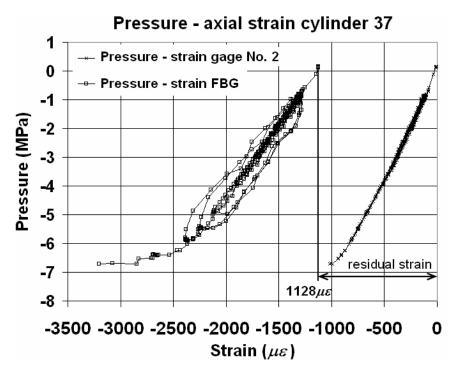
Figure 12. Axial pressure-strain plots.

When pressure-strain diagrams are analyzed (Figures 12 and 13), a critical pressure can be observed around 5.5 MPa (the pressure at which the pressure versus strain plot becomes non-linear). Beyond this point, a Bragg grating hysteresis response is observed, which is not detected by the strain gages. The reasons for this hysteresis are not clear, more tests are required to investigate its origins. Observing each diagram between 0 and 5 MPa (before pressure reaches a critical value), the Bragg grating strain response follows a very similar slope to that of the strain gages, within the variations between the strain gages (due to different flexural strains at different points on the mode-shape as indicated in Figure 3c).
