Crushing of composite tubular structures and energy absorption for aircraft seat development

CRUSHING OF COMPOSITE TUBULAR STRUCTURES AND ENERGY ABSORPTION FOR AIRCRAFT SEATS DEVELOPMENT

Keywords: Crushing, Composite tubes, Energy dissipation, Specific Energy Absorption, Aeronautics

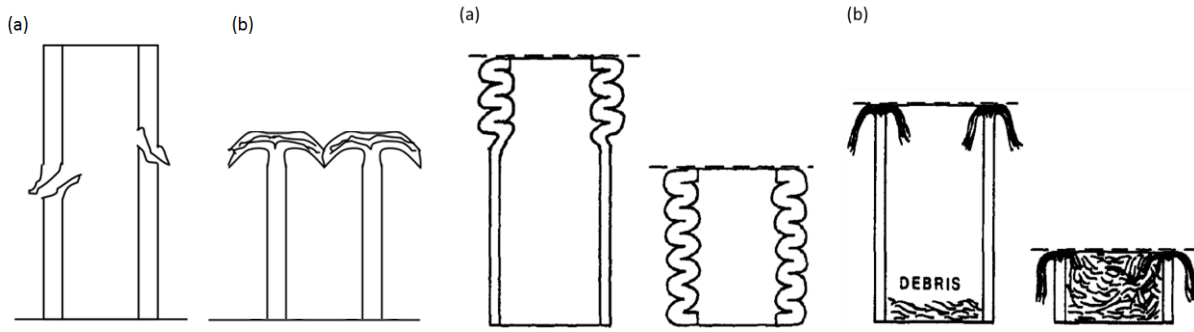
Figure 1. Catastrophic (a) and progressive (b) failure [2], progressive folding (c) and crushing (d) [3].

Two main failure mechanisms for composite tubular structures have been identified as either catastrophic or progressive failure [1, 2]. (Figure 1). For the latter failure mode, a distinction can be made as the composite tube may undergo progressive folding or progressive crushing [3]. (Figure 1). During the first case, composite tube walls progressively fold under successive local buckling (similar to shell buckling) when loaded in axial compression. The extremity of the tube yields in buckle mode, leading to hinge formation and progressive folding; the folded zone then grows progressively down the tube wall. For the second case, the tube collapses as a result of successive brittle fractures. The extremity of the tube breaks leading to the splaying of the tube wall and fragmentation. Local fracture occurs at the crush front; splaying and micro-fractures then propagate down the tube [3]. Such rupture tends to generate random sized debris.

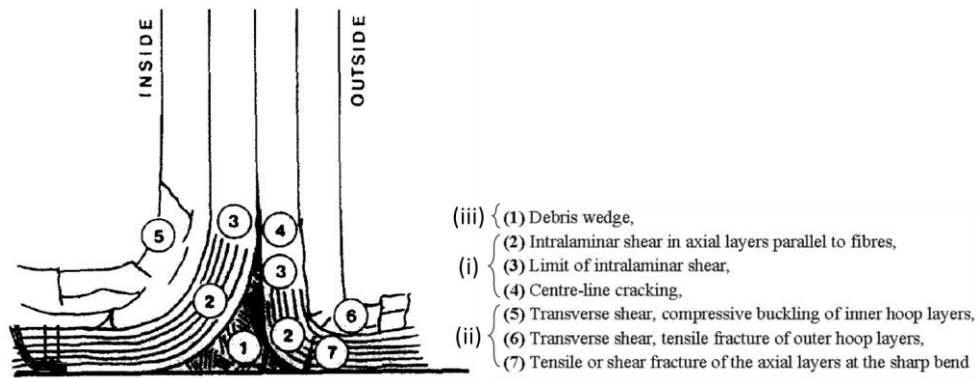
Figure 2. Main features and major damage mechanisms occurring at the crush zone (adapted from [3]).

In progressive crushing mode, damage mechanisms may be summed up into three types: (i) splaying, (ii) fragmentation and (iii) debris creation and accumulation [4]. (Figure 2).

Fragmentation might occur at two levels: under the tip of the plies (due to micro-buckling of fibers for 0° plies and to multiple shear micro-cracks for 90° plies) or within the plies as intra-laminar failure, fiber breakage and matrix cracks (due to a combination of compression, bending and shear) [4]. (Figure 2). The localized fragmentation at the tip of the plies is pointed as the mechanism leading to the definition of the ply Mean Crushing Stress (MCS) [4].

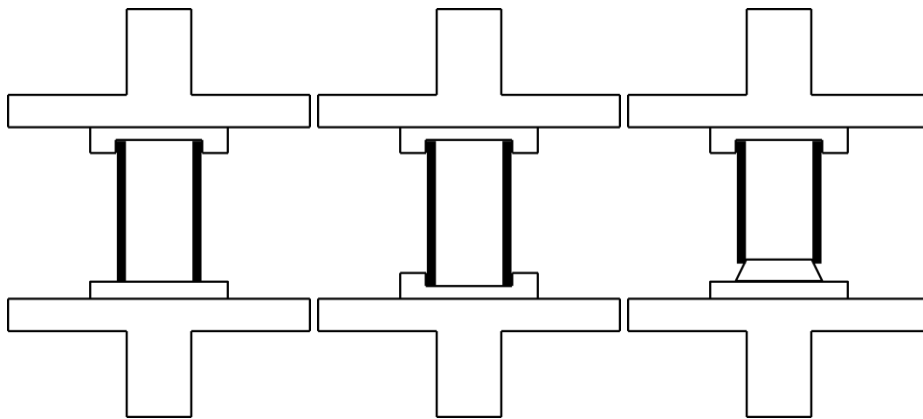
Figure 3. Experimental set-ups with one end free (a), encased (b) and on a conic plug initiator (c).

Quasi-static crushing tests were carried out using a 250 kN Schenck hydraulic testing machine in compression testing mode, through a constant loading speed of $0.2 \text{ mm}\cdot\text{s}^{-1}$. Several configurations were tested for crushing initiation and hopeful enhancement. Tubular structures were clamped and encased at one end, while several options were tested for the other. For instance, they were (a) let free on a plane surface, (b) also encased, (c) positioned on a conic plug initiator. Figure 3 presents these three configurations.

Although some specimens underwent catastrophic failure, breaking down from a midpoint zone of their wall length and not from their extremity, none underwent progressive folding, the majority following a progressive crushing scheme. Nevertheless, a clear difference was observed in the spreading array of damaged wall parts depending on the tests configurations (cf. Figure 3).

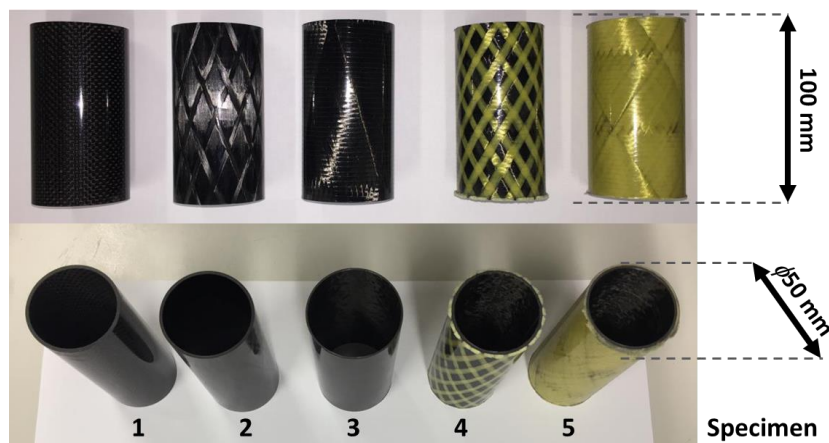
Figure 4. Picture of the five tube specimens with dimensions.

Five specimens with different structure and of different composition were tested in various crushing modes. Structural and material basis for the specimens include 12K HR carbon fibers and polymer Epoxy resin. Fibers orientation and laminate stratification differ from one specimen to another as shown in Figures 4 and 5 and summarized in Table 1. Provided tubular structures were machined and shaped in tubes of 100 mm length as pictured in Figure 4. Outer diameter was set at an average of 50 mm, with inner diameter varying from one sample to another due to stratification differences. Stratification layout and tube wall thickness are summarized in Table 1 for each sample.

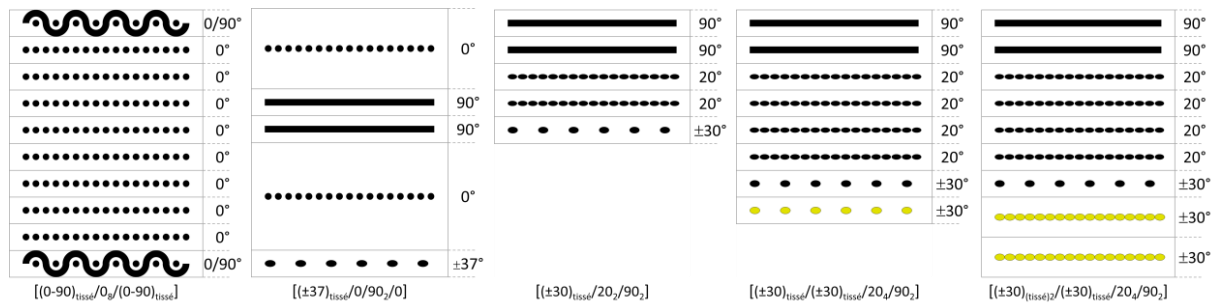
Figure 5. Schematic representation of the five tube specimens by their stratification.

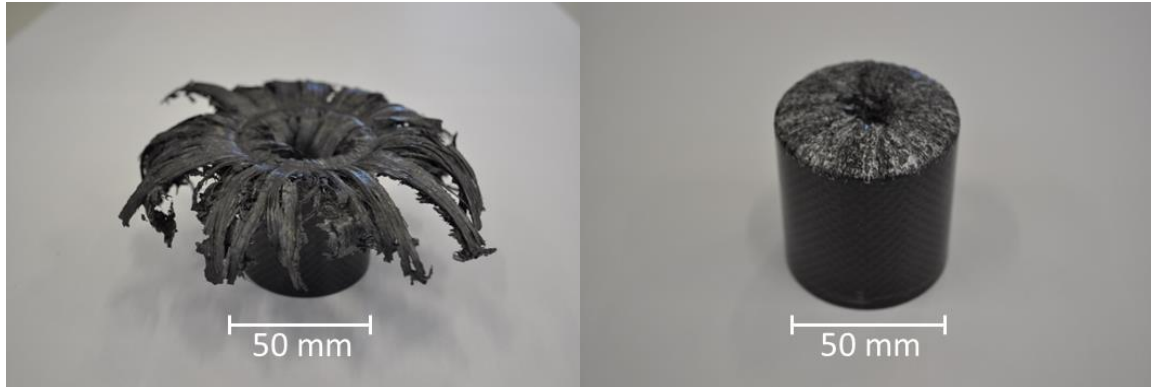
Figure 6. Crushed CFRP tubes showing outer spreading (left) and inner folding (right).

As an example, the pictures in Figure 6 present the difference in crushing behavior for the same CFRP tube specimen submitted to axial crushing under the first two different configurations presented in Figure 3. Both underwent progressive crushing. The first (left) corresponding to configuration type (a) presents inner and outer spreading of splayed parts, whereas the second (right) corresponding to configuration (b), have the whole bundle of splayed parts that folds towards the inside of the tube.

Configuration type (c), with a cone-shaped plug initiator, does not differ much from configuration type (a) apart from the fact that the entire splayed bundle spreads on the outside.

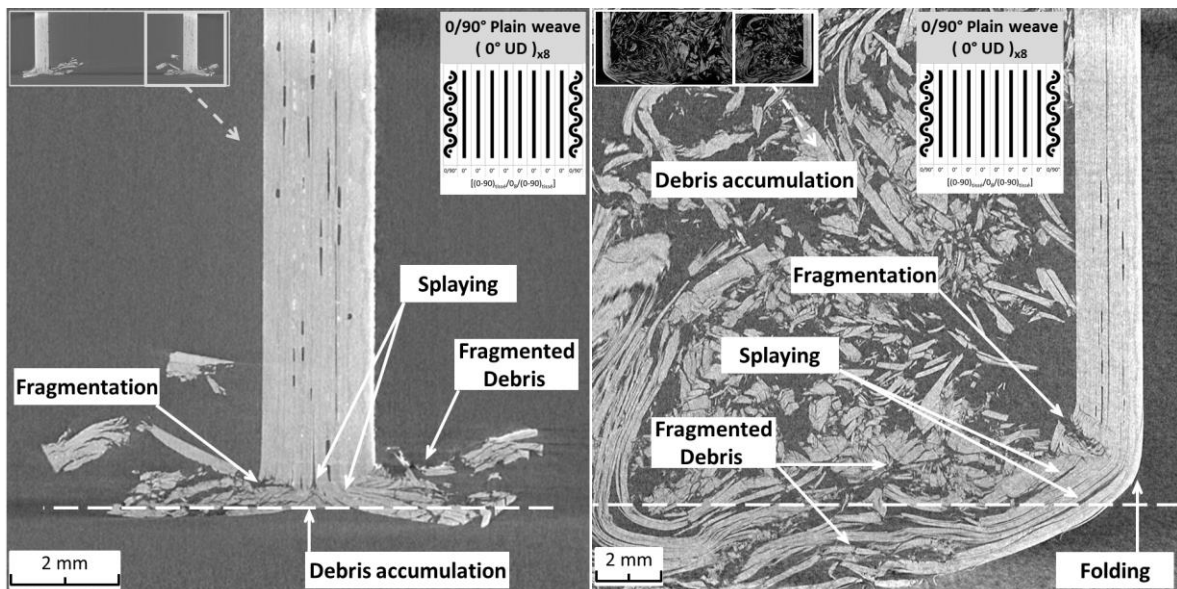
Figure 7. Tomographic images of crushed CFRP tubes showing major damage for two configurations.

Figure 7 highlights major occurring damage resulting from progressive crushing instigated by quasi-static axial compression load for specimen 1 through the means of tomographic imaging for two different crushing modes ((a) and (b) when referring to Figure 3). Inner (a, b) and outer (b) splaying of fragmented or un-fragmented parts are clearly visible, as well as debris accumulation.

The crushing plane surface is schematized by a discontinued line on both pictures on Figure 7. It is strongly suspected that for each tube samples, folded plies at the end of the tube walls between the sane part of the tubes and the crushing surface moved back downward when the crushing force was unloaded, due to a spring back effect. Hence an estimated positioning of the crushing surface appearing to be situated within the tube and entering inside the tube structure.

For the first configuration, a pyramidal-shaped debris accumulation can be observed at the center under the tube wall, between the tube section and the crushing surface, where the laminate plies spread towards the inside or the outside of the tubular structure. This debris accumulation forms from the void created by the plies splaying from the center under the tube wall then subsequently helps further and heighten this splaying.

At the contact surface between the tube circular section and the plane surface, micro-buckling occurs progressively and successively, resulting in matrix and/or fibers fragmentation for the laminate plies that undergo such splaying. This damage increases the debris formation. As observed and mentioned in previous study, the formation and the evacuation or accumulation of debris remains rather random.

For the second test configuration, damage mechanisms are similar in type and classification, but are all shifted toward the inside of the tube, since the outer wall is encased, leaving no leeway for splayed plies to spread that way. Incidentally, although major occurring damage are the same, their origin varies somewhat. Bending and folding resulting from the compression generate the splaying of the composite plies, and therefore the fracture and fragmentation for those sustaining a higher stress. Fragmentation still generates an important number of debris that varies in forms and shape, but those are freely evacuated from the crushing zone under the tube section to the inside of the tube. They do not form a tip that parts the laminate wall and split it, as observed with the pyramidal debris accumulation on the first configuration.

At the extremity of the tube wall, where the folding appears, outer plies seem to be more submitted to bending whereas inner plies undergo plain compression and break through intra-laminar fracture.

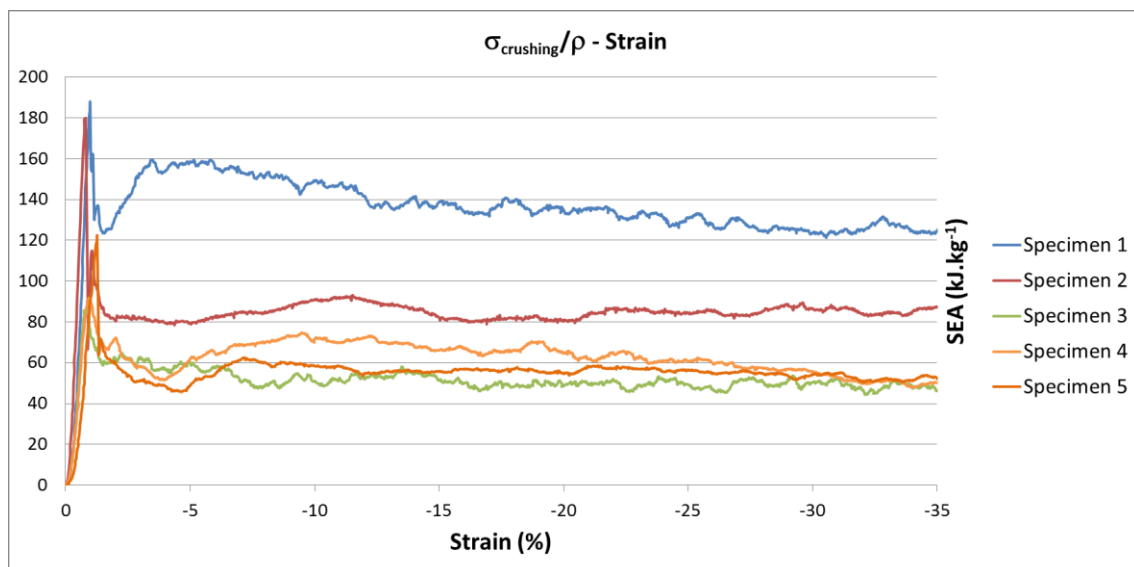
Figure 8. SEA evolution for 5 CFRP tube specimens submitted to pure axial crushing.

The Specific Energy Absorption was calculated after each crushing test for each specimen for every configuration. Results are presented in Figure 8, which highlights the benefit of specimen 1 in terms of energy absorption with a SEA value well above the others, at around 140 kJ.kg^{-1} , and the good performance of specimen 2, with a SEA value of around 80 kJ.kg^{-1} . It can be seen that specimens 3, 4 and 5 have a similar behavior and identical energy absorbing capability, but lesser than the others.

Similarity in behavior and energy absorbing capability for specimen 3, 4 and 5 are not incoherent when referring to Table 1 which shows the same basis structure for these specimens. Outer aramid covering does not improve or worsen the general behavior or energy absorbing capability.

For each axial compression tests, a stiff peak can be observed on the load-displacement curves or the stress/density-strain curves as showed on Figure 8, when the structure yields before it starts collapsing by progressive crushing at a stable and constant load, as reflected by the continuous plateau level. Ideally the gap between the peak and plateau value has to be reduced to a minimum, as a small gap and constant plateau level means an optimized dissipation of energy for a fixed and given load value.

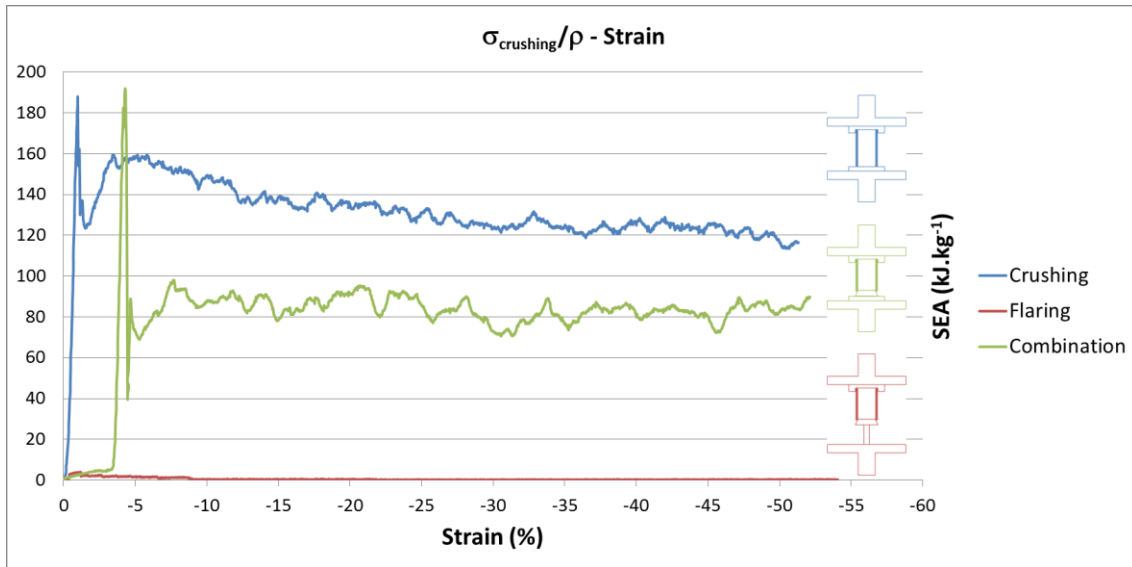
Figure 9. SEA evolution for 3 crushing configurations for the same CFRP tube specimen (n°1).

The use of a conic plug initiator to introduce a radial flaring of the tube structure before it is submitted to crushing does not improve the energy absorbing capability, compared to pure and plain crushing, as it is shown in Figure 9. Moreover, this configuration worsens the energy absorbing capability as it significantly lowers the SEA value. At last, the use of the conic plug alone, passing through the tube along its whole length, hardly dissipate any energy.

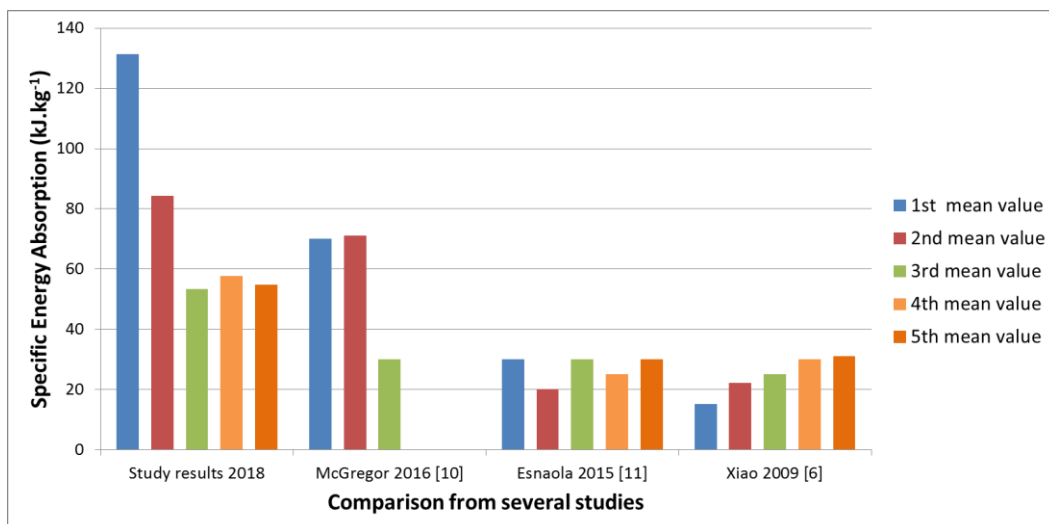
Figure 10. SEA values comparison from different studies.

SEA values up to 140 kJ.kg⁻¹ were obtained, achieving better than most instances from the literature, averaging around 30 kJ.kg⁻¹ and reaching up to around 80 kJ.kg⁻¹. (Figure 10).
