Crushing of composite tubular structures and energy absorption for aircraft seat development

CRUSHING OF COMPOSITE TUBULAR STRUCTURES AND ENERGY ABSORPTION FOR AIRCRAFT SEATS DEVELOPMENT

Abstract

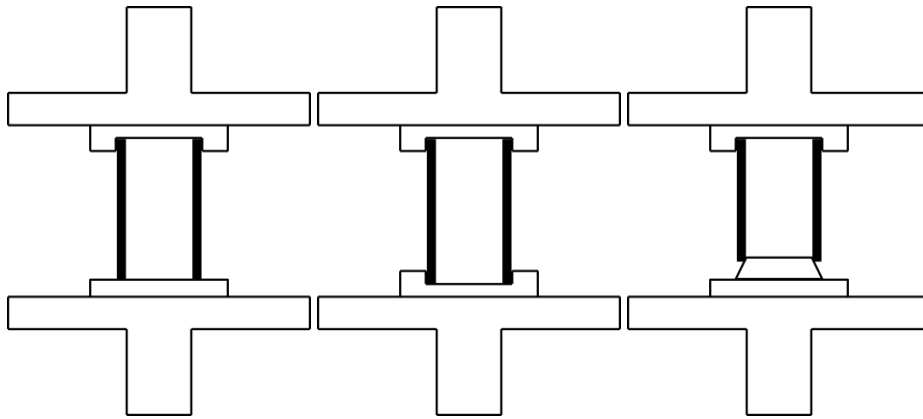
Figure 3. Experimental set-ups with one end free (a), encased (b) and on a conic plug initiator (c).

Quasi-static crushing tests were carried out using a 250 kN Schenck hydraulic testing machine in compression testing mode, through a constant loading speed of 0.2 mm.s^{-1} . Several configurations were tested for crushing initiation and hopeful enhancement. Tubular structures were clamped and encased at one end, while several options were tested for the other. For instance, they were (a) let free on a plane surface, (b) also encased, (c) positioned on a conic plug initiator. Figure 3 presents these three configurations.

Although some specimens underwent catastrophic failure, breaking down from a midpoint zone of their wall length and not from their extremity, none underwent progressive folding, the majority following a progressive crushing scheme. Nevertheless, a clear difference was observed in the spreading array of damaged wall parts depending on the tests configurations (cf. Figure 3).

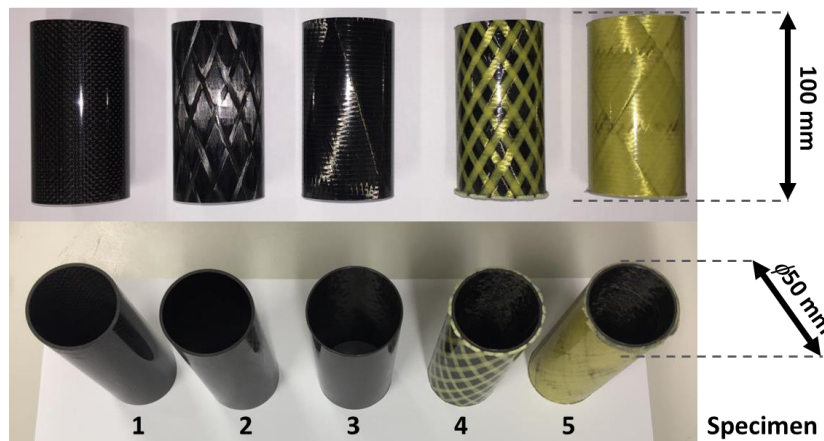
Figure 4. Picture of the five tube specimens with dimensions.

Five specimens with different structure and of different composition were tested in various crushing modes. Structural and material basis for the specimens include 12K HR carbon fibers and polymer Epoxy resin. Fibers orientation and laminate stratification differ from one specimen to another as shown in Figures 4 and 5 and summarized in Table 1. Provided tubular structures were machined and shaped in tubes of 100 mm length as pictured in Figure 4. Outer diameter was set at an average of 50 mm, with inner diameter varying from one sample to another due to stratification differences. Stratification layout and tube wall thickness are summarized in Table 1 for each sample.

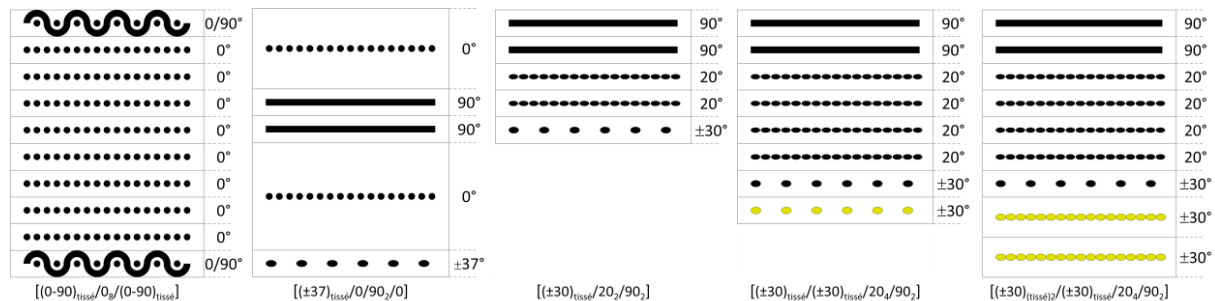
Figure 5. Schematic representation of the five tube specimens by their stratification.

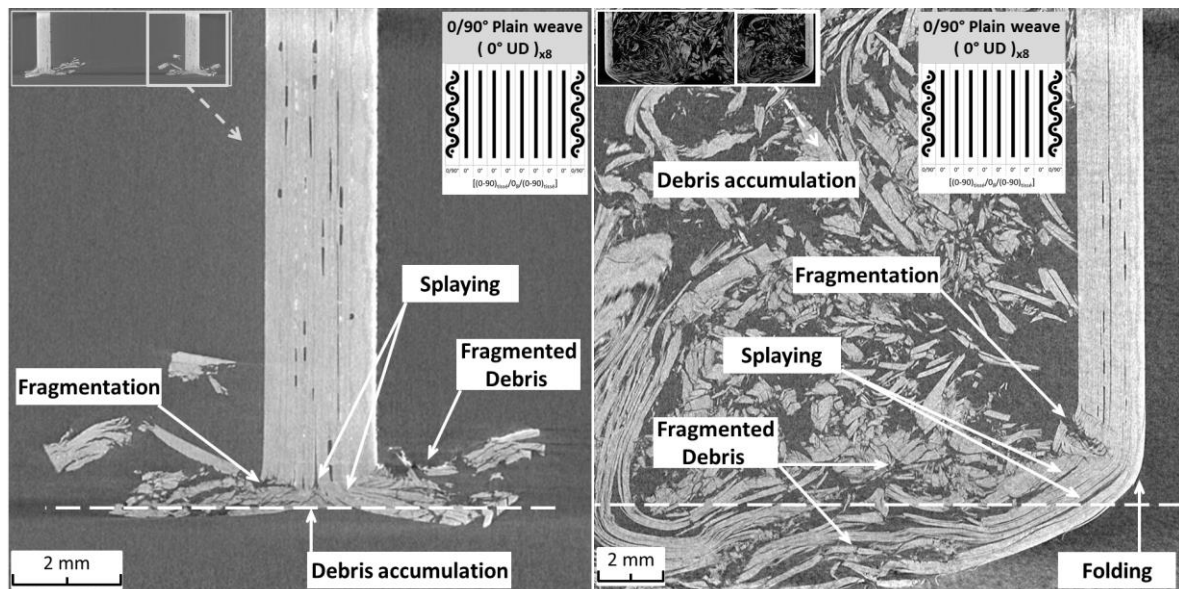
Figure 7. Tomographic images of crushed CFRP tubes showing major damage for two configurations.

Figure 7 highlights major occurring damage resulting from progressive crushing instigated by quasi-static axial compression load for specimen 1 through the means of tomographic imaging for two different crushing modes ((a) and (b) when referring to Figure 3). Inner (a, b) and outer (b) splaying of fragmented or un-fragmented parts are clearly visible, as well as debris accumulation.

The crushing plane surface is schematized by a discontinued line on both pictures on Figure 7. It is strongly suspected that for each tube samples, folded plies at the end of the tube walls between the sane part of the tubes and the crushing surface moved back downward when the crushing force was unloaded, due to a spring back effect. Hence an estimated positioning of the crushing surface appearing to be situated within the tube and entering inside the tube structure.

For the first configuration, a pyramidal-shaped debris accumulation can be observed at the center under the tube wall, between the tube section and the crushing surface, where the laminate plies spread towards the inside or the outside of the tubular structure. This debris accumulation forms from the void created by the plies splaying from the center under the tube wall then subsequently helps further and heighten this splaying.

At the contact surface between the tube circular section and the plane surface, micro-buckling occurs progressively and successively, resulting in matrix and/or fibers fragmentation for the laminate plies that undergo such splaying. This damage increases the debris formation. As observed and mentioned in previous study, the formation and the evacuation or accumulation of debris remains rather random.

For the second test configuration, damage mechanisms are similar in type and classification, but are all shifted toward the inside of the tube, since the outer wall is encased, leaving no leeway for splayed plies to spread that way. Incidentally, although major occurring damage are the same, their origin varies somewhat. Bending and folding resulting from the compression generate the splaying of the composite plies, and therefore the fracture and fragmentation for those sustaining a higher stress. Fragmentation still generates an important number of debris that varies in forms and shape, but those are freely evacuated from the crushing zone under the tube section to the inside of the tube. They do not form a tip that parts the laminate wall and split it, as observed with the pyramidal debris accumulation on the first configuration.

At the extremity of the tube wall, where the folding appears, outer plies seem to be more submitted to bending whereas inner plies undergo plain compression and break through intra-laminar fracture.

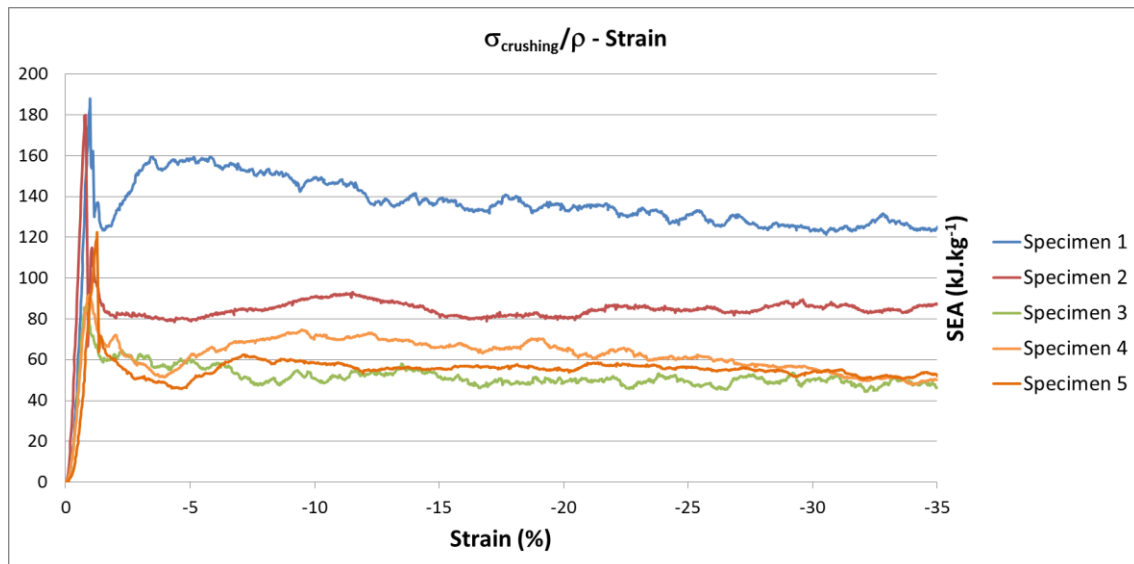
Figure 8. SEA evolution for 5 CFRP tube specimens submitted to pure axial crushing.

The Specific Energy Absorption was calculated after each crushing test for each specimen for every configuration. Results are presented in Figure 8, which highlights the benefit of specimen 1 in terms of energy absorption with a SEA value well above the others, at around 140 kJ.kg⁻¹, and the good performance of specimen 2, with a SEA value of around 80 kJ.kg⁻¹. It can be seen that specimens 3, 4 and 5 have a similar behavior and identical energy absorbing capability, but lesser than the others.

Similarity in behavior and energy absorbing capability for specimen 3, 4 and 5 are not incoherent when referring to Table 1 which shows the same basis structure for these specimens. Outer aramid covering does not improve or worsen the general behavior or energy absorbing capability.

For each axial compression tests, a stiff peak can be observed on the load-displacement curves or the stress/density-strain curves as showed on Figure 8, when the structure yields before it starts collapsing by progressive crushing at a stable and constant load, as reflected by the continuous plateau level. Ideally the gap between the peak and plateau value has to be reduced to a minimum, as a small gap and constant plateau level means an optimized dissipation of energy for a fixed and given load value.

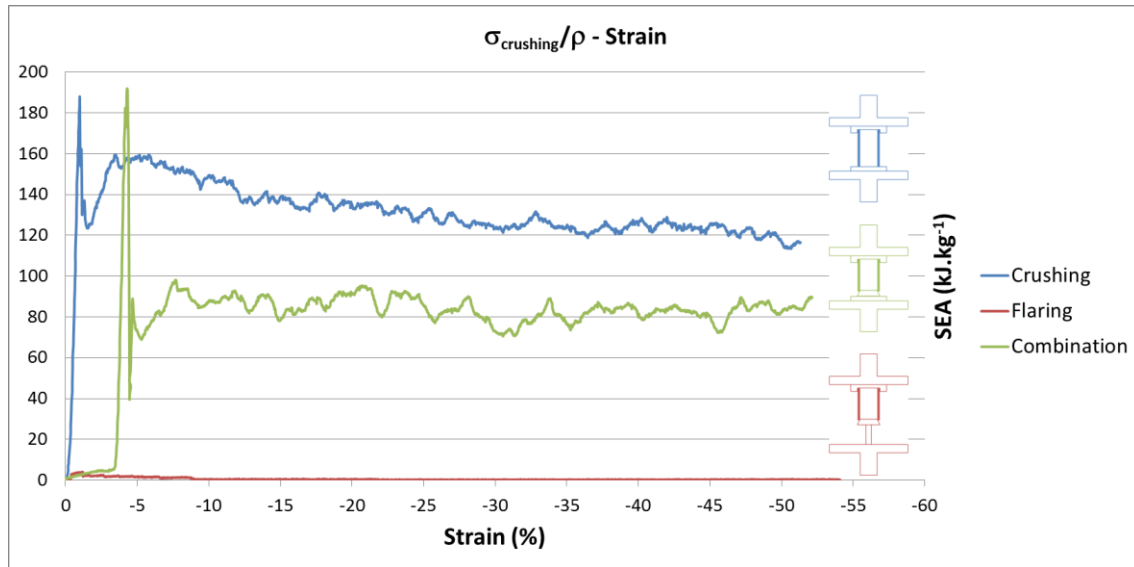
Figure 9. SEA evolution for 3 crushing configurations for the same CFRP tube specimen (n°1).

The use of a conic plug initiator to introduce a radial flaring of the tube structure before it is submitted to crushing does not improve the energy absorbing capability, compared to pure and plain crushing, as it is shown in Figure 9. Moreover, this configuration worsens the energy absorbing capability as it significantly lowers the SEA value. At last, the use of the conic plug alone, passing through the tube along its whole length, hardly dissipate any energy.

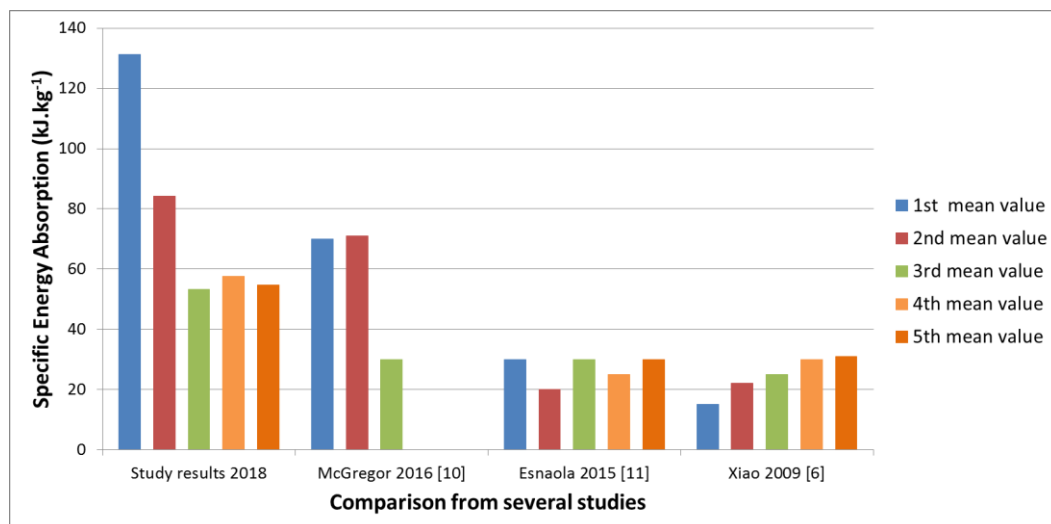
Figure 10. SEA values comparison from different studies.

SEA values up to 140 kJ.kg^{-1} were obtained, achieving better than most instances from the literature, averaging around 30 kJ.kg^{-1} and reaching up to around 80 kJ.kg^{-1} . (Figure 10). Specimens with 0° -oriented fibers achieved better in energy absorption than specimens with none. Woven reinforcement on the inner and outer wall structure proved more effective than solid strengthening support such as poured resin in providing and achieving stability of the structure. Furthermore it helps containing 0° -oriented fibers from splaying and flaring too easily. However, the additional aramid draping was proven needless in term of energy absorbing capacity. Yet this overlapping covering may be valuable in acting as a nest to refrain outer spreading by directing splayed chunks towards the inside and keep brittle parts within the inside of the tubular structure, avoiding expelled debris, as could be required in an aeronautical context.
