Wetting by liquid sodium and fracture path analysis of sodium induced embrittlement of 304L stainless steel

Bassem Barkia, Thierry Auger, Jean Louis Courouau, Julie Bourgon

Bassem Barkia, Thierry Auger, Jean Louis Courouau, Julie Bourgon. Wetting by liquid sodium and fracture path analysis of sodium induced embrittlement of 304L stainless steel. *Journal of Materials Research*, 2018, 33 (2), pp.121-129. <10.1557/jmr.2017.435>. <hal-02162257>

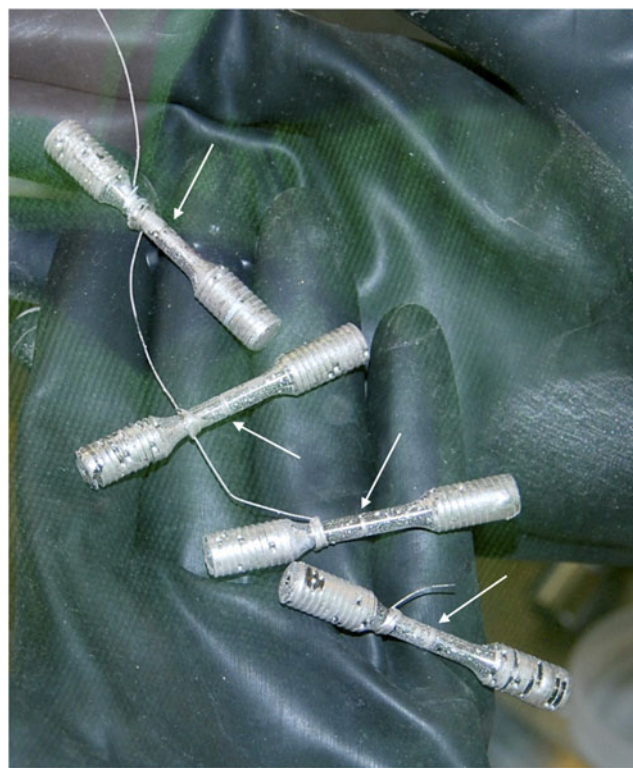
FIG. 1. Image of sodium wetted specimens extracted from the sodium bath after 250 h pre-exposure at 550 $^\circ\text{C}$ (sodium wetted notches indicated by arrows).

The initial surface of the mechanical test specimen was in the state left by machining i.e., a bright and shiny surface. After exposure to liquid sodium for 250 h at 550 °C with 200 $\mu\text{g/g}$ dissolved oxygen, the surface had a dark aspect indicating that either roughness had developed on the surface or that a compound had formed (sodium was removed by a few minutes immersion in ethanol). The SEM analysis of the surface of the exposed sample is shown in Fig. 2. One can see a continuous coverage of the surface by small crystallites that formed during the immersion in liquid sodium. Therefore, a clear change in the surface phase composition induced by pre-exposure had occurred. Grazing angle X-ray analysis was carried out but did not allow identification of the phase forming this very thin layer.

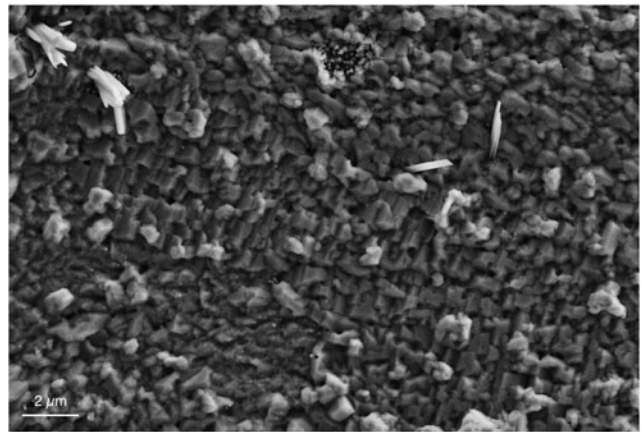
FIG. 2. SEM images of the 304L surface after pre-exposure.

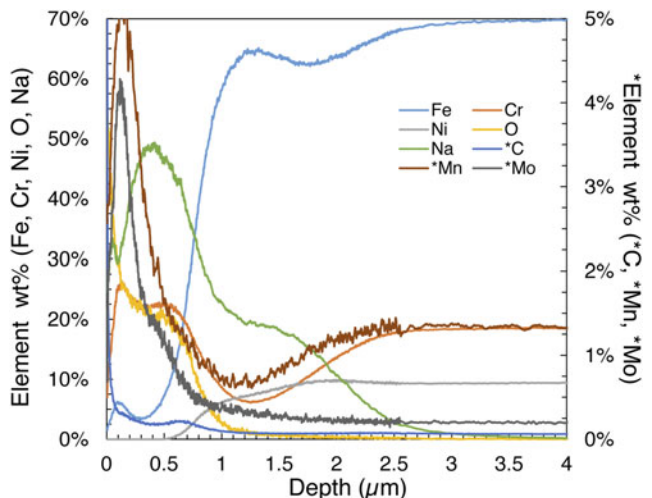
FIG. 3. GD-OES profile of sodium-exposed 304L's surface.

The GD-OES profile carried out on the flat plate introduced with the samples is shown in Fig. 3. At the

surface (at the left side of the graph), one notices a drop in the steel's iron and nickel constituents correlated with a plateau in chromium, oxygen, and sodium. Other minor elements (carbon and molybdenum) have a peak concentration at the extreme surface potentially indicative of mass transfer between the liquid, the molybdenum crucible, and the steel during pre-exposure. The increase in manganese could be explained by the formation of NaMnO_2 since it is possible at a high temperature above 80 wppm oxygen.³ One notices a secondary peak for sodium between 1 and 1.5 μm depth.

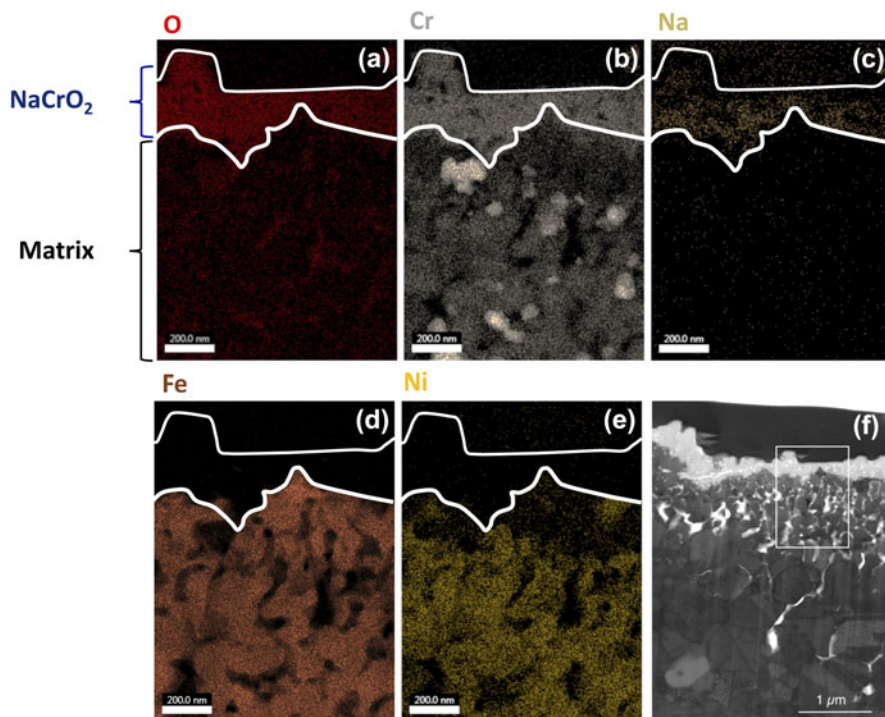
FIG. 4. (a–e) EDX mapping of main elements (f) TEM BF micrograph of the area (the rectangle indicates the area of EDX mapping).

The nanoscale-resolved chemical mapping performed on the TEM lift out is shown in Fig. 4. It indicates that a layer composed mainly of sodium, chromium, and oxygen elements is clearly separated from the underlying matrix elements (iron, chromium, and nickel). The thickness of that layer is of the order of one hundred nm, and the steel/oxide interface is rough. One can note as well that chromium-rich particles formed below the outer NaCrO_2 . This constitutes an unambiguous evidence of the formation of a continuous layer of this phase over a short-term exposure time in oxygenated sodium. This is the key to explain the role of dissolved oxygen on the wettability of sodium over 304L's steel.

Immediately, underneath this oxide layer, a Cr-depleted zone is found which is certainly caused by the oxidation reaction. The TEM bright field (BF) image of the interface is shown in Fig. 4(f). This corrosion zone presents intergranular pores that are clearly seen on the

TEM foil. These porosities were probably filled with liquid sodium so that it explains the secondary sodium peak on the GD-OES profile. The preferential dissolution of iron along the grain boundaries could be the result of the formation of soluble Na_4FeO_3 .

The interface is constituted of small grains of a few hundred nm with holes in between at over a depth of several μm . The microstructure at the surface therefore evolved remarkably from a large grain size to small grains in the machining-affected area. This finding bears similitude with the early finding of Moberly et al. of intergranular precipitates forming during the contact with liquid sodium in the 304L steel.⁸ The corroded area below the oxide layer is then porous and not protective. One can note that this constitutes a posteriori justification for taking the reference measurement from a batch of sodium-exposed samples since the corrosion-affected area develops some voids that weaken the surface layer.

Early on, it was shown that the 304L steel interacted with sodium by the formation of an intergranular phase.⁸ Here, it is found that the first few microns of the corroded layer develop some porosity and Cr-rich precipitates (see BF TEM image in Fig. 4). This might also be an ingredient favoring early crack initiation. Within a wetted crack, the capillary flow of sodium induced by good wetting is then the key to supply liquid sodium at the crack tip at the earliest stage of LME in a self-maintained process. Once started, a crack is filled and will remain filled as it propagates.

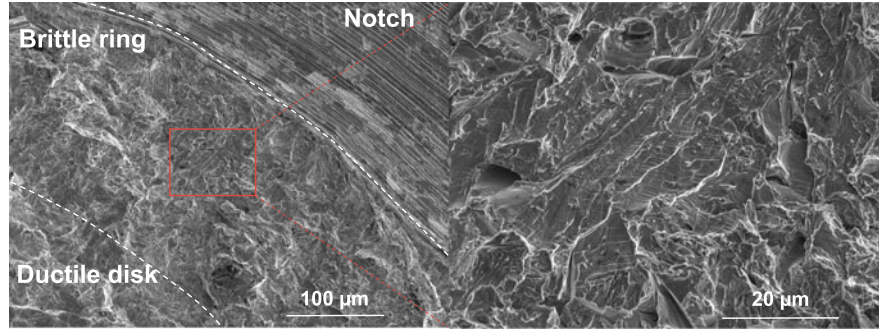
FIG. 5. Fracture surface analysis after tensile test in sodium at 573 K for 304L.

The SEM analysis of the fracture surface is shown in Fig. 5. A brittle ring of 200–300 μm starting at the notch is visible, while the final fracture formed a ductile central ring. Therefore, the fracture surface has a mixed brittle/ductile character that can be explained by the strain rate acceleration at the center during final cracking. A higher magnification view of the fracture surface in the brittle area reveals that some clear intergranular cracks occurred, but the majority of the fracture surface is covered with

a quasi-cleavage type fracture surface and numerous step ridges. This is the type of fracture surface that we aimed at investigating further.

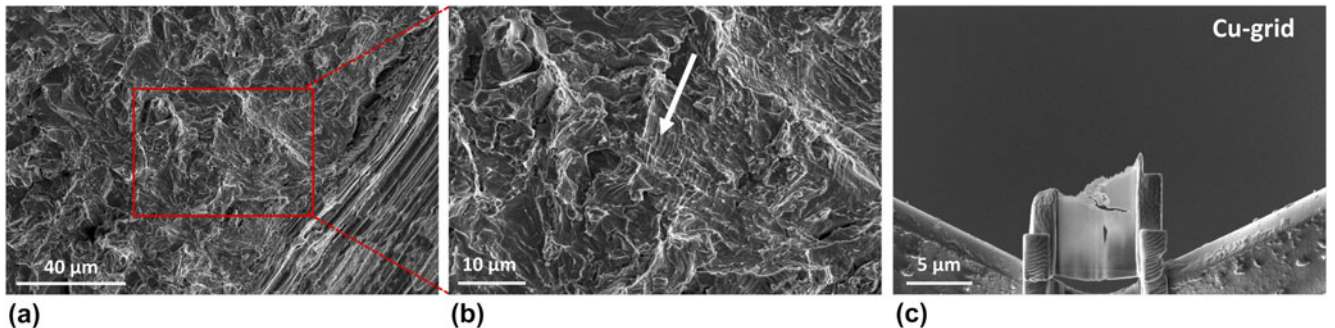
FIG. 6. Steps of TEM thin foil 2 preparation using FIB: (a, b) choice of the site of interest (arrow) (c) transfer of the thin foil to the Cu-grid and thinning.

The standard lift out procedure is applied here on carefully selected areas of the fracture surface. The sites were chosen to allow for a potential analysis of the microstructure lying underneath specific features of the fracture surface. The TEM foil 1 was extracted to look for an explanation of the numerous step ridges that are seen on the fracture surface. Arrested cracks were also looked for to analyze the crack path by preserving its crack tip. It was selected looking for cracks seemingly going in the material's bulk that might have a chance to be short cracks fully captured within the thinned area of the TEM lamella. Such a case is presented here in the TEM foil 2. Figure 6 shows the fracture surface from the FIB preparation of that TEM lamella.

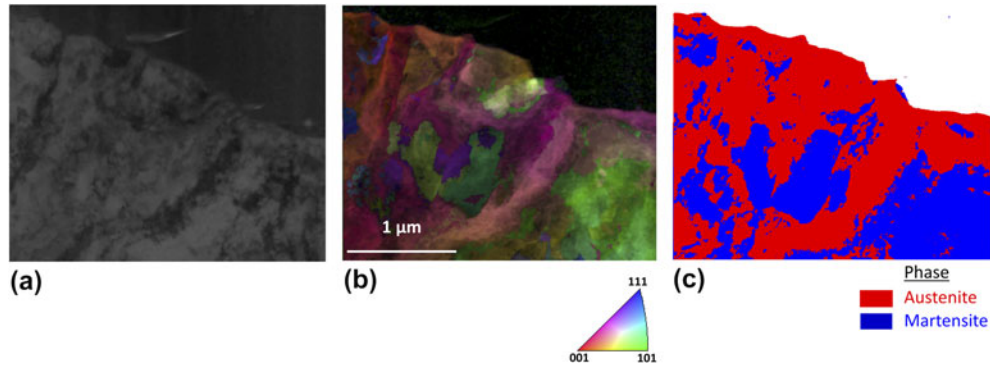
FIG. 7. Microstructure beneath the fracture surface in thin foil 1: (a) TEM BF micrograph (b, c) corresponding orientation map superposed with image quality (IQ) with respect to the normal direction and phase mapping.

The microstructures indexed by the ACOM-TEM tool of foil 1 and foil 2 are shown in Figs. 7 and 8. The thin foil 1 analysis detected numerous areas with α' (bcc) phase transition underneath the fracture surface [Fig. 7(c)]. At the same time, twinning and grain refinement was induced by plastic deformation prior to cracking creating a wealth of newly formed interfaces. One can note the clear correlation between the presence of step ridges at the fracture surface [top part of the orientation map in Fig. 7(b)] and large abrupt orientation

changes just below the surface ridges. This indicates that the step ridges visible on the fracture surface are a legacy of the deformed microstructure lying below. Indeed, the ridges are correlated with newly formed large grains transverse misorientations or eventually mechanical twin boundaries.

Firstly, the 304L steel microstructure is heavily deformed with a large amount of α' phase transformed material. Twinning at the microscale is also observed right below the fracture surface. These processes created a microstructural refinement with a large increase in the density of sub-grain boundaries. The step ridges structure is correlated with a large underlying orientation change (subgrains or twin boundaries) and is the trace of the interplay of twinning or phase transform and fracture.

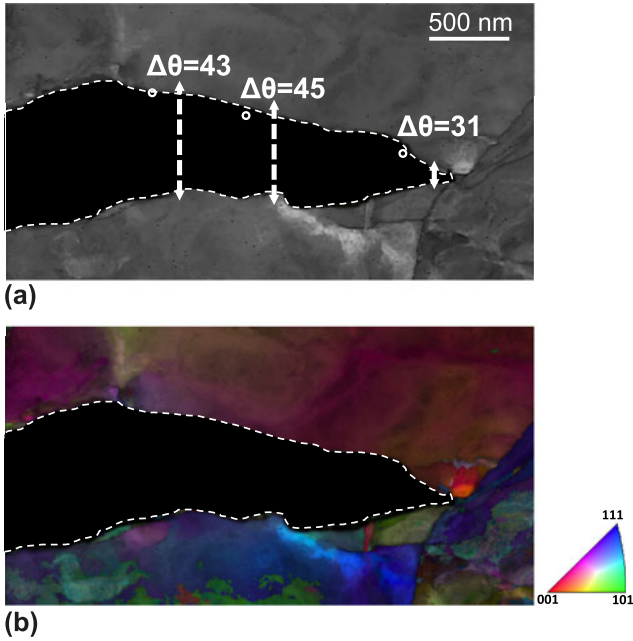
FIG. 8. Microstructure beneath the fracture surface in thin foil 2: (a) The TEM BF micrograph and (b) The corresponding orientation map superposed with IQ with respect to the normal direction (the detected phase is entirely austenitic).

An arrested crack was captured in the TEM foil 2 and subsequently indexed (see Fig. 8). The crack has an opening angle of roughly 20° . The crack is clearly intergranular in the γ matrix and was stopped at an interface (a twin boundary) that was slanted toward the presumed vertical loading axis (therefore not oriented favorably for crack propagation). Several measurements of the misorientation across the cracked interface show that the interface belongs to the general type, the one with a misorientation higher than 15° (not corrected for the crack opening angle). The rapid variation of orientations above and below the cracked interface also indicates highly inhomogeneous plastic deformation. The crack stopped at a twin boundary oriented diagonally but did not go further by a cleavage process. The crack path in this case is fully γ/γ interfacial.

Secondly, the arrested crack of foil 2 shows a typical case of γ/γ interfacial fracture. The underlying microstructure is extremely complex with numerous twins and subgrain boundaries. The fracture surface in the analyzed area was typical of the quasi-cleavage-like fracture area. We can infer that a large part of the crack propagation proceeds as an interfacial fracture.
