## Wetting by liquid sodium and fracture path analysis of sodium induced embrittlement of 304L stainless steel

Bassem Barkia, Thierry Auger, Jean Louis Courouau, Julie Bourgon

Bassem Barkia, Thierry Auger, Jean Louis Courouau, Julie Bourgon. Wetting by liquid sodium and fracture path analysis of sodium induced embrittlement of 304L stainless steel. *Journal of Materials Research*, 2018, 33 (2), pp.121-129. 10.1557/jmr.2017.435 . hal-02162257

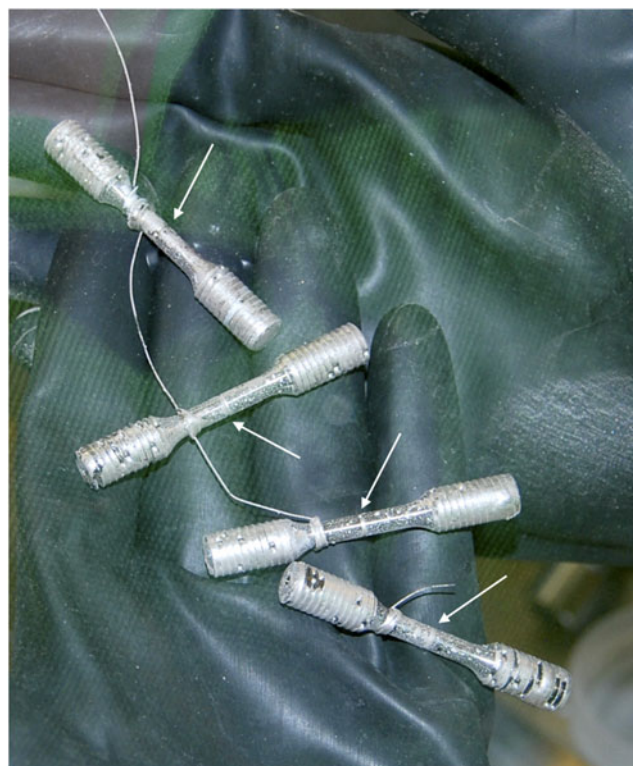
FIG. 1. Image of sodium wetted specimens extracted from the sodium bath after 250 h pre-exposure at 550  $^\circ\text{C}$  (sodium wetted notches indicated by arrows).
