Electrochemical chloride extraction to repair combined carbonated and chloride contaminated reinforced concrete

1 **Electrochemical chloride extraction to repair combined carbonated and**
2 **chloride contaminated reinforced concrete**

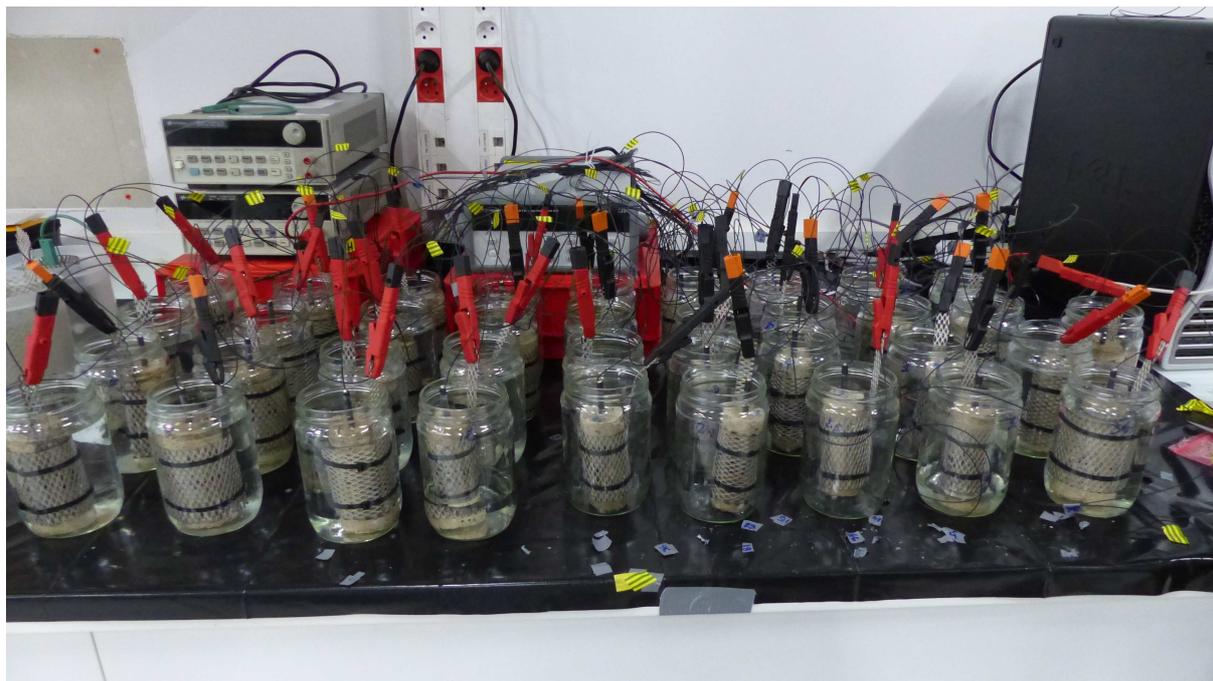
106 The electrochemical chloride extraction (ECE) treatment is illustrated in Figure 1.
107 ECE was conducted on 37 specimens of each sample series. A cathodic current
108 density of -100 $\mu\text{A}/\text{cm}^2$ of steel was applied with a power supply between the rebar
109 and a titanium/platinum grid (counter-electrode) for 8 weeks, corresponding to a total
110 charge of 1344 A.h/m². These current density and duration conditions are in
111 accordance with those reported in the technical specification or standards for chloride
112 extraction [25] and realkalization [26]. A disodium tetraborate solution (25g/L of
113 Na₂B₄O₇ · 10H₂O) electrolyte was used as a 9 pH buffer corresponding to a
114 carbonated concrete. Moreover, some samples were immersed in the electrolyte then

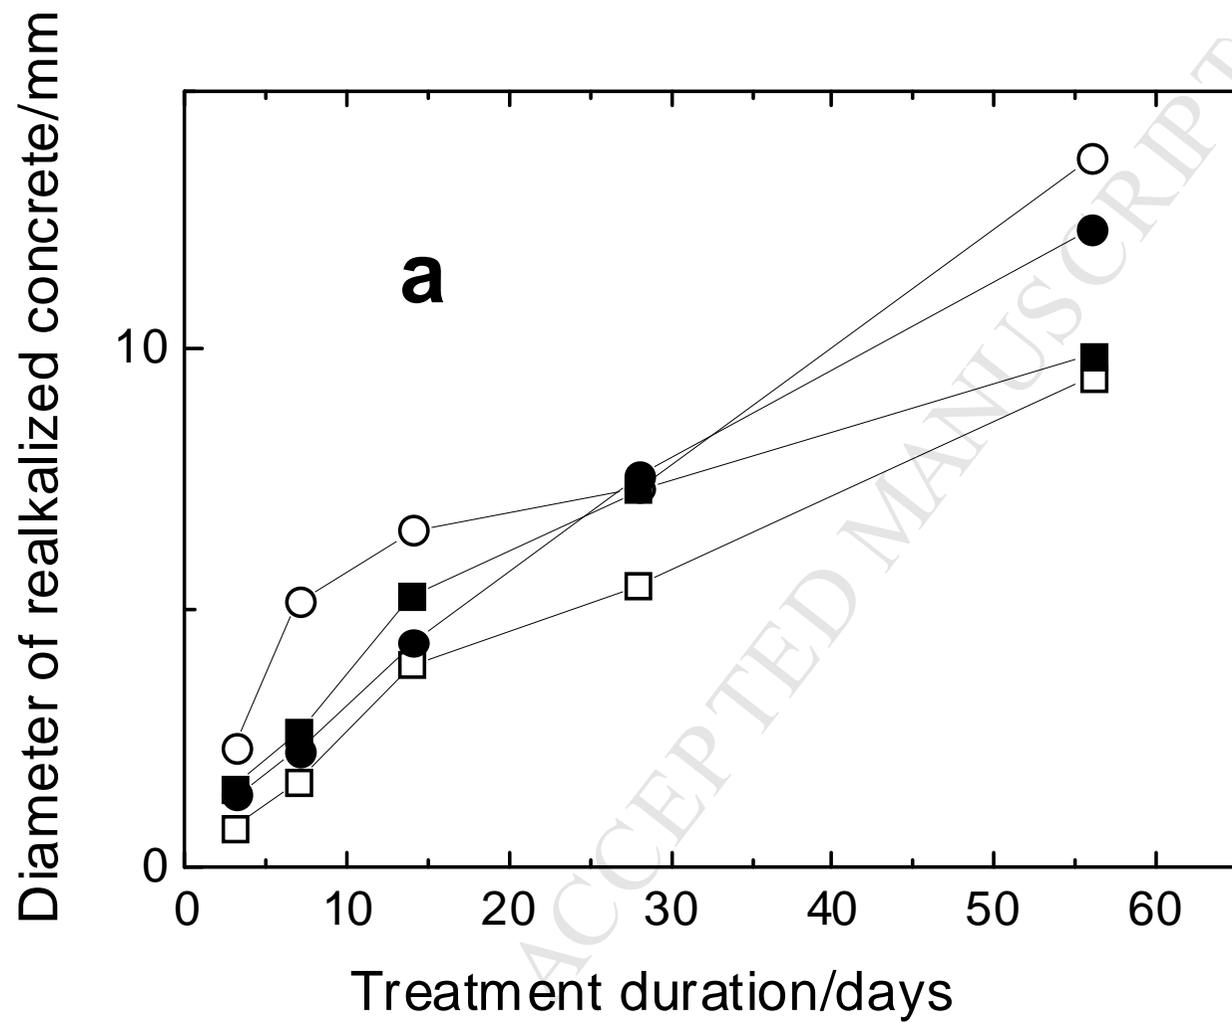
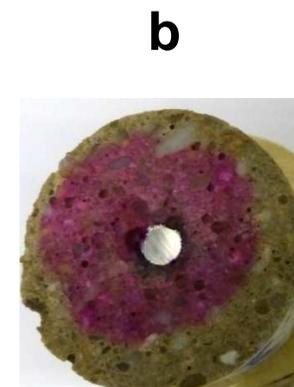
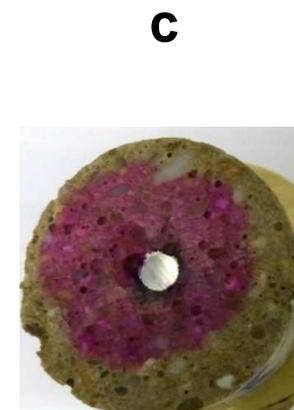
210 rebar is equal to the diameter of the rebar if the latter measures less than one
211 centimeter in diameter, or 1 cm for larger rebar diameters. The results shown in
212 Figure 4a demonstrate that the realkalization was efficient after 14 days for all four
213 series: the ring thickness was larger than the 5 mm rebar diameter. After 56 days of
214 treatment, it was equal to 9, 10, 12 and 14 mm respectively for G3, G1, I1, and I3
215 series., As expected, no realkalized ring was observed for the non-polarized
216 samples.

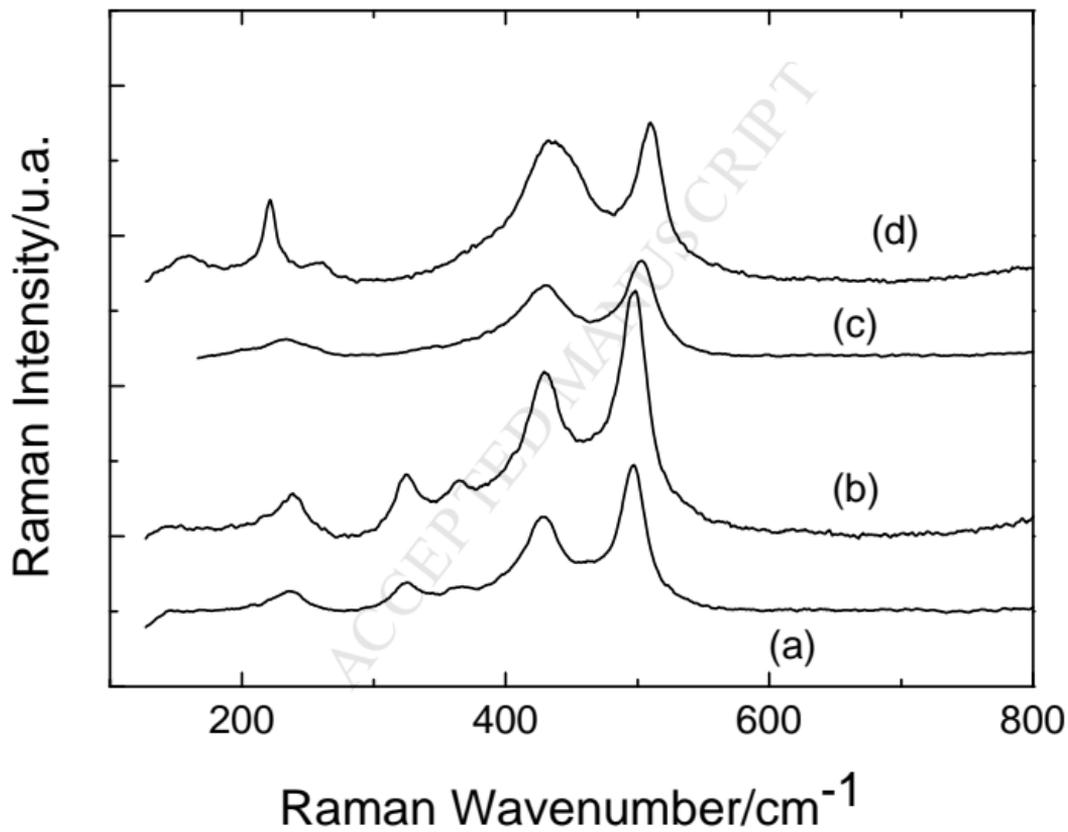
223 Raman spectra obtained at this stage are reported on Figure 5a and 5c with
224 reference Raman spectra of Green Rust (GR) grown respectively in chloride (Figure
225 5b) or carbonate (Figure 5d) solution according to the protocols described in SI1-2.
226 The four series tested mainly showed spectrum 5a, while some spots on G1 samples
227 indicated spectrum 5c.

228 The main differences between the two types of Green Rust spectra are the gap and
229 the position between the two main bands, which are respectively 70 cm^{-1} [500-430]
230 for $\text{GR}(\text{Cl}^-)$ and 75 cm^{-1} [510-435] for $\text{GR}(\text{HCO}_3^-)$, and the presence of two smaller
231 bands at 320 and 360 cm^{-1} for $\text{GR}(\text{Cl}^-)$. Clearly spectrum a) is linked to $\text{GR}(\text{Cl}^-)$;
232 while spectrum 5c is attributed to $\text{GR}(\text{CO}_3^{2-})$.

233 The presence of these compounds attests a fast corrosion process in which chloride
234 is incorporated within corrosion products as the anions in Green Rust structure to
235 counterbalance the presence of iron III. GR(Cl⁻) are known to be thermodynamically
236 unfavored compared to carbonate (or sulphate)-based GRs [37]. The localized
237 observation of GR(CO₃²⁻) on G samples shows inhomogeneous distribution of
238 chloride ion concentration in pore solution.

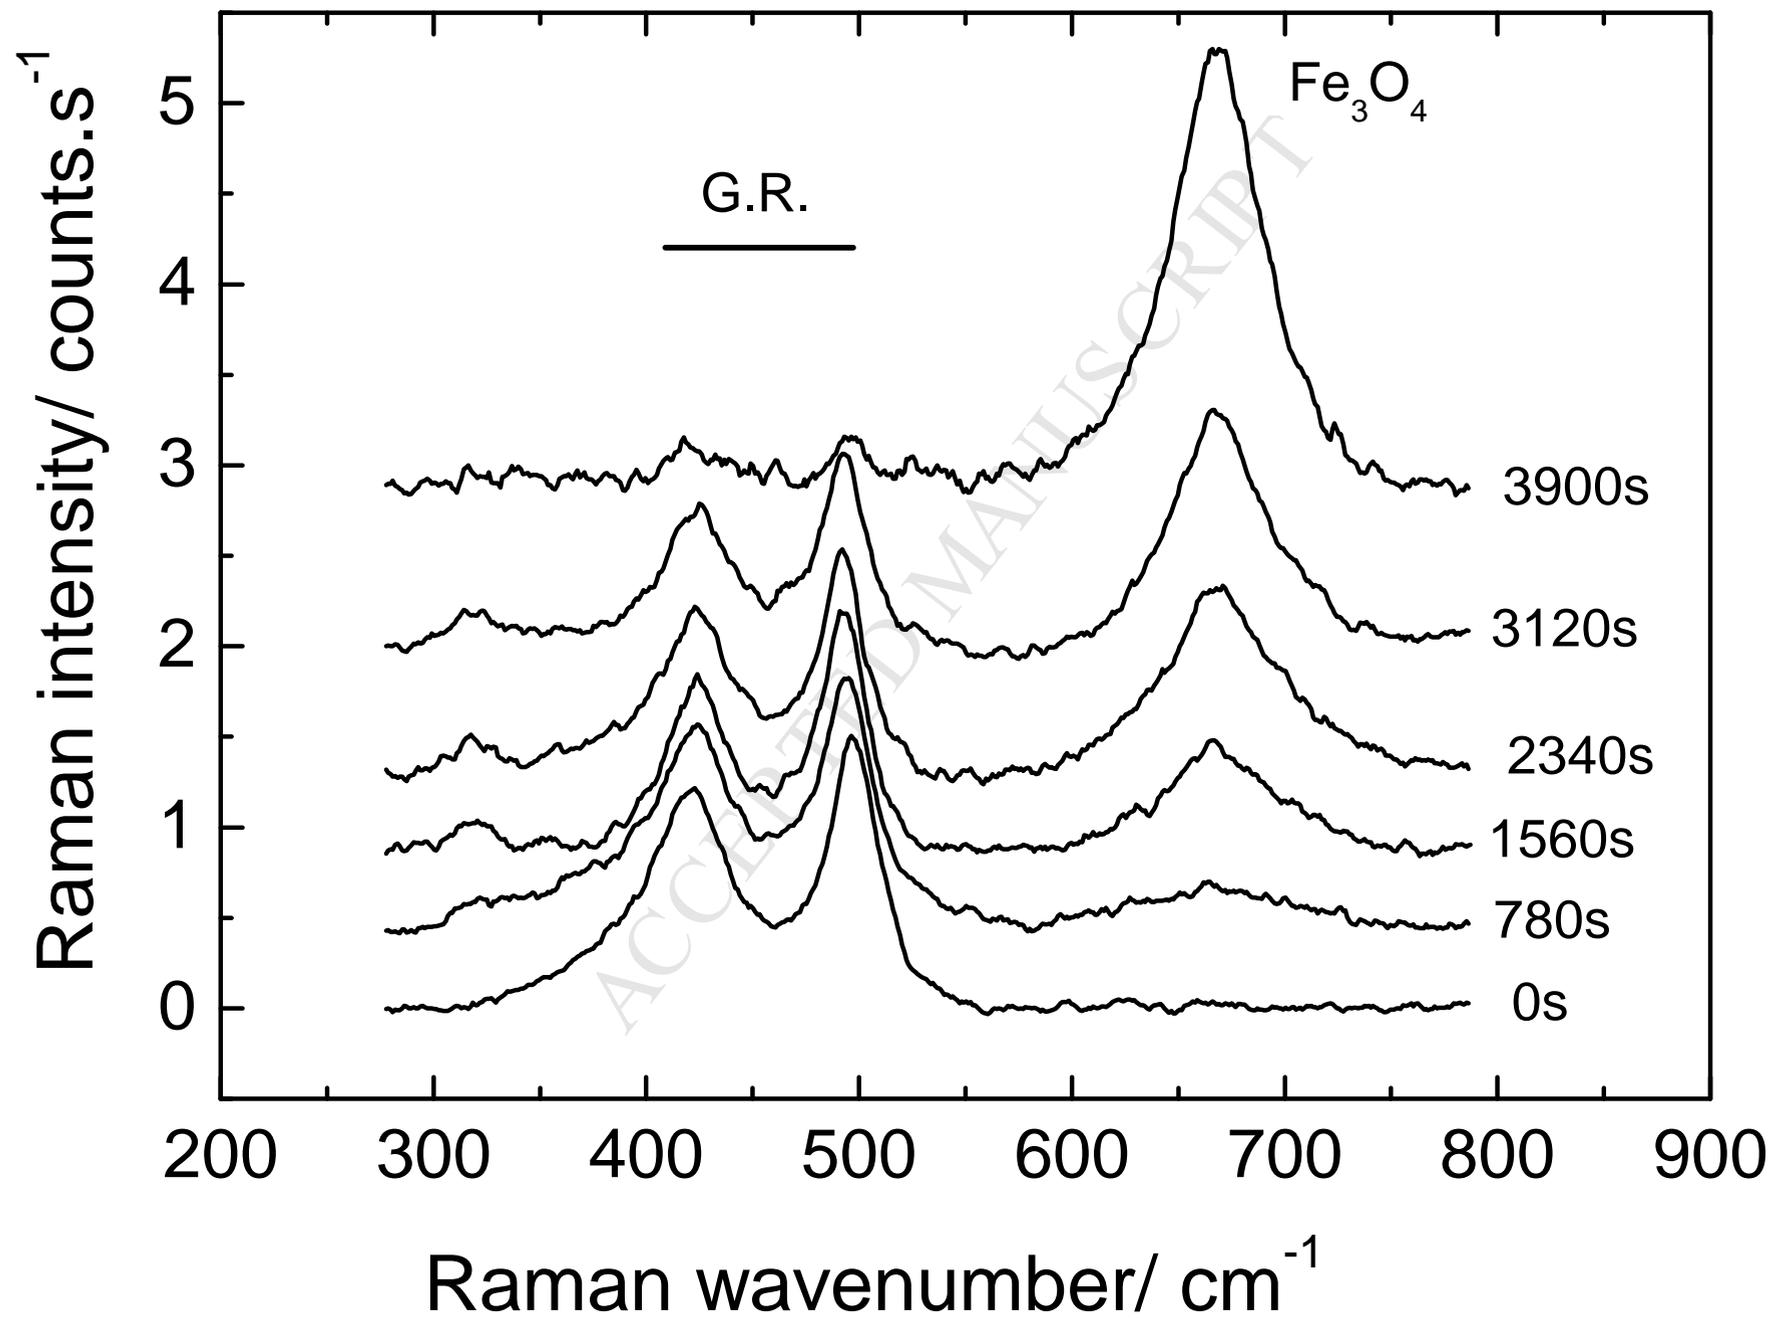
242 During treatment, once corrosion was proved to occur by the formation of spots of
243 Green Rust, a cathodic current of -100 $\mu\text{A}/\text{cm}^2$ was added to the system. Raman
244 spectra were periodically recorded during this treatment. The spectra observed
245 during the reduction process are depicted in Figure 6 for I1 sample.

246 After polarization is turned on, the characteristic band of magnetite Fe₃O₄ appears at
247 670 cm^{-1} . With time, a progressive increase is observed in magnetite bands, causing
248 a decrease in Green Rust bands until they almost completely disappear. All the
249 studied series behaved in the same manner, the only differences being the induction
250 time and the growing rate of magnetite, which both varied from one sample to the
251 other (SI 4). However, magnetite was the predominant band for all samples after 24
252 hours of polarization.

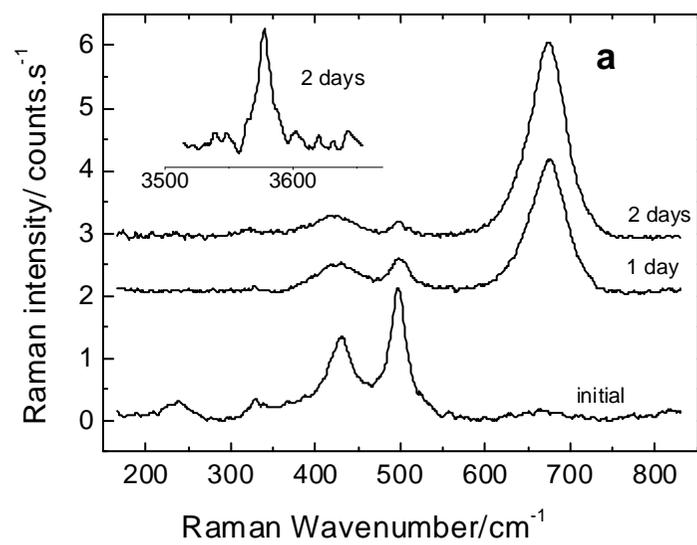
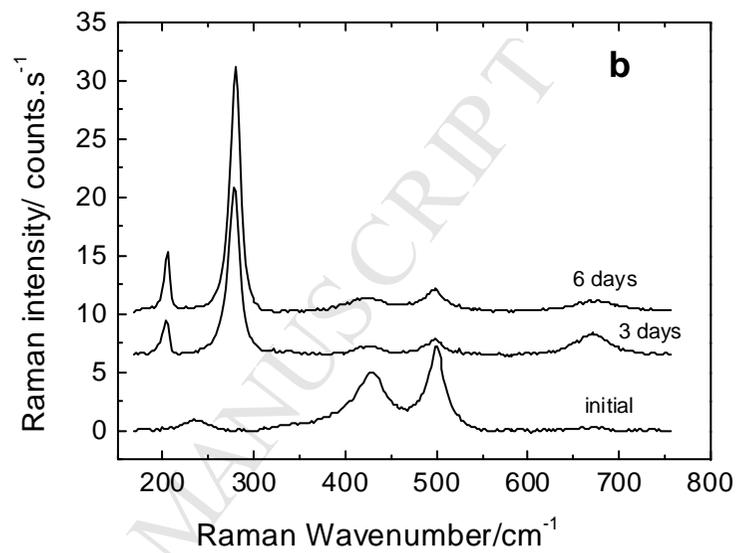
257 to a high interface fluorescence. Figure 7a presents the evolution of the Green Rust
258 bands, with a rapid decrease in the intensity of the 500 cm^{-1} band compared that of
259 the 430 cm^{-1} band. A shift of the 430 cm^{-1} band towards a lower wavenumber (410
260 cm^{-1}) is also observed. Moreover, after 2 days a new band appears in the 3600 cm^{-1}
261 range (see insert in Figure 7a) corresponding to O-H stretching vibration at 3575
262 cm^{-1} . These values were in accordance with reference [39] and indicated the
263 formation of $\text{Fe}(\text{OH})_2$ in I1 series. In Figure 7b, after 3 days of treatment, two new
264 bands appeared in the Raman spectrum: 205 cm^{-1} and 280 cm^{-1} . They correspond to
265 mackinawite Fe_{1-x}S [40] in G3 series (also observed for I3 series, not shown). The
266 presence of sulfide is due to the blast furnace material contained in cement 3 (CEM
267 III/A) [22].

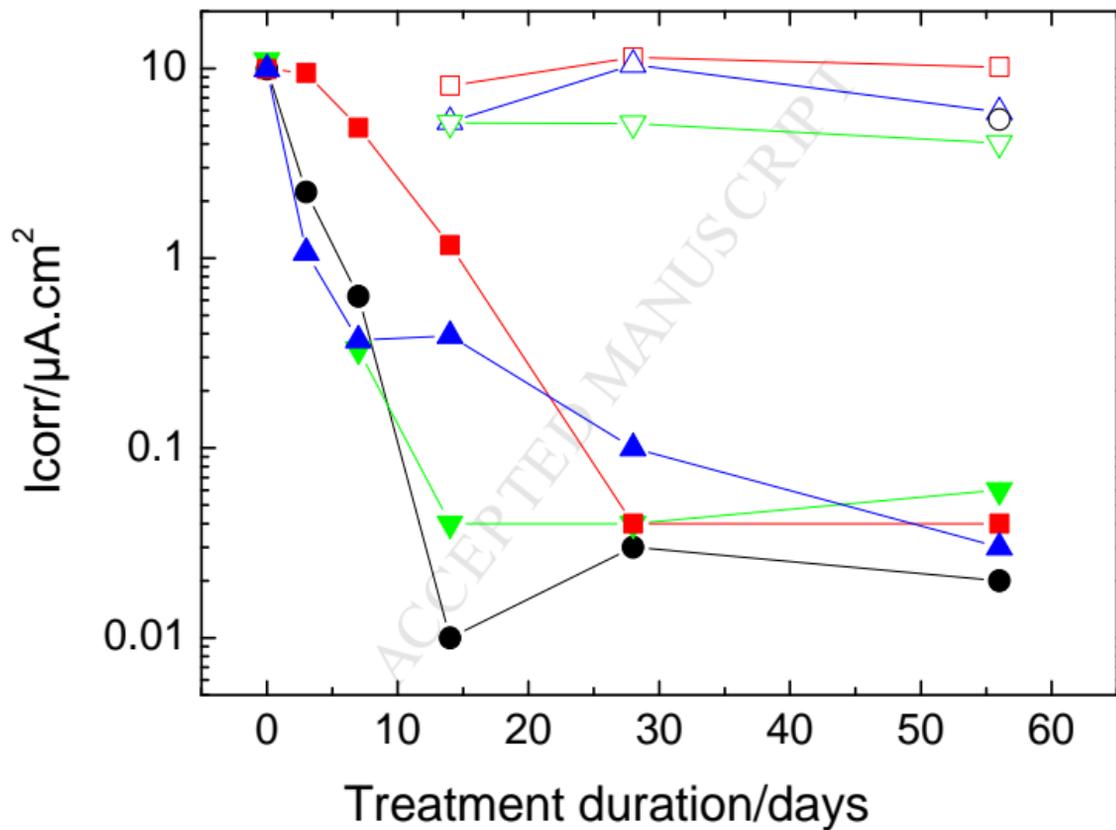
286 ECE treatment aims to decrease or even stop reinforcement corrosion. Figure 8
287 presents the results of corrosion rates versus treatment duration. These
288 measurements were performed 3 months after the end of the treatment period in
289 order to allow the system to recover a stable state (with the exception of time 0). For
290 the four series, the ECE treatment leads to a decrease of the corrosion rates over
291 time, with two or three orders of magnitude (log scale). From days 14 to 56 of
292 treatment (corresponding to durations after which free chloride content was below
293 0.4%), corrosion rates decreased to values below $0.1 \mu\text{A}/\text{cm}^2$.

294 Corrosion rates remained in the range 1 to $10 \mu\text{A}/\text{cm}^2$ in the non-polarized samples,
295 where chloride ions had been removed by lixiviation but were still carbonated.

Figure 8: Corrosion current for ●G1, ■G3, ▼I1 ▲I3 series polarized in tetraborate solution and ○G1, □G3, ▽I1 △I3 non polarized sample versus treatment duration.

296 These results show that chloride extraction and pH increase are both needed to slow
297 down the corrosion of the reinforcement and that realkalization is mandatory.

304 Nevertheless, corrosion rates for after treatment remained one order of magnitude
305 higher than for the sound concrete for all contaminated samples. The passive state of
306 the rebar in the sound concrete was not therefore recovered in the samples. This was
307 confirmed by the presence of iron II revealed by Raman spectroscopy, indicating that
308 corrosion was still active on some spots.

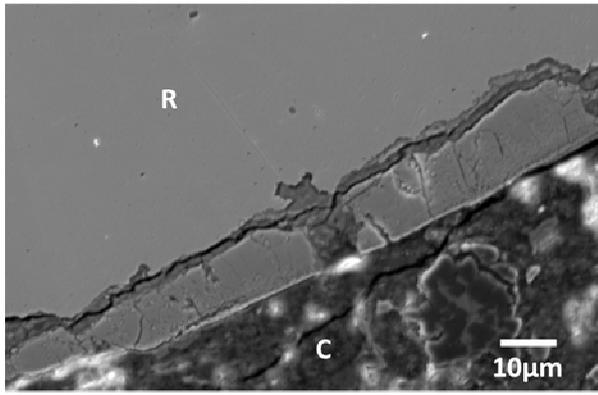
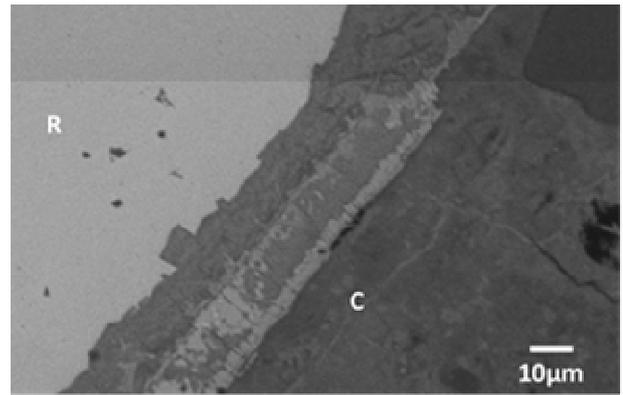
321 increase in carbonated solution due to a buffer effect. Figure 9 presents SEM
322 observations of realkalized samples thirty months and five years after treatment.
323 They exhibit a doubling of the corrosion layer thickness (15 to 30 μm) over time (30
324 to 60 months), evidencing a reactivation of corrosion.

Figure 9: Corrosion products layers after the realkalization treatment a) 30 months after (thickness = 15 μm) and b) 60 months after (thickness = 30 μm). R: rebar, C: concrete
