Evidence for the breakdown of an Angkorian hydraulic system, and its historical implications for understanding the Khmer Empire

Terry Lustig, Sarah Klassen, Damian Evans, Robert French, Ian Moffat

This paper examines the construction and design of a 7-km long embankment, probably built for King Jayavarman IV between 928 and 941 CE, as part of a new capital. We calculate that the capacities of the outlets were too small, and conclude that the embankment failed, probably within a decade of construction, so that the benefits of the reservoir stored by the embankment and the access road on top of it were lessened substantially. We explain how the design was sub-optimal for construction, and that while the layout had a high aesthetic impact, the processes for ensuring structural integrity were poor. Simple and inexpensive steps to secure the weir were not undertaken. We speculate that this early failure may have contributed to the decision to return the royal court and the capital of the Khmer Empire to the Angkor region, marking a critically important juncture in regional history.

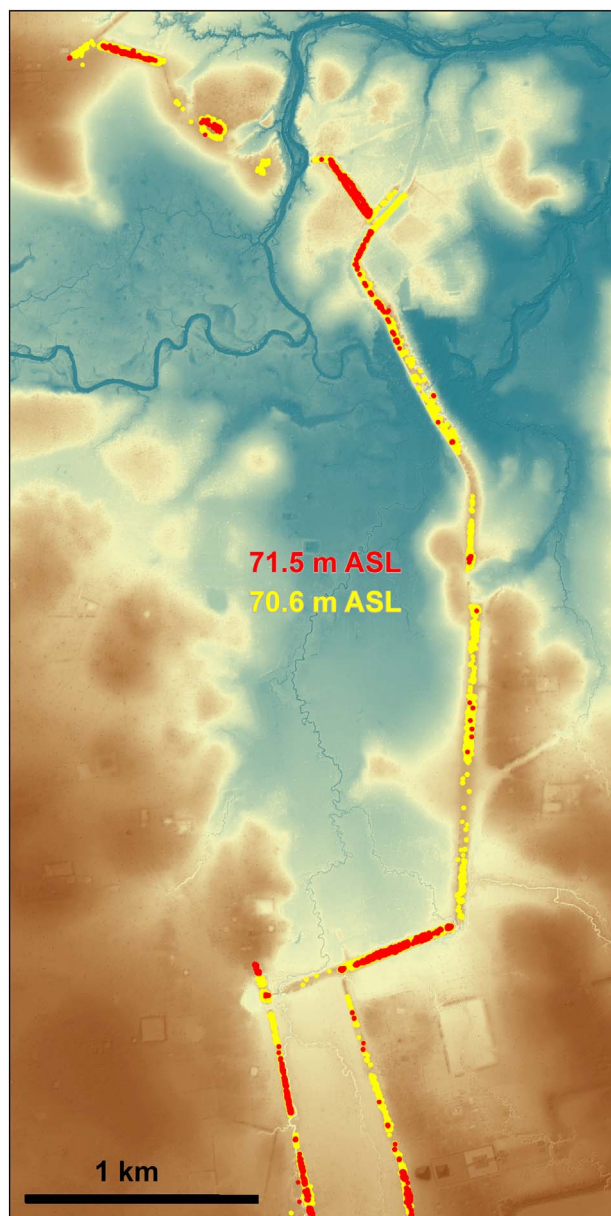
Fig. 8. Embankment showing where the crest is at or above 70.6 m ASL (yellow) and 71.5 m ASL (red), respectively.

This section outlines evidence for the embankment being overtopped twice. Much of the embankment is still higher than 70.6 m, and some is above 71.5 m ASL today (Fig. 8), so it is reasonable to suppose most of it was initially higher than now and has since eroded.

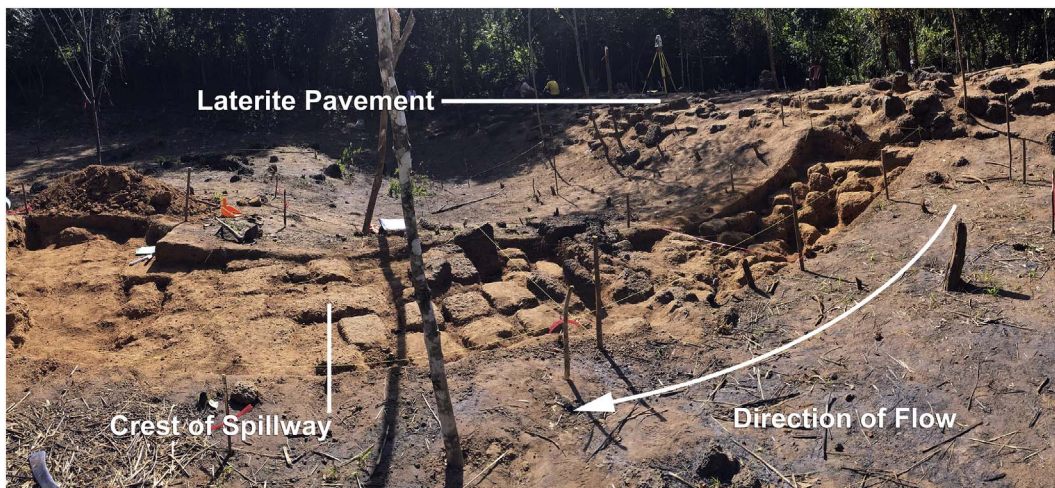
Fig. 14. Spillway in chute with crest at ~68.5 m ASL. Pavement-like structure on right with top at ~69.8 m ASL. Water would have flowed over the spillway towards the left, before the pavement was there.

The chute may have failed less dramatically than the main spillway to the south. The spillway in the chute has a much gentler slope and the blocks that eroded at the toe — again there was no energy dissipator — do not seem to have resulted in a rapid failure of the whole structure. Our probing did, however, find gaps in the subsurface laterite layer, and this was supported by the results of the ground penetrating radar (GPR) data from the chute, which showed that about a third of the spillway eroded severely, but that some of it remained largely intact. Detailed hydraulic modeling will be required to estimate the peak velocities of the water flowing over the reasonably complete portions of the spillway, but they do lend support to the idea that the water in the reservoir was not much higher than 70 m ASL when the embankment failed.

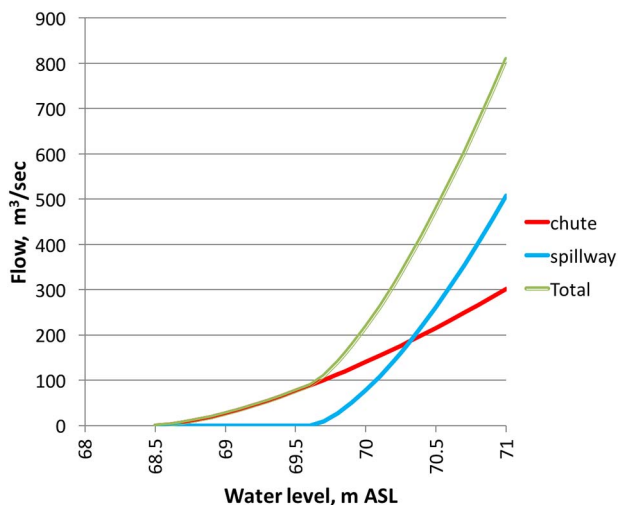
Fig. 16. Flow over both spillways increasing with water level in reservoir.

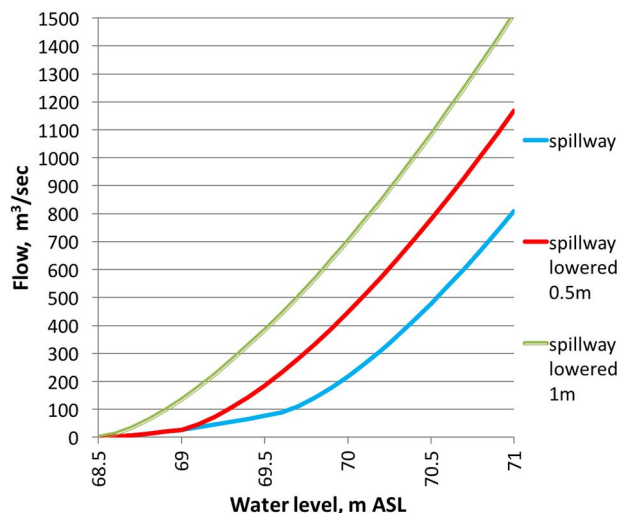
Fig. 17. Total flow over spillway and chute, and with spillway lowered.

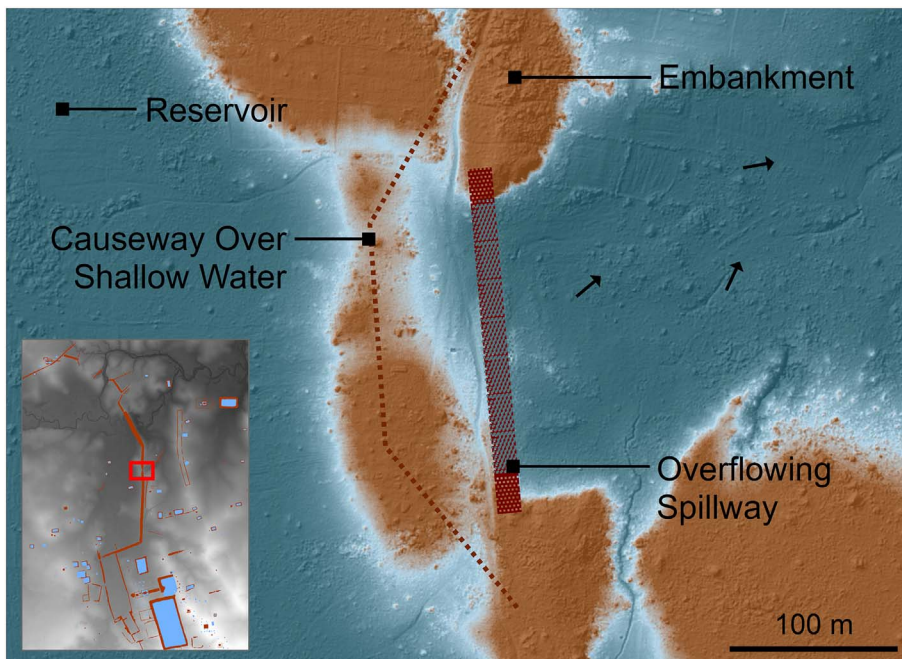
Fig. 24. Possible layout of causeway option to bypass spillway.

a causeway on piers along the high ridge upstream to bypass the spillway (Fig. 24). If so, this might help explain why the main spillway was installed downstream of high ground.
