Evidence for the breakdown of an Angkorian hydraulic system, and its historical implications for understanding the Khmer Empire

This paper examines the construction and design of a 7-km long embankment, probably built for King Jayavarman IV between 928 and 941 CE, as part of a new capital. We calculate that the capacities of the outlets were too small, and conclude that the embankment failed, probably within a decade of construction, so that the benefits of the reservoir stored by the embankment and the access road on top of it were lessened substantially. We explain how the design was sub-optimal for construction, and that while the layout had a high aesthetic impact, the processes for ensuring structural integrity were poor. Simple and inexpensive steps to secure the weir were not undertaken. We speculate that this early failure may have contributed to the decision to return the royal court and the capital of the Khmer Empire to the Angkor region, marking a critically important juncture in regional history.

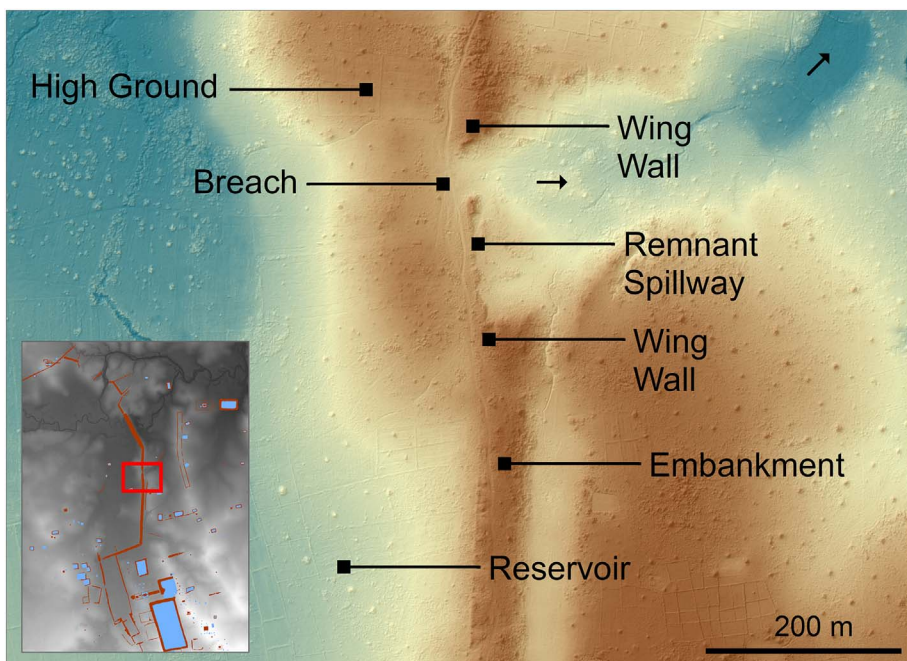
Fig. 6. Spillway with high ground upstream, and washed out at northern end. The tops of the wing walls are at about 70.6 m ASL. See also Figs. SI 3 and SI 4.

the high velocities of water flowing over the spillway. Laterite blocks have also been located as far as 500 m downstream, supporting the idea that the failure of the spillway was catastrophic. This major breach can be seen clearly (Figs. 6 and SI 3).

A deficiency in design that contributed to the failure of the embankment was that the spillway was founded on the low side of a sloping sandstone rock shelf. We judge from the lidar, together with surveys on site, that the elevation of the crest may have been originally at about 69.6 m ASL. However, there is a ridge of sandstone whose crest ranges from 68.9 m to 69.7 m ASL just upstream (to the west in Fig. 6). It is impractical to construct a spillway at a level that is at much the same level as a ridge just upstream. With the adopted layout, this high ground upstream would have impeded the flow of water from the reservoir to the spillway, so the structure's capacity for discharging excess flows was less than optimal.

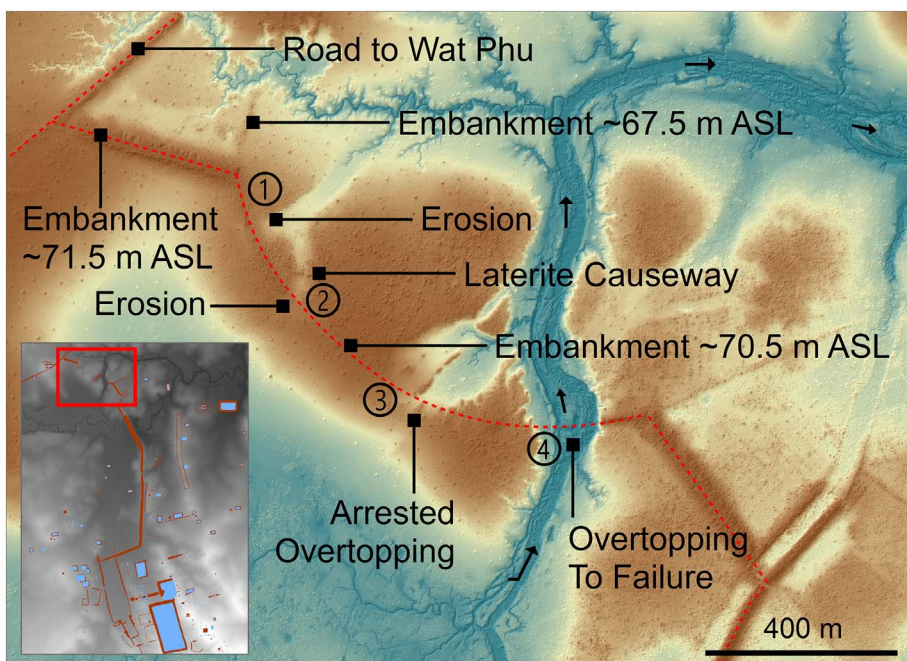
Fig. 7. Northwestern section of embankment. The high embankment meets a possibly older embankment, which appears to have been eroded by water from the reservoir when it overtopped the first time. The embankment seems to have been replaced with a new one (Points 1 and 2). Both sections seem to have eroded a second time, possibly when there was also overtopping further east (Points 3 and 4), with the river forming at Point 4.

The north-western section of the embankment appears to be unfinished (Fig. 7). Again, allowing for erosion, we suggest that it may have run eastwards from the Wat Phu Road at an elevation of about 71.5 m ASL for about 400 m until it met a lower embankment with crest seemingly at 70.6 m ASL.¹⁰ At one location, this lower embankment appears to have been eroded and then repaired, then eroded again (Sections 2.3 and 2.6), suggesting that the embankment was overtopped twice.

The erosion marks in Fig. 7 are too high to have been formed by natural runoff from the landscape, and are consistent with the ground being washed away by water from the reservoir. Points 1 and 2 show erosion less than at Points 3 and 4. But if we look more closely at Point

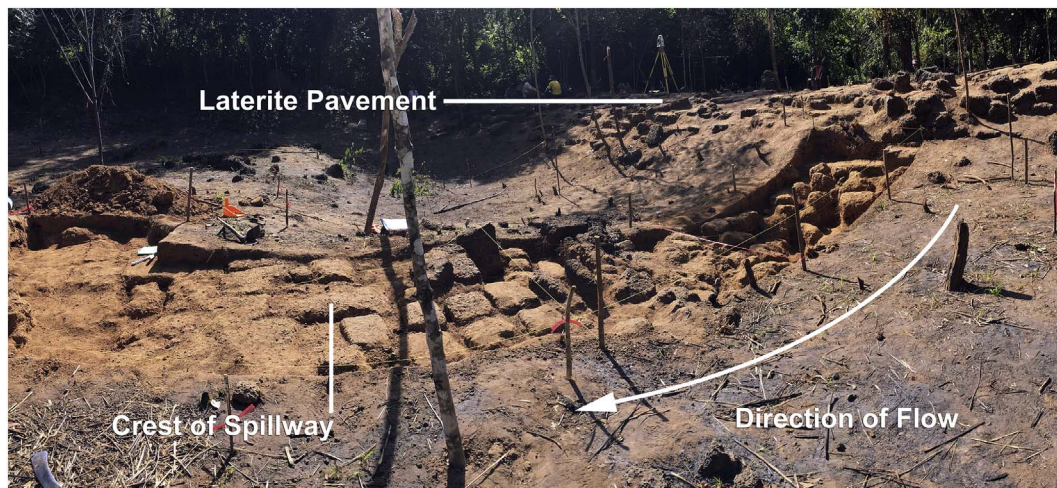
Fig. 14. Spillway in chute with crest at ~68.5 m ASL. Pavement-like structure on right with top at ~69.8 m ASL. Water would have flowed over the spillway towards the left, before the pavement was there.

The chute may have failed less dramatically than the main spillway to the south. The spillway in the chute has a much gentler slope and the blocks that eroded at the toe — again there was no energy dissipator — do not seem to have resulted in a rapid failure of the whole structure. Our probing did, however, find gaps in the subsurface laterite layer, and this was supported by the results of the ground penetrating radar (GPR) data from the chute, which showed that about a third of the spillway eroded severely, but that some of it remained largely intact. Detailed hydraulic modeling will be required to estimate the peak velocities of the water flowing over the reasonably complete portions of the spillway, but they do lend support to the idea that the water in the reservoir was not much higher than 70 m ASL when the embankment failed.
